Seismic Assessment and Retrofitting of a Container Wharf and Container Yard following the 27 February 2010 Chile Earthquake

J. P. Smith-Pardo
Seattle University, USA

J. C. Bardi, C. E. Ospina
BergerAbam Inc., USA

SUMMARY:

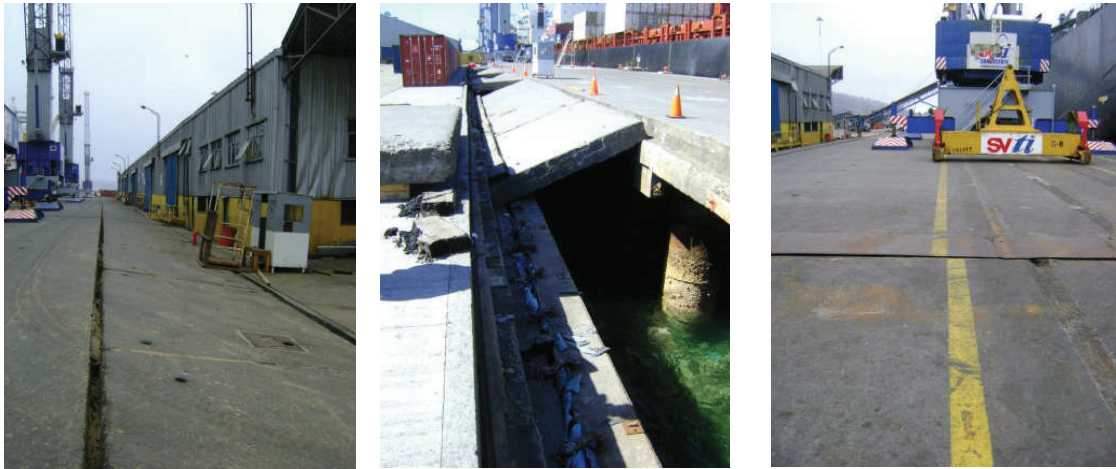
Figure 6 Observed wharf surface damage

Lateral seaward movement of the wharf was observed not only as a result of embankment subsidence, possibly associated to insufficient compaction of both the fill itself and the silty sand layer, and also twisting of the deck in plan. The former is a problem that may occur in terminals that have been reclaimed to the sea, whereas the latter occurs because the center of stiffness of a marginal wharf does not coincide with its center of gravity. The fact that the embankment failure was more pronounced at the extreme north and south ends forced a clockwise twisting of Berth 1 and a counterclockwise twisting of Berth 3 and thus the full marginal wharf system formed a C-shape in plan after the earthquake. At Berth 1, the twisting was accompanied by significant seaward tilting of the wharf that was as large as 1.5 meters at the north end, which suggested that the slope may also have experienced a slip-circle rotational failure below the pile tip elevation.

Embankment subsidence ran along the shoreline of the entire platform (Fig. 5a). The twisting of the deck at the extreme wharf's ends also triggered loss of support for the approach slab (Fig. 5b), which severely limited operations of the terminal. Both the lateral wharf movement and the deck twisting in plan led to a relative lateral displacement at expansion joints varying from 100 mm to 200 mm (Fig. 5c). The maximum observed sway of Berths 2 and 3 was about 300 mm and took place at the southeast end of the wharf. The presence of the expansions would have critically crippled operations had SVTI had STS cranes. It is the authors' opinion that the use of expansion joints in marginal wharf applications is usually driven by tradition rather than actual need, because the temperature gradients would not typically induce significant induced forces even for long segments.

a) Embankment settlement

b) approach slab seat loss at wharf ends

c) Deck displacement at expansion joint

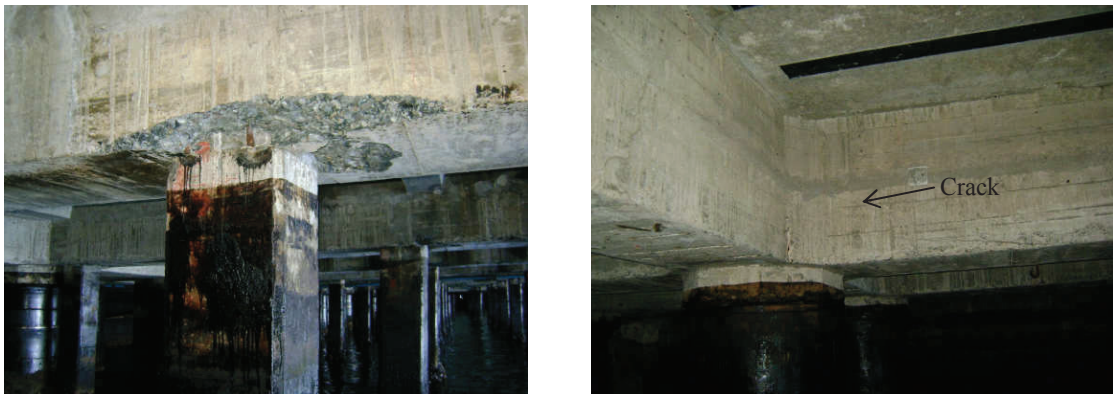
Figure 7 Observed underside wharf damage

An underside inspection of the marginal wharf revealed different damage levels in the structural components. The top of pile/deck connection showed no evidence of non-prestressing reinforcement projecting from the pretensioned piles into the pile caps (pinned connection). Typical pile damage at these locations consisted of significant concrete bottom cover spalling in the transverse cap (Fig. 6a). Unlike the pretensioned piles, the large steel pipe shafts did develop curvature at the pile/cap

connection as evidenced by the diagonal tension (shear) cracking shown in the cap (Fig. 6b). The extent of cracking appears to reflect the significant resistance exerted by the landside steel piles to prevent the lateral movement of the rather flexible seaside concrete piles.

a) typical seaside concrete pile-to-cap damage

b) typical landside concrete pile-to-cap damage
