Post Earthquake Field Investigation of the M_w 9.0 Tōhoku Earthquake of 11th March 2011

A reconnaissance was conducted by the UK-based Earthquake Engineering Field Investigation Team (EEFIT) to study the effects of the recent M_w 9.0 Tōhoku earthquake. The purpose of the mission was to assess the damage on buildings and infrastructure caused by the earthquake and tsunami. The consequent effects of the catastrophe on the local community were also one of the mission's key interests. This paper presents a wide coverage of the earthquake event, comprising the damage observed on residential, commercial and industrial buildings and facilities, geotechnical failures such as ground settlement, liquefaction and landslides, the effectiveness of coastal defences, vertical evacuation facilities and the use of geospatial tools after experiencing the nation's largest earthquake event since the beginning of instrumental seismology circa 1900. The observations on ground motion and shaking damage are discussed in the accompanying paper.

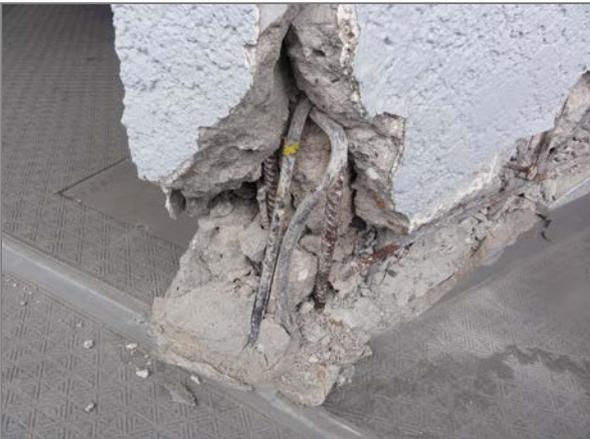
Diagonal shear cracks and column buckling failures were observed in some buildings during the reconnaissance which were identified as unsafe with red-label notices by the local authorities. Observations of some reinforced concrete (RC) residential apartments such as one shown in Figure 1 indicated the use of smooth reinforcement bars, insufficient hook length and angles. Ground settlement of about 100 to 200mm could also have exacerbated the severity of the damage. Other reinforced concrete buildings such as the Sukagawa city office, constructed in 1970 showed similar failures (see Figure 2). The buckling and shear failure of columns were also largely due to the older version of the code during construction. Emphasis was placed on providing more reinforcements at the joints at that time. As a result, failures occurred towards the middle of the column where provision of reinforcements was lesser.

Figure 1. Failure at column-slab joint

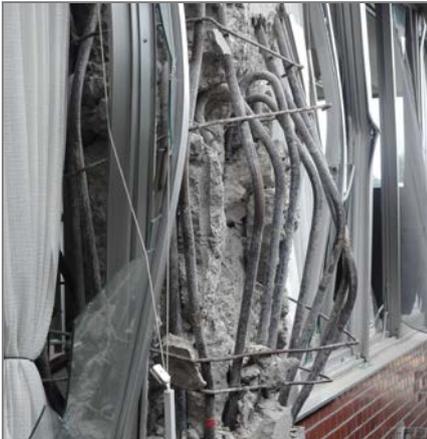
Figure 2. Buckling at mid-span of column

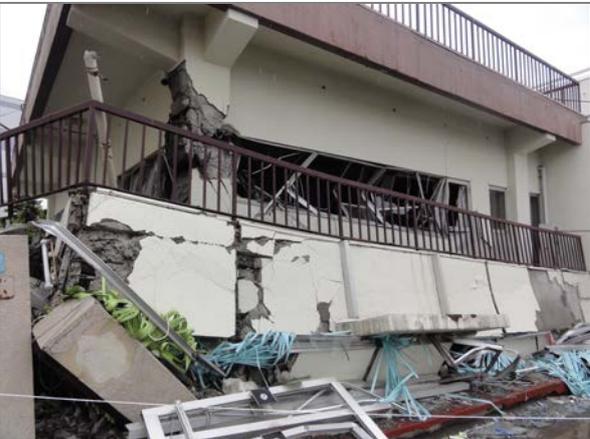
Figure 3. Soft storey collapse of RC building

In contrast to the frequent observations of soft storey failures in many reconnaissance missions such as the 2009 Padang earthquake (EEFIT, 2009), soft storey collapse was rarely observed in this Tōhoku earthquake event. An exception was an office building in Sendai constructed in 1969 (Figure 3), where columns failed by shear due to insufficient confining reinforcement stirrups. Damage to wooden structures was also observed in Sendai, Sukagawa and Shirakawa, which indicated the susceptibility of wooden structures against such strong earthquake shaking in these areas (Figure 4).

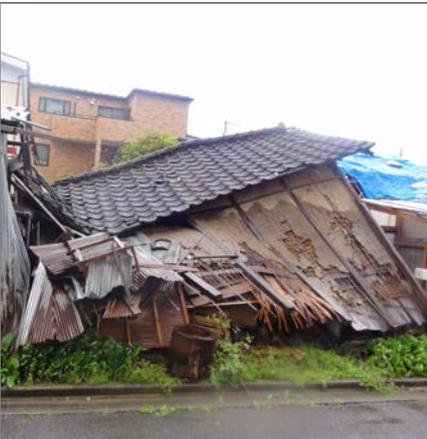
Figure 4. Collapse of wooden structure

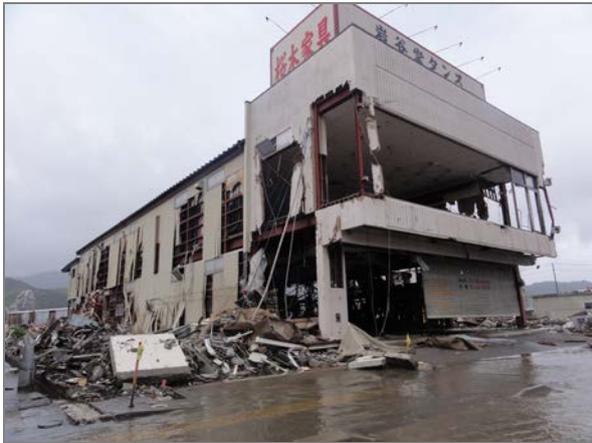
The sheer impact of the tsunami on structures lying near the coastline was the major contributor to the number of damaged buildings. During the reconnaissance to Tarō, Kamaishi, Ōfunato, Rikuzentakata, Minamisanriku, Ishinomaki, Natori, Wakabayashi, Yamamoto and Watari, these buildings were either swept away by the tsunami or severely damaged by passing waves of the tsunami as typically shown in Figure 5. Reinforced concrete buildings with stiff shear walls did not allow rapid tsunami flow through the buildings. As such, these buildings with small plan layout could suffer from overturning due to extreme tsunami flow as evident in Figure 6.

Figure 5. Damaged steel frame building at Ōfunato

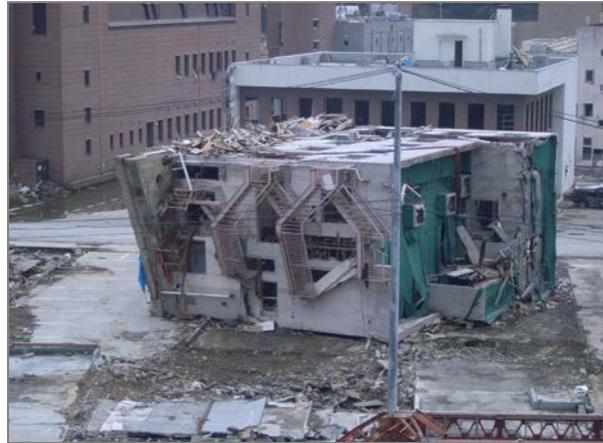
Figure 6. Overturned RC building at Onagawa

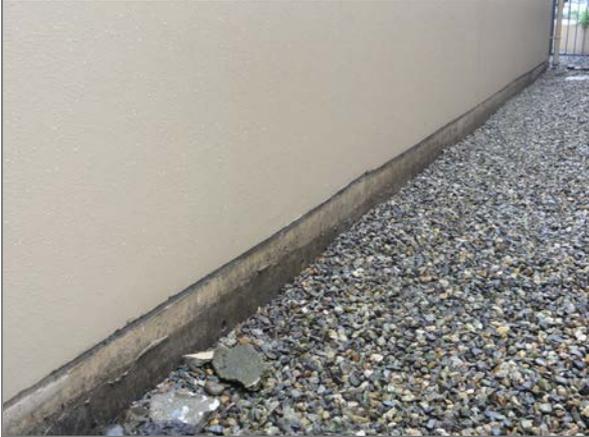
Geotechnical failures such as ground settlement, landslides, liquefaction and coastal subsidence were observed in the Tōhoku region. Several locations in the eastern part of Sendai city suffered ground settlement measuring as much as 70mm. In the affected areas, some reinforced concrete buildings showed lower settlement relative to the surrounding ground (Figure 7), while a handful sank relative to the surrounding ground level (Figure 8). This is likely due to the difference in pile penetration depth and soil condition. Not far from this location, sand boils were observed near the K-NET station in Oroshi district. Ground settlement also affected the use of external staircase and roadways leading to carparks. A high-rise residential building (Takasago apartment), as shown in Figure 9, also suffered differential settlement which rendered its unsuitability for occupancy after the earthquake and had to be demolished.

Figure 7. Ground settlement around building

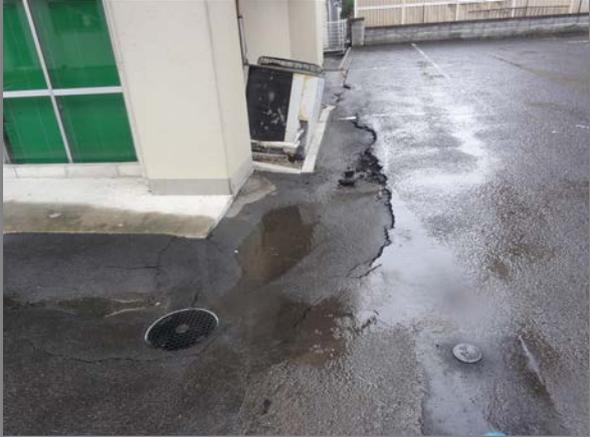
Figure 8. Sinking of building relative to surrounding

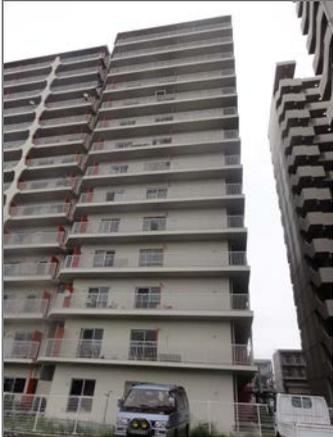
Figure 9. Tilted building due to differential settlement

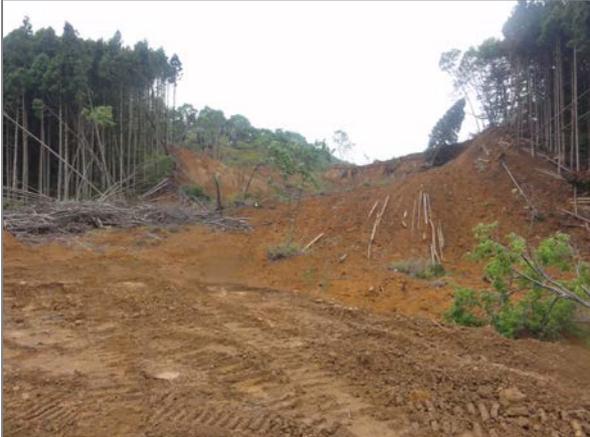
Locations of slope failure in Sendai and Shirakawa were also visited. These earthquake induced slope failures resulted in damage to low-rise residential wooden houses in Oritate, Sendai. The strong shaking also led to the failure of the gravity stone retaining walls at Komine Castle in Shirakawa due to insufficient horizontal ties within the cobble rocks. Large-scale landslides burying roads and houses at the foot of slopes also resulted in traffic disruption, property losses and 13 casualties in Shirakawa as shown in Figure 10.

Figure 10. Earthquake-induced landslide

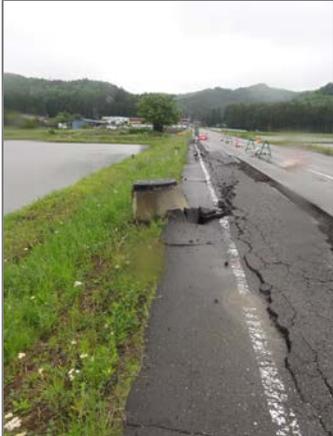
It was understood from other reconnaissance reports (GEER, 2011; Takahashi, 2011) that liquefaction induced damage to roads and levees were severe in locations visited by EEFIT. However, most evidence of soil liquefaction had been cleared up as repair work was carried out swiftly following the earthquake. There was however still some evidence of soil liquefaction inferred by the uplift of manholes and lateral spreading in Shirakawa and Sendai. An example is shown in Figure 11.

Figure 11. Uplift of manhole and lateral spreading

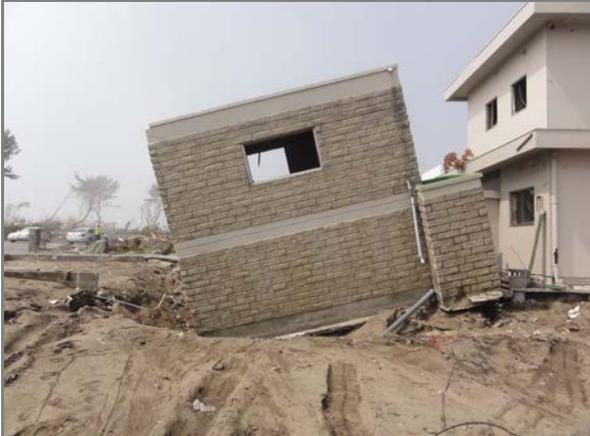
Overturning of buildings due to impact of the tsunami mainly occurred to buildings with shallow foundation or slender piles. Soil liquefaction can allow piles to be pulled out of the soil more easily. Scouring due to fast-flowing tsunami waves around buildings also reduces ground bearing support which led to tilting of these buildings as shown in Figure 12. Coastal subsidence of more than 0.5m in numerous coastal towns and cities also caused these shorelines to suffer frequent tidal flooding.

Figure 12. Loss of soil bearing due to scour

- Considering tsunami induced scour and overturning of buildings with shallow pile foundation.

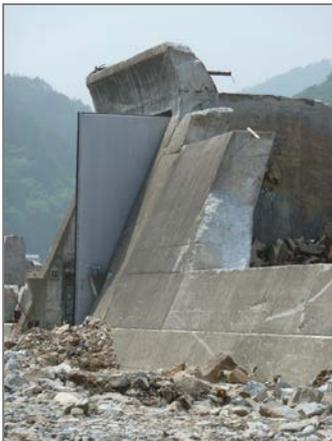
Concrete seawalls were not spared by the tsunami in various coastal areas such as Minamisanriku, Ryoishi and Tarō, the formerly proclaimed “Town of Tsunami Disaster Prevention” with seawalls resembling the Great Wall of China. In some lengths of the enormous seawall, despite the provision of 10m high seawall, the concrete sections toppled due to insufficient horizontal restraint from interlocking blocks as shown in Figure 14. Similar failures to large concrete seawalls were also observed in Minamisanriku and Ryoishi. Concrete block revetment along the beaches of Yamamoto also performed poorly (Figure 15). Sand in-fill wash-out and breaks in the lattice revetment were observed across the length of the revetment with some sections failing catastrophically due to the overtopping of the tsunami wave. Concrete revetment structures at Arahama also showed a similar

Figure 14. Failed seawall section at Tarō

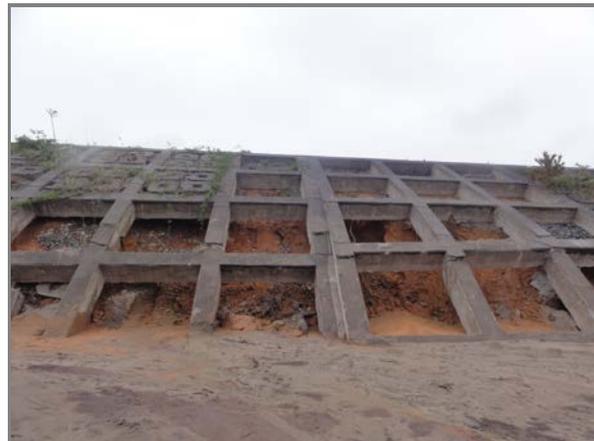
Figure 15. Sand in-fill wash-out in revetment
