# Buddhist Monasteries in Grave Danger in Himalayan Region

**Arun Menon, Rupen Goswami, A.R. Vijaya Narayanan, C.V.R. Murty**  
*Indian Institute of Technology Madras, Chennai, India*

## SUMMARY:

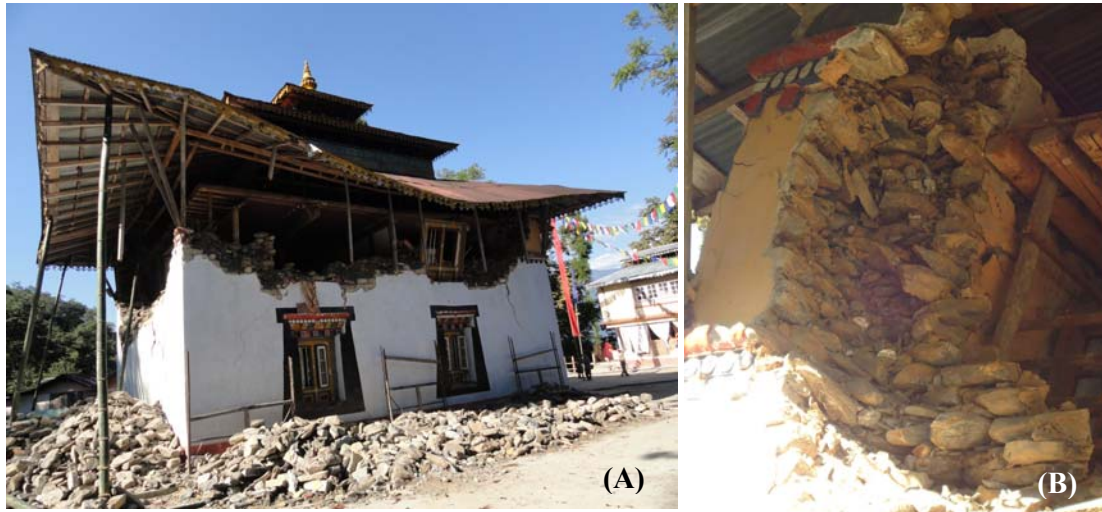
Extensive damage to RRM walls was observed in the Ringin monastery in Mangan, North Sikkim. The poorly consolidated RRM walls with no through-stones can be seen in the photograph in Fig. 3B. Thrust from the roof structure has not been resisted by the RRM walls in the first floor of the structure.

The PGA estimated at Mangan using a finite fault seismological model was 0.281g, and in comparison to the PGA from estimated Modified Mercalli Intensity (MMI) for Mangan (VIII) the PGA was 0.25g (Raghukanth et al., 2012). Near total collapse of such a structure is expected under this level of ground shaking.

**Figure 3. (A) Extensive damage to the RRM structure of the Ringin Monastery in Mangan, (B) Out-of-plane failure of RRM walls of the Ringin Monastery in Mangan**

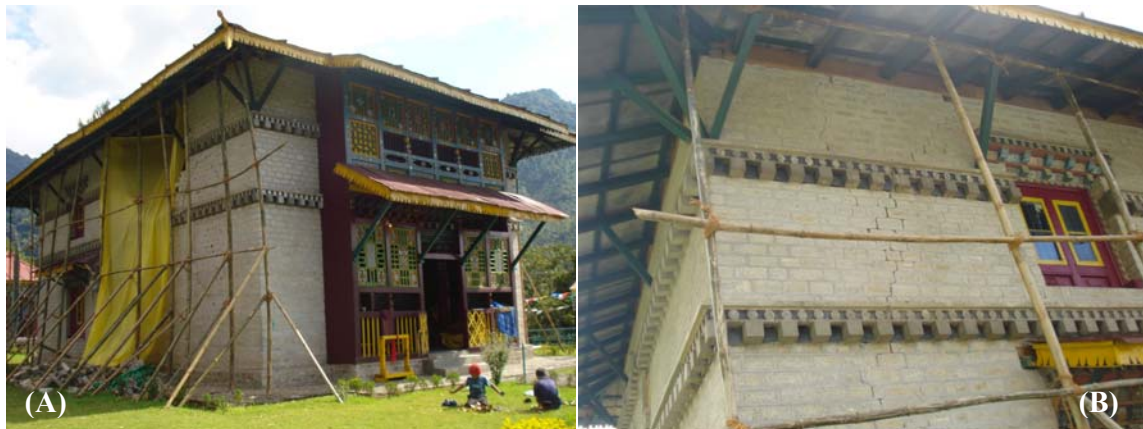
Partial out-of-plane collapse of semi-dressed stone masonry walls was observed in the Dubdi Monastery in Yuksom, West Sikkim (see Fig. 4A). While the portion of the façade with timber framing and panel work (in the traditional Ekra style) has performed very satisfactorily under the ground shaking, out-of-plane mechanism has formed in the unreinforced masonry wall as envisaged from the widened masonry joints on the façade (see Fig. 4B). Temporary scaffolding to prevent further bulging of walls in which, out-of-plane mechanism has been initiated can be observed. However, this may be inadequate in the event of a strong aftershock. PGA from estimated MMI (VI) was 0.06g; level of damage is much more than what should be expected at this level of ground shaking. The PGA estimated at Yuksom the previously mentioned stochastic model was 0.279g.

**Figure 4. (A) Wood frame structure with semi-dressed stone walls in the Dubdi Monastery, Yuksom, (B) Initiation of out-of-plane mechanism in the semi-dressed stone masonry walls**

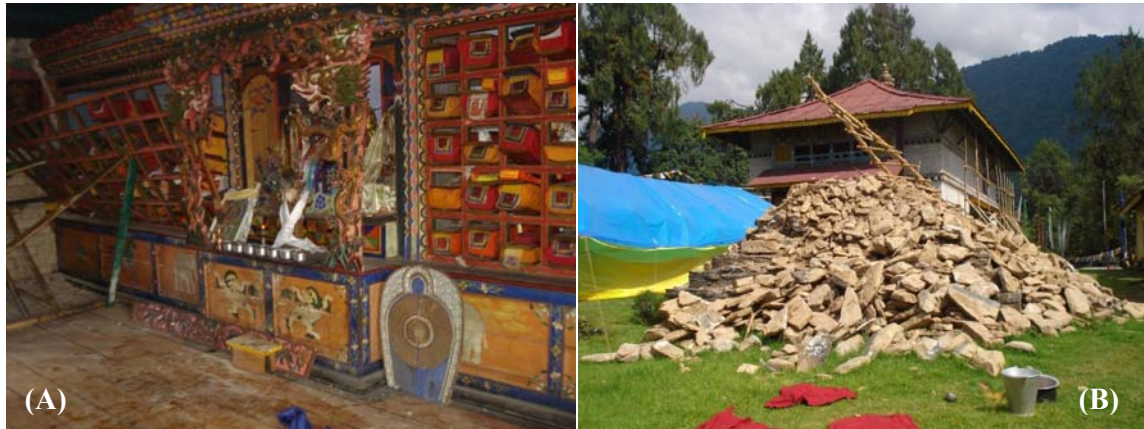
on walls have been displaced due the amplified motion at the upper storey (Fig. 5A). Stone masonry stupas are regular feature in the monasteries, marking burial chambers of monks. They are typically RR masonry free-standing structures of different sizes built on a raised plinth, and are normally plastered. They are massive and unconsolidated making them vulnerable to ground shaking due to their sheer mass. One such stupa was completely damaged in the premises of the Dubdi Monastery in Yuksom, West Sikkim. The random rubble blocks used in the construction of the stupa can be seen in the damaged structure (Fig. 5B).

**Figure 5. (A) Holy scriptures dislodged from the cabinet in the Dubdi Monastery, Yuksom (B) Collapse of stone masonry stupa in the Dubdi Monastery, Yuksom**

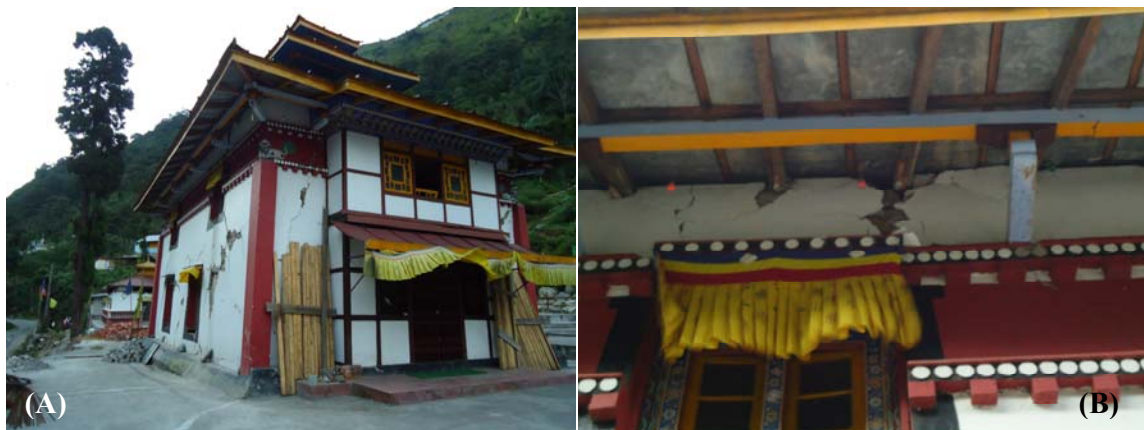
The structure of the monastery at Chungthang is rather peculiar due the presence of the RC columns at the four corners of the plastered stone masonry structure (see Fig. 6A). The RC elements are evidently recent additions. The peculiarity is that the RC elements are not framed, but merely provide partial confinement to the corners of the unreinforced masonry structure. The introduction of the RC elements seems to have partially resulted in the desired effect, i.e. in preventing out-of-plane failure of the unreinforced masonry walls. Diagonal shear cracks are noticed in the unreinforced masonry (URM) walls of the structure, implying that the in-plane shear resistance has been garnered (see Fig. 6A). However, the shear strength of URM walls being small, diagonal cracks have formed in all the four perimeter walls. Interestingly, no visible damage is noticed in the timber-framed wall (front façade). Local damage to walls due to pounding from poorly connected rafters is seen (see Fig. 6B). Chungthang experienced a PGA of 0.25 g (MMI VIII).

**Figure 6. (A) Wood frame with plastered stone masonry walls and RC columns in Chungthang Monastery, Chungthang, (B) Damage to walls from pounding of rafters**

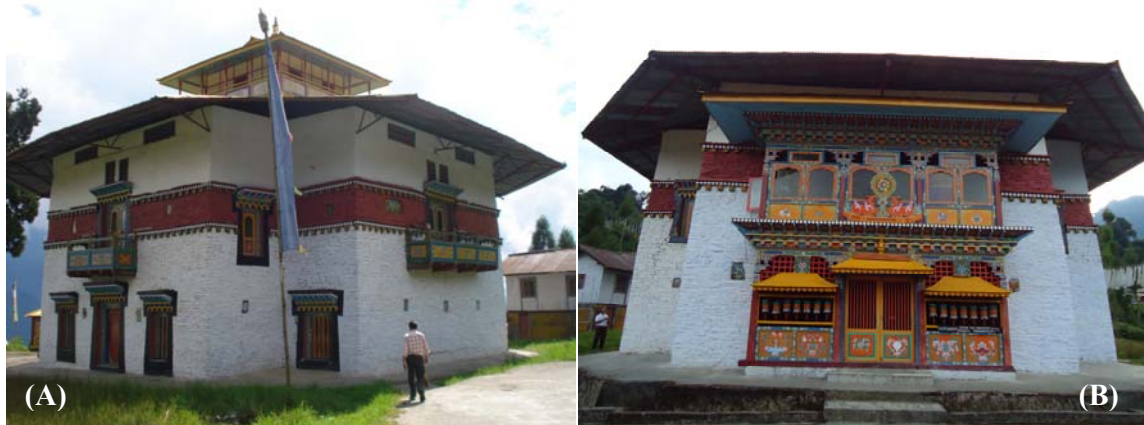
From the exterior, the Phodong monastery in Central Sikkim, with wood frames and RRM walls, seems almost intact after the earthquake with signs of initiation of out-of-plane mechanism in the RRM walls (see Fig. 7A-B, 8A). However, this structure has undergone massive structural alterations with the introduction of RC frames in the interior space, most probably replacing the earlier timber post and beams (see Fig. 8B). All the RC columns in the first storey of the structure have failed in shear, rendering the structure extremely susceptible to collapse under any additional load.

**Figure 7. (A) Wood frame with RR masonry walls in Phodong Monastery, Phodong, (B) Wood frame with RR masonry walls in Phodong Monastery, Phodong**

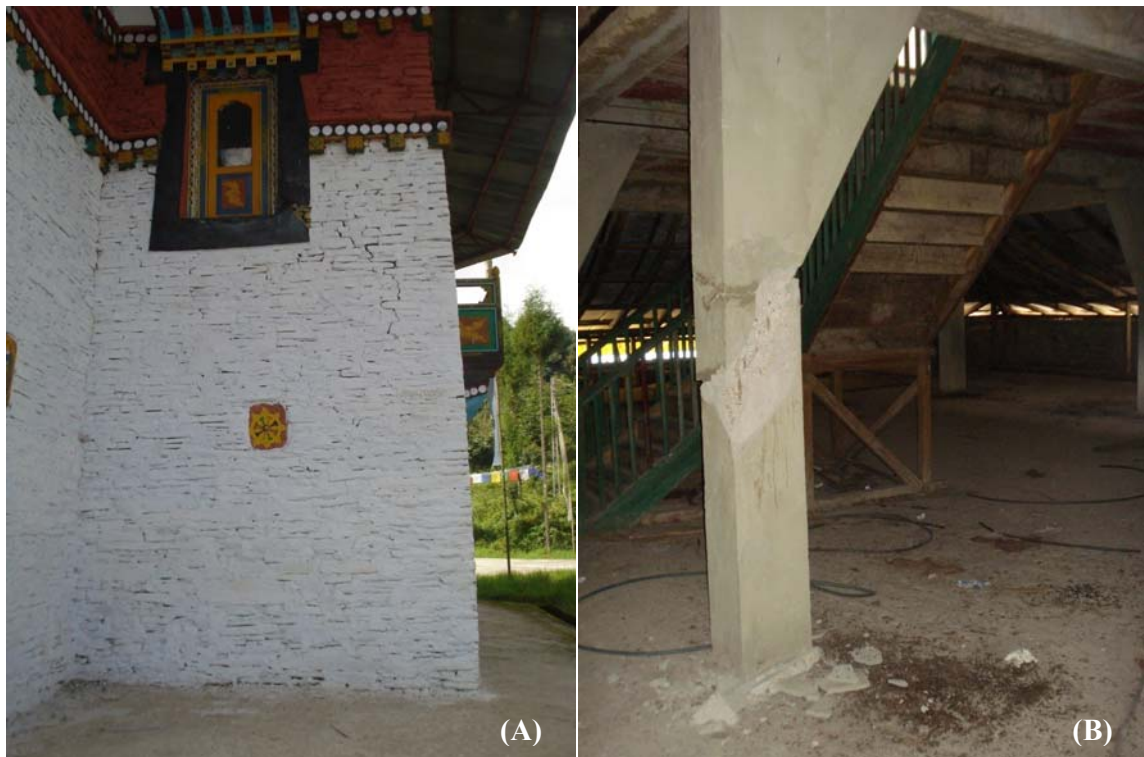
**Figure 8. (A) Out-of-plane mechanism in the RR masonry walls in Phodong Monastery, Phodong, (B) Shear failure of RC columns at roof level in Phodong Monastery, Phodong**

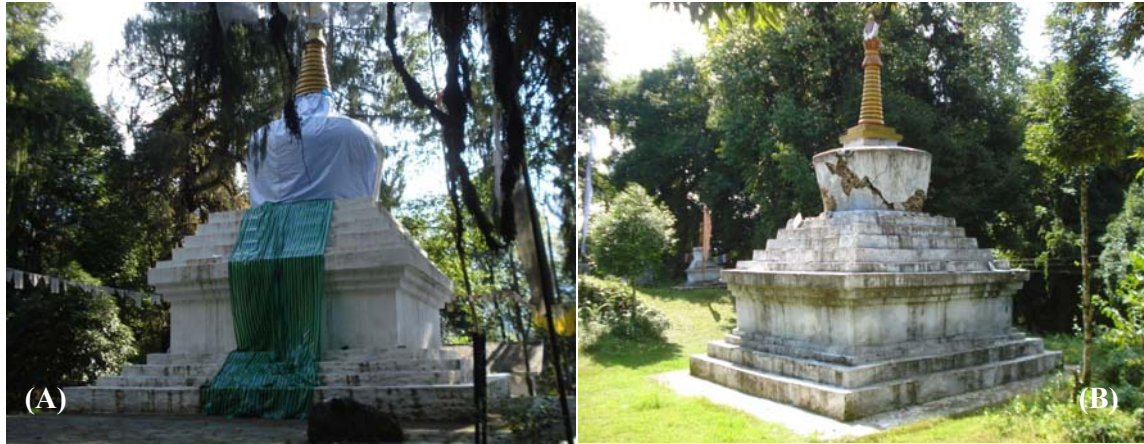
The damaged stone stupa at the Coronation throne in Norbugang, West Sikkim can be seen in Fig. 9A. The sheet has been draped around the portion of the structure where a wide crack has formed to prevent the ingress of water. The nature of the crack can be seen in a similar stupa in the premises of the Pemayangtse Monastery in Pelling, West Sikkim (see figure).

**Figure 9. (A) Damaged stone masonry stupa at the Coronation Throne, Norbugang (B) Damaged stone masonry stupa in the Pemayangtse monastery premises, Pelling**

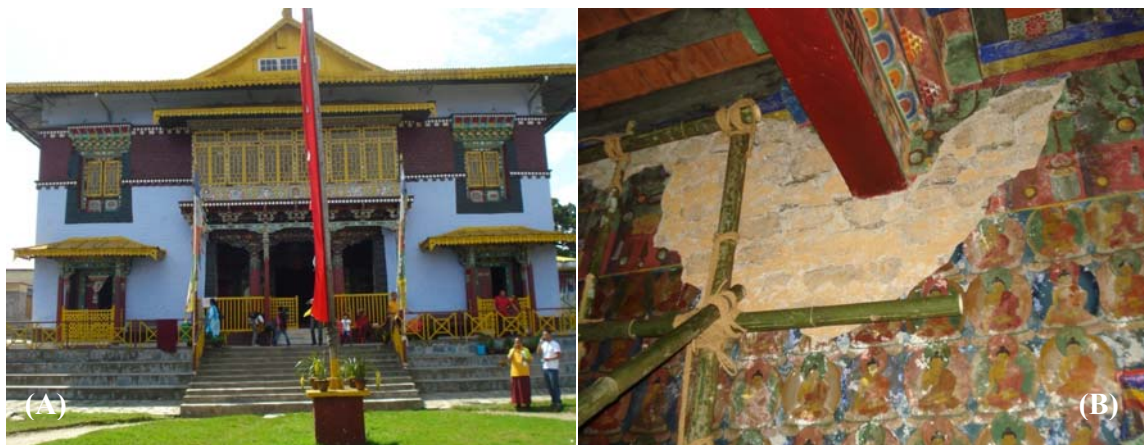
Pemayangtse is a magnificent monastery in Pelling, Western Sikkim, built in 1705 AD and one of the most respected monasteries (Lhatsun Chenpo, one of the three Lamas who brought Buddhism to Sikkim had earlier erected a shrine here). Minor damage can be observed to the semi-dressed stone masonry walls of the Pemayangtse Royal Monastery. In the interiors, damage to the plaster on the walls has been noticed at locations where timber joists are supported on the walls (see Fig. 10B). Such damage can be attributed to the excessive out-of-plane thrust from the horizontal elements (timber joists) to the vertical elements (masonry walls), which are poorly interconnected.

**Figure 10. (A) Semi-dressed stone masonry walls with wood frame, Pemayangtse Royal Monastery, Pelling (1705 AD) (B) Out-of-plane damage to stone walls by timber beams resting on them, Pemayangtse Royal Monastery, Pelling**

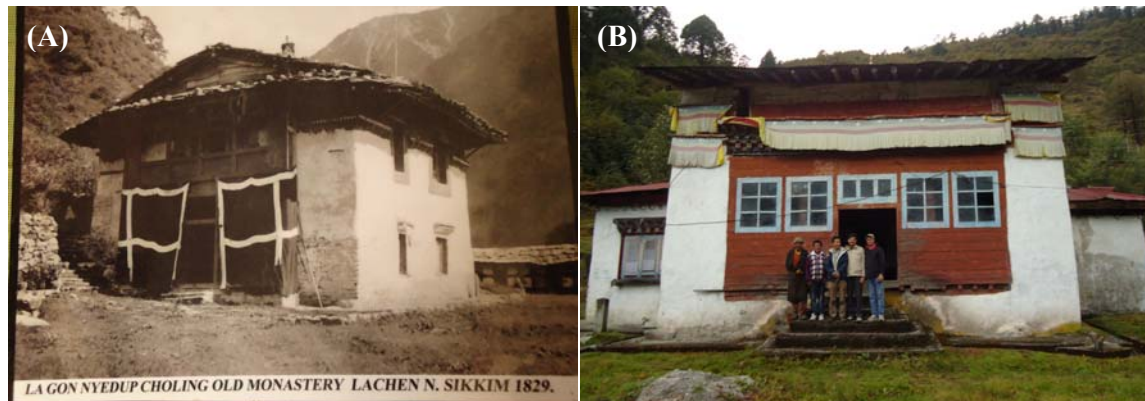
recent years, the structure has undergone lateral expansion (see Fig. 11B). The structure did not show any visible signs of damage in the earthquake. The PGA estimated from MMI (VII) was 0.13g and that from the stochastic model was 0.297g. Observed performance is does not seem to be commensurate with estimated PGA.

**Figure 11. (A) Lachen Monastery, Lachen (archive photo) (B) La Gon Nyedup Choling Old Monastery, Lachen with recent lateral appendages, after the 2011 earthquake**

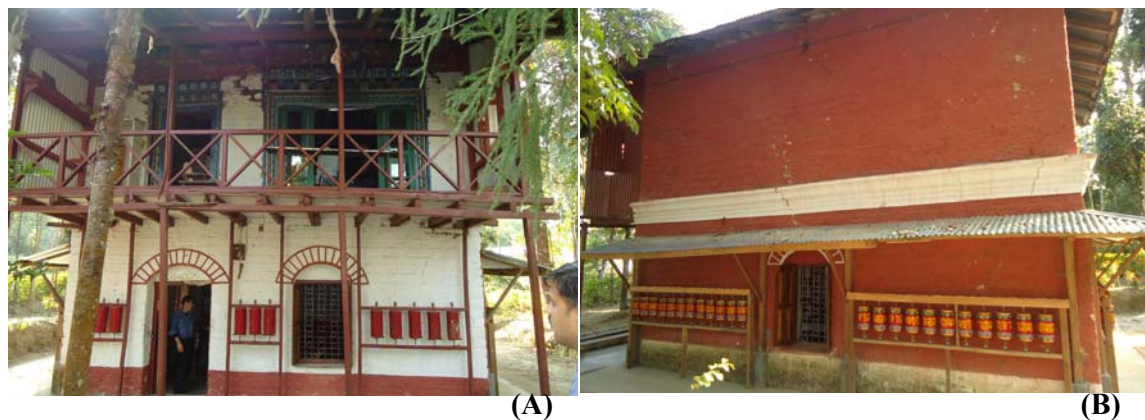
This small semi-dressed stone masonry monastery in the neighbouring Darjeeling district of West Bengal suffered significant damage to both ground and upper stories (note large openings and reduced pier sizes in upper storey). Large cracks in the arches of the ground storey can be seen in Fig. 12B. The PGA estimated from MMI (VII) was 0.13g and that from the stochastic model was 0.156g.

**Figure 12. (A) Kalimpong Monastery, West Bengal, (B) Damage to arches**
