Observations from Damages Sustained in India during 2011 (India-Nepal) Sikkim Earthquake

C. V. R. Murty, Arun Menon, Rupen Goswami, A. R. Vijaya Narayanan, S. R. Gandhi, K. N. Satyanarayana, S. T. G. Raghukanth
Indian Institute of Technology Madras, Chennai, India

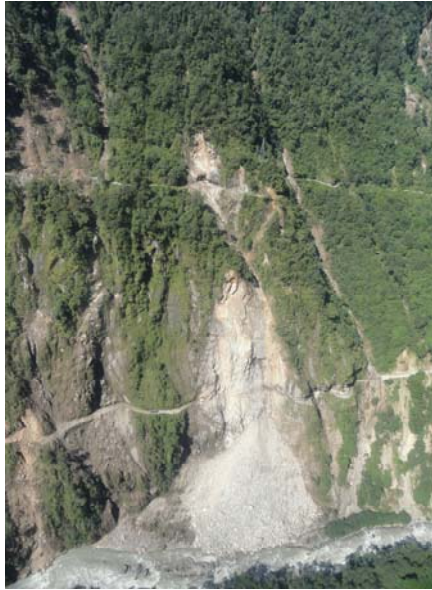
Two significant signatures of the 2011 (India-Nepal) Sikkim earthquake are landslides and landslides-induced loss of life and damage to economy and infrastructure (Figure 2.1a). While landslides are known to occur in the region in the rainy season, extensive landslides occurred during and after the event. Major road and bridge infrastructure was built in Sikkim by cutting hill slopes. Significant loss occurred to the network of road and bridges by landslides and rolling boulders, which affected relief operations to far flung towns and villages that were completely cut-off. Quality of engineering practice adopted in road construction is poor; no soil data is used for assessing stability of mountain slopes. Design documents are not available to study the scientific approach adopted for assessing landslide potential of the relatively soft mountain slopes along the Singalila range and in the Teesta Valley. Alternate road network is almost absent with no redundancy for undertaking rescue and relief operations.

Figure 2.1 (a) Wide spread land slide observed on the hill slopes (b) Clearing landslide debris to restore road network

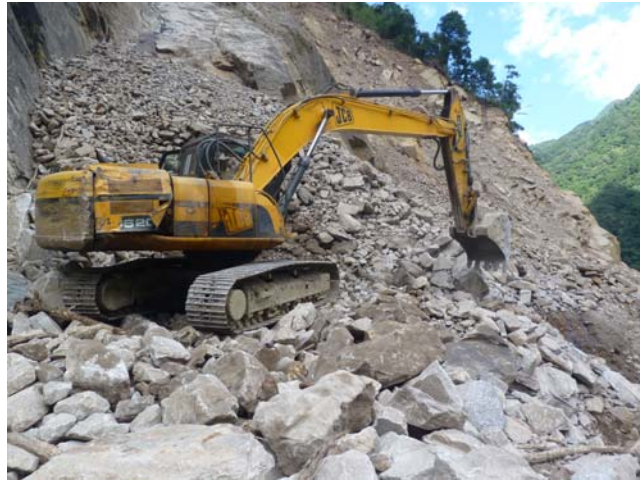
(b)

Cuts are made in mountain slopes to build roads were safe when the entire road width was on the native cut, than when on fill soils with retaining walls. Inner edges of cuts along the mountains were not provided always with seepage/rainwater drains. Professional inputs are not taken from structural geologists, while intervening with the existing formation of rocks for development of roads along mountain slopes; only heuristic and experience-based methods were employed. Construction techniques are inefficient, non-scientific and of poor quality, even though there is no shortage of resources; construction safety standards were not met with. Equipments used were insufficient for clearing landslides and inappropriate for the type of work and progress expected (Figure 2.1b).

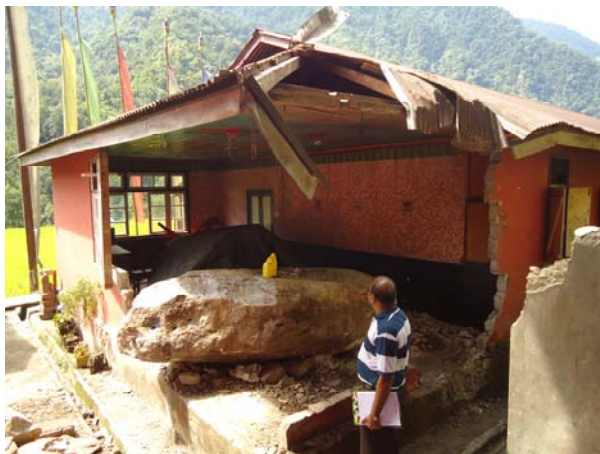
Three types of damages were sustained by houses in the severely shaken areas, namely (i) sliding of houses on weak mountain slopes; (ii) impact of rolling boulders on houses (Figure 3.1a); and (iii) ground shaking-induced textbook-type damage and collapses. Scientifically-based land use zoning was not employed to demarcate obviously unsafe sites for preventing development of built environment in unsafe areas.

Figure 3.1 (a) Damage to Building due to rolling boulders, and (b) Failure of soft soil slopes

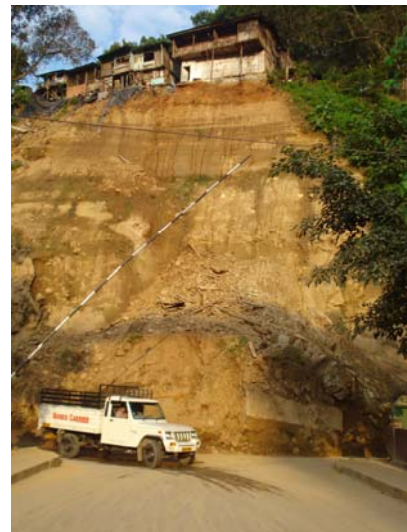
(b)

Many instances are observed of creeping of soil under buildings rested on hill slopes, which are largely made up of metamorphic and sedimentary rocks covered with soft soil (Figure 3.1b). In areas of proximity to tunnelling works of hydro-power projects, local people ascribed such creeping to vibrations arising from frequent blasting performed for tunnelling. But, the earthquake provided higher levels of ground shaking that resulted in a number of landslides. Detailed analyses were not carried out to identify stable slopes and thereby determine safety of buildings built on hill slopes, especially in urban areas. Thus, indiscriminate construction was allowed irrespective of the building typology (without earthquake resistant features) and parameters like (i) material of the underlying soil and/or rock, (ii) slope of the hills, (iii) seismic hazard prevalent at this site, and (iv) moisture level in the soil.

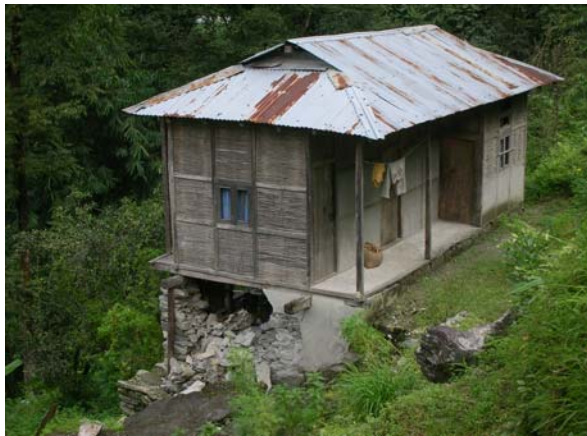
Traditional housing typology in Sikkim is the *Assam-type* or *Ekra* construction. It consists of a wood frame infilled with cross-woven wood matting plastered on both sides with mud or fine river sand in earlier times and by cement mortar in recent times. Another variation to this is the use of wood planks in constructions by the rich, in place of the mats. When made on flat ground, it rests on a relatively shallow and uniform masonry plinth (made of stone and mud mortar), and when made along hill slopes, it rests on a tapered stone plinth. Four varieties of stone masonry plinths are observed in Sikkim – random rubble masonry (RRM) with and without mud mortar, dry dressed stone masonry, dressed stone masonry, and dressed stone masonry with pointing. In recent times, the plinth also is being constructed in RC. During the earthquake, large stock of this typology of housing was shaken to different intensities across Sikkim. With the exception of distress in few stone masonry plinths (especially RRM plinths without any mortar), this typology has performed exceptionally well (Figure 3.2a). In instances, where the wood matting was replaced by clay-brick masonry infill walls in cement mortar, significant damage was sustained in them, including out-of-plane collapse. Good performance of this typology of housing in contrast to poor performance of the recently adopted (but aggressively built and desired) RC frame buildings with URM infill masonry re-iterates that this typology should be continued in the Himalayan region. But, Government of Sikkim notified this typology to be informal (*kachcha*) and just did the opposite.

Figure 3.2 (a) Traditional *Ekra* Construction (b) Masonry Building

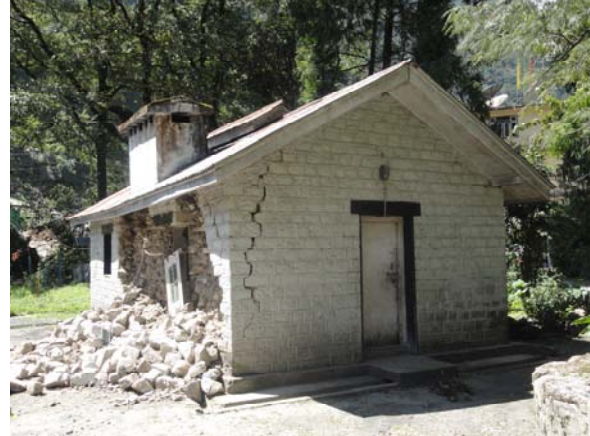
(b)

Traditional construction of the region is of *Ekra-type*, but abundance of soft and hard stone along the hills of Sikkim has offered another dominant typology – *Stone Masonry Construction*. This has been patronised largely in the constructions of Military Engineer Services and Government of Sikkim. This typology is characterised by its thick walls in random rubble stone masonry and lack of any earthquake-resistant features, despite these constructions being in high seismic region of India – no *bands*, no *through stones*, and no *vertical reinforcements at corners and around openings* (Figure 3.2b). Many government schools and primary health centres were constructed in URM. Falling stones and out-of-plane collapse of walls are potential threats to people living in these constructions.

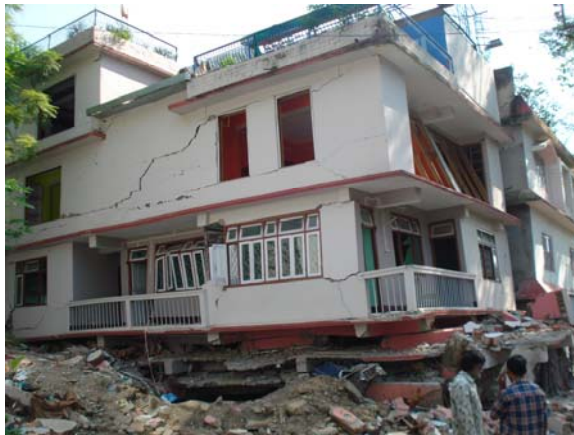
The following are some observations of RC buildings in Sikkim: (a) *Design*: Most buildings are not designed, but simply built without any engineering input in seismic zone IV (zone V is the worst as per Indian seismic code). This makes them vulnerable under earthquake effects (Figure 3.3a). No RC building in Sikkim has been seen to adopt structural walls; (b) *Construction*: Buildings are being constructed by poor construction methods and standards, which violate specifications laid down in prevalent Indian Standards. No quality control and quality assurance procedures are in place to ensure good and durable construction; and (c) *Maintenance*: Maintenance is absent in almost all buildings, irrespective of whether it is a government or private building. Fractured drains/pipes of the open drainage-cum-sewage system are major contributors to sustained moisture in buildings beyond excessive water directly from rains.

Figure 3.3 (a) Failure of RC Building (b) Heritage Structure

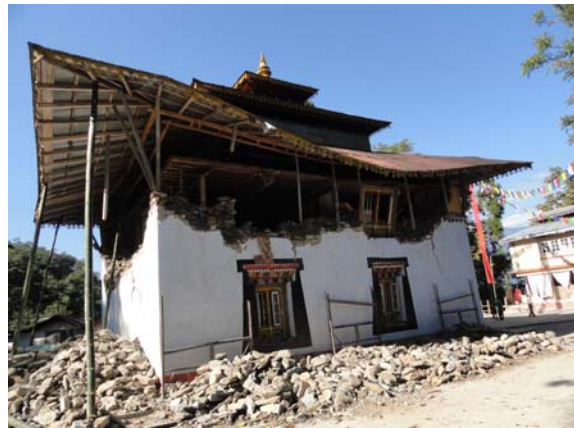
Sikkim has large number of Buddhist monasteries, many of which were built in 16th century AD with random rubble masonry (RRM) walls and timber floor slabs and roofs. Some structures have masonry walls with timber framework. Monasteries constructed in the recent decades are in RC with infill masonry panels. Structural repair works in the recent years introduced RC elements (columns, beams and slabs) in these heritage masonry structures. Most interventions were adhoc and non-engineered. Some monasteries were retrofitted after the 2006 Sikkim earthquake (*e.g.*, Enchey Monastery, Gangtok), but suffered damage during this earthquake. Extensive damage to these monasteries was observed, with partial to near-total collapse in several structures (Figure 3.3b). Typical seismic damage observed includes: (a) Out-of-plane bulging or collapse of RRM walls; (b) Sliding of timber roof relative to the masonry walls; (c) Out-of-plane collapse of orthogonal corners of perimeter RRM masonry walls; and (d) Shear failure of interior RC columns.

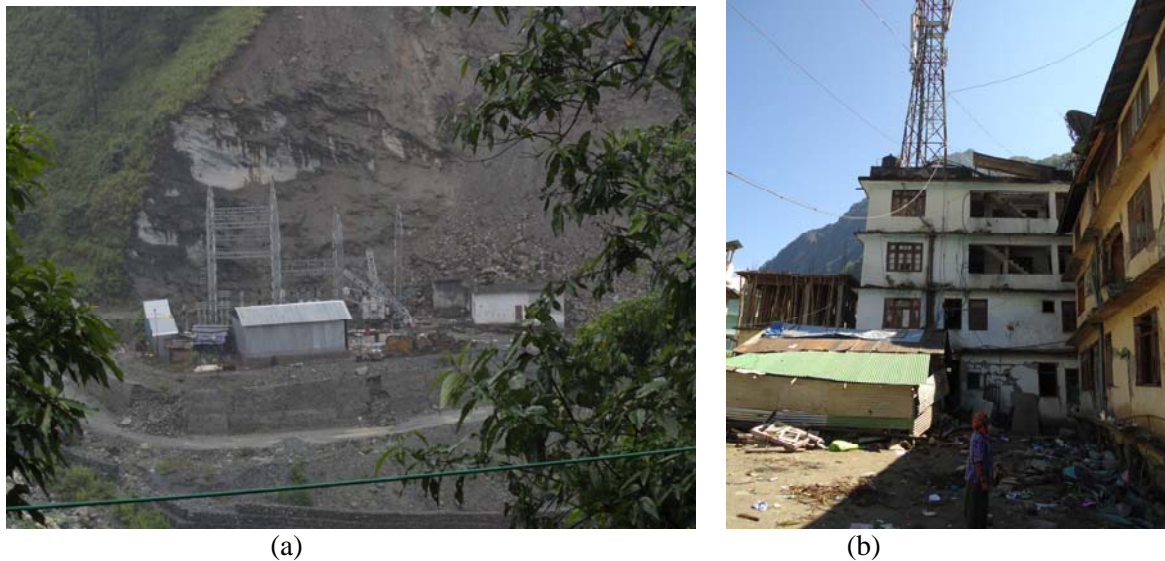
There was a power surge during the earthquake in the meiseismic area. Many appliances were damaged by this power surge. Also, power outage occurred in the areas with strong earthquake shaking. High tension towers and lines were damaged due to falling debris from landslides. Even local distribution poles were dislodged due to ground deformation generated by soft soil slope failure (Figure 4.1a). Restoration of power was not done in locations worst hit, *e.g.*, Chungthang, even 12 days after the earthquake. Due to unavailability of power, services dependent on the same were greatly affected, *e.g.*, water supply and phone network. This earthquake re-iterates that earthquake menace is not just a concern for architects, engineers and governments to worry about; electrical engineers and mechanical engineers also need to address some attention to this aspect.

Communications failed to towns, like Chungthan, Lachen and Lachung, due to effects of earthquake shaking, like (a) general power failure to the communication system, and (b) severe damage to RC buildings carrying the communication towers on their roof (the staff feared to enter these buildings as many of them were damaged) (Figure 4.1b). Absence of staff, non-availability of power and non-availability of linking communication towers were prime reasons for delay in restoring communication facilities. No emergency plan was available to ensure continuity of communication in all areas. Backup power systems were not available at critical communication facilities. Also, communication antennas were hosted on towers or on antennas that are rested on buildings that are not earthquake-resistant.

Figure 4.1 (a) Electrical Power, and (b) Communication System
