Damage of Road Bridges by 2011 Great East Japan (Tohoku) Earthquake

K. Kawashima

Tokyo Institute of Technology

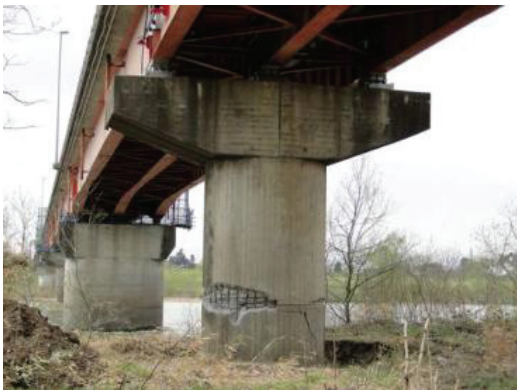
Extensive damage occurred at the bridges which were designed in accordance with the pre-1990 design code and not yet been retrofitted in accordance with the post-1990 design codes. For example, Photo 1 shows flexural-shear failure of reinforced concrete piers at Fuji Bridge. The damage occurred due to an overestimated concrete shear capacity and an inadequate development of longitudinal bars at cut-offs

Photo 1. Shear failure due to insufficient termination of longitudinal bars at cut-offs (Fuji Bridge, courtesy of Hoshikuma, J., PWRI)

cut-off which were the common practice prior to 1980. Such a failure occurred extensively during the 1995 Kobe, Japan earthquake (Kawashima and Unjoh 1997). Extensive investigation was directed to clarify the failure mechanism of such damage (Kawashima et al 1995) including a series of large scale shake table experiments using E-Defense. It should be noted that damage progresses very sharply once shear cracks were initiated under this failure mechanism. Seismic retrofit was initiated in the 1980s, and it was accelerated after the 1995 Kobe earthquake. Over 30,000 columns were so far retrofitted. Consequently, during the 2011 Great East Japan earthquake, damage due to this mechanism did not occur at the bridges which were retrofitted, while the damage still continued to occur at the bridges which were not yet been retrofitted.

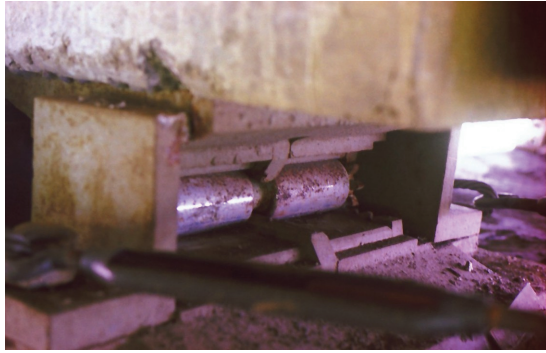
(a) 1978 Miyagi-ken-oki earthquake

Photo 3. Damage of steel roller and pin bearings Yuriage Bridge

Yuriage Bridge (refer to Photo 2) suffered extensive damage at reinforced concrete hollow and solid columns, an end of prestressed concrete girders, and steel pin and roller bearings during the 1978 Miyagi-ken-oki earthquake as shown in Photo 3(a). Since the damaged columns were repaired and retrofitted by reinforced concrete jacketing, they did not suffer damage during the 2011 Great East Japan earthquake. However steel pin and roller bearings suffered extensive damage again in the similar mode as shown in Photo 3 (b). It is obvious that steel pin and roller bearings are vulnerable to seismic action, because the stress builds up to failure by allowing no relative displacements at pin bearings and relative displacements accommodated by roller bearings are insufficient to real relative displacement under a strong excitation. Furthermore, exactly the same end of a prestressed concrete girder which suffered damage during the 1978 Miyagi-ken-oki earthquake suffered damage.

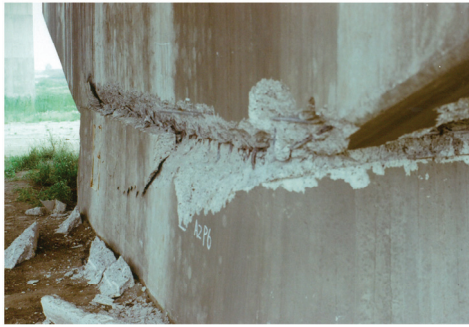
(a) 1978 Miyagi-ken-oki earthquake

Bridges which had been retrofitted suffered virtually no damage. For example, Sendai Bridge which is an extremely important bridge in Sendai City suffered extensive damage at reinforced concrete piers and steel bearings as shown in Photo 4(a) during the 1978 Miyagi-ken-oki earthquake. However this bridge suffered no damage during the 2011 Great East Japan earthquake, because columns were retrofitted as shown in Photo 4(b) and the original steel bearings were replaced with elastomeric bearings.

Photo 4. Effect of seismic retrofitting of piers, Chiyoda Bridge, National Road 4

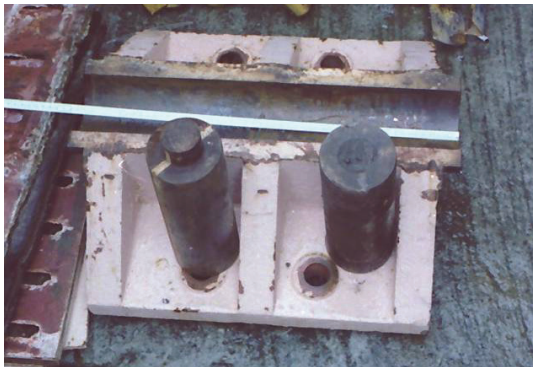
Shin-Iino-gawa Bridge which carries National Road 45 over Kitakami River suffered extensive damage at steel pin and roller bearings as shown in Photo 5(a) during the 1978 Miyagi-ken-oki earthquake. It was retrofitted prior to the 2011 Great East Japan earthquake such that 1) several reinforced concrete piers were retrofitted using steel jacketing, 2) nonlinear viscous dampers were installed between a superstructure and a substructure, and 3) steel bearings were replaced with elastomeric bearings as shown in Photo 5(b). As a result, the bridge suffered no damage during the 2011 Great East Japan earthquake.

(a) Rupture of a pin in a pin bearing during 1978 Miyagi-ken-oki earthquake

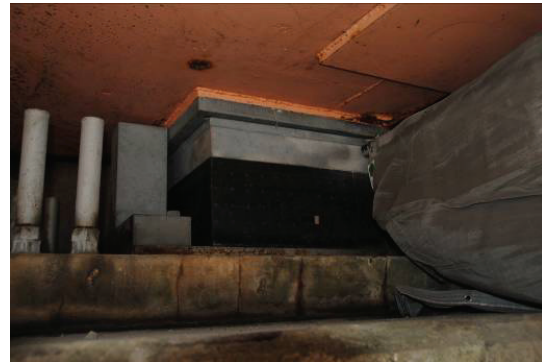
(b) An elastomeric bearing which did not suffer damage during 2011 great east Japan earthquake

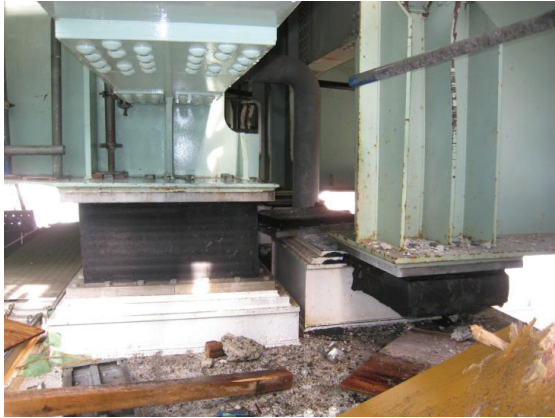
Elastomeric bearings generally performed quite well under the extreme ground motions. However it should be noticed that elastomeric bearings ruptured in several bridges. For example, several elastomeric bearings ruptured such that a deck offset by 0.5m in the transverse direction as shown in Photo 7(a) at Sendai-Tobu Viaduct. Rubber layers detached from steel plates in addition to rupture of

(a) Offset of left girder by 0.5m due to rupture of elastomeric bearings (NEXCO East)

rubber layers as shown in Photo 7(b). Though detailing is not yet released, there may be two possible reasons for the damage. The first is a miss design and fabrication of the elastomeric bearings. The second is an interaction between adjacent decks. Since an expansion joint must have constrained relative displacement between adjacent decks in the transverse direction, it is possible that a larger displacement demand of a deck is imposed to an adjacent deck resulting in larger shear deformation in the damaged bearings.

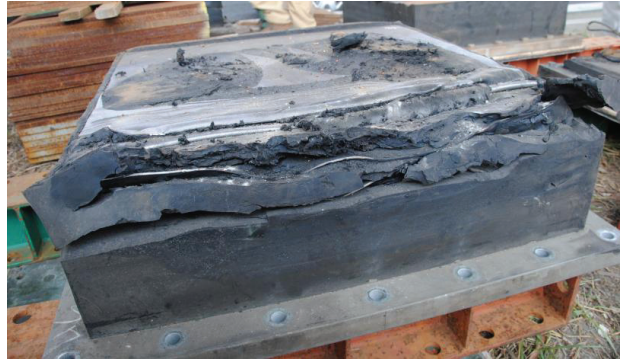
(b) Rupture of an elastomeric bearing

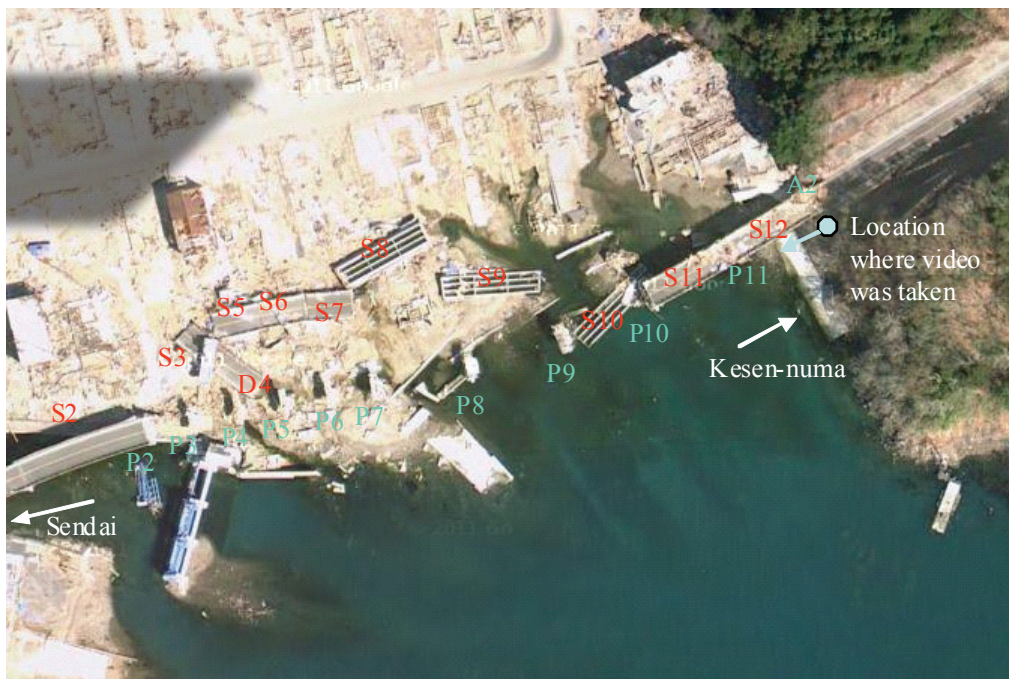
Utatsu Bridge built in 1972 carrying National Road 45 at Minami-sanriku Town over Irimae Bay suffered extensive damage by tsunami as shown in Photo 8. It was a 303m long 12 simply supported PC girder bridge consisting of 3 types of superstructures with spans ranging from 14.4m to 40.7m. Diaphragms were set between PC T-beam girders at the ends and mid points. The concrete decks had an inclination as large as 6% in the transverse direction due to curved alignment of the bridge.

The bridge was retrofitted a few years ago. Columns were retrofitted by reinforced concrete jacketing and unseating prevention devices were installed. The spans S1, S2, S11 and S12 remained but spans S3-S10 were washed ashore. Spans S3-S7 were simply supported pre-tensioned PC T-beam girder bridges. As a part of the seismic retrofit, cable restrainers were set for between S3-S7, and three steel stoppers were provided at the end of S3 and S7 for preventing excessive longitudinal deck movements. Though cable restrainers ruptured between S4 and S5, S3-S4 and S5-S6-S7 were still tied together after floated ashore as shown in Photo 9. S8, S9 and S10 laid down upside down as shown in Photo 10.

Photo 8. Utatsu Bridge (Google)

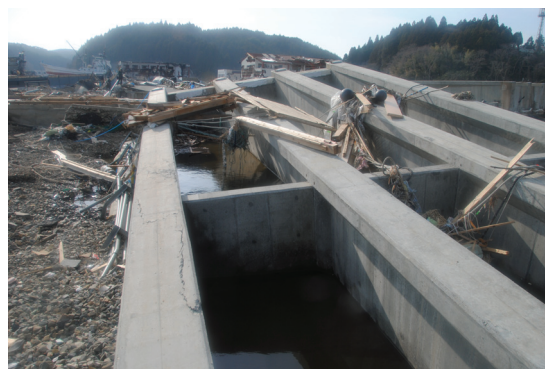
Photo 10. Overturned Span S8

A preliminary analysis was conducted to evaluate possible uplift of spans of Utatsu Bridge. As shown in Photo 10, since the PC T-beam girders had diaphragms at both ends and mid spans, they were subjected to uplift force due to trapped air under the deck (Chen 2007). The uplift force by trapped air F_u was estimated as

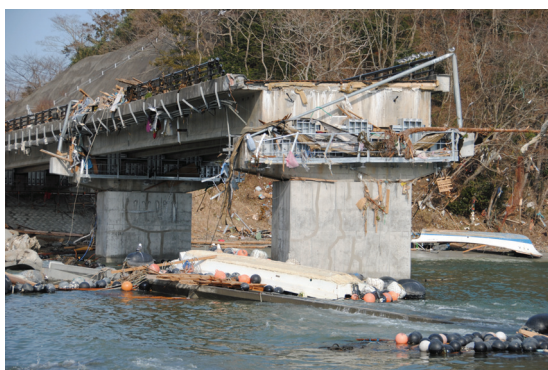
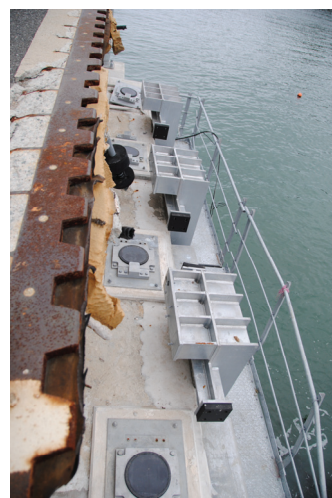
Photo 11. Stoppers and bearings on P10

Photo 11 shows three stoppers and four pot bearings on P10. Three longitudinal stoppers did not suffer damage at all. All four upper bearings were detached from the lower bearings and remained at the end of S10. Three side stoppers in the sea side were removed due to rupture of four anchor bolts each. The sea most lower bearing slightly uplifted but other three lower bearings were in their original position without damage. From the fact that three stoppers neither suffered damage nor tilted, it was likely that S10 was uplifted higher than the top of three stoppers before floated. Other shorter spans (S2-S6) were simply dragged laterally by tsunami.

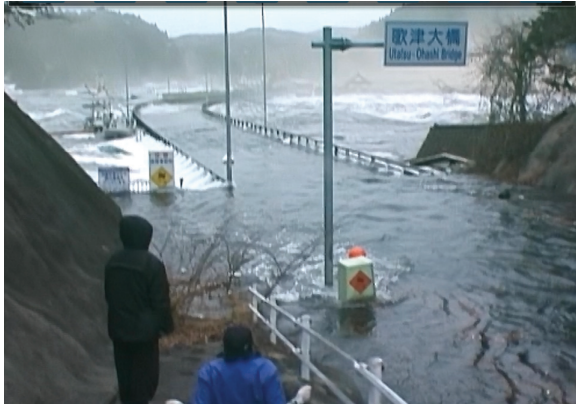
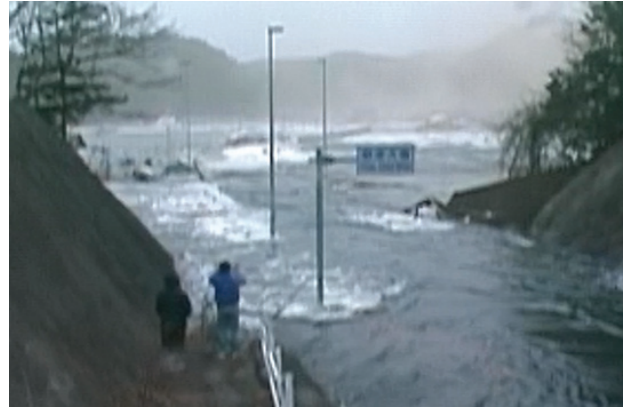
Photo 12. Utatsu bridge, National Road 45, under tsunami water

A video was taken at a slope near the north abutment A2 by a local resident. This video shows a whole rising process of tsunami until the spans were completely covered by tsunami as shown in Photo 12. Since tsunami reached the top of a 6m tall pole shown at the center of the photo, it is estimated that the deck surface was saturated 6m deep. Since the spans failed after they were completely under water, it is not known when the spans were uplifted and floated. At both ends of the bay, tsunami flow was not as fast as the flow at the center, which saved spans S1-S2 and S11-S12 from collapse. Tsunami flow velocity at the center of the bay was about 6m/s.

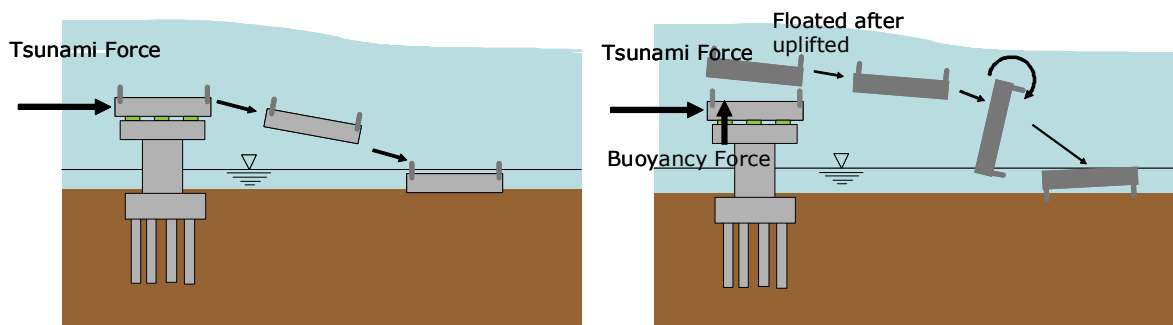
Figure 3. Failure mechanisms of spans due to tsunami effect

Damage of Utatsu Bridge may be summarized as shown in Fig. 3. If spans uplift before floated under tsunami action, it may be effective to install restrainers in the vertical direction between girders and substructures so that bridge spans can be tied down to substructures. Such a tsunami unseating prevention device may be cheaper and effective as a countermeasure for tsunami. Since installation of tsunami unseating prevention devices imposes an additional upward force to substructures, substructures have to be strengthen if they do not have enough capacity. However because an uplifting force due to tsunami action does not reach several times the span weight, strengthening of substructures is not generally required at most bridges except very old bridges.

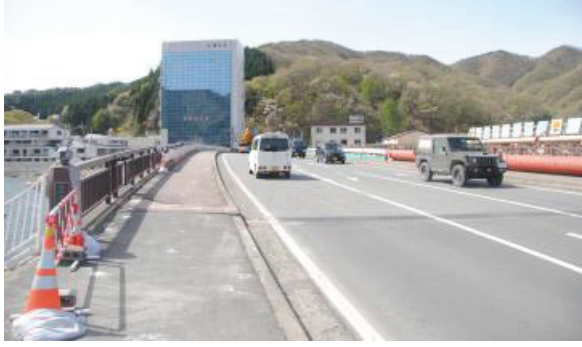
Photo 13. Yanoura bridge after tsunami, National Road 45

There are a number of bridges which survived tsunami though they were completely saturated by tsunami. For example, Yanoura Bridge that carried National Road 45 over Koshi River in Kamaishi City was a 108.6m long curved three span simply supported steel girder bridge. Photo 13 shows the bridge after tsunami. Two abutments and two piers were supported by four pile foundations with ten 30m long and 1m diameter cast in place reinforced concrete piles.

As shown in Photo 13, a white center stripe did not drift indicating that the spans did not offset in the transverse direction. The bridge suffered only minor damage on hand rails. The bridge remained open for use by emergency vehicles following the earthquake.

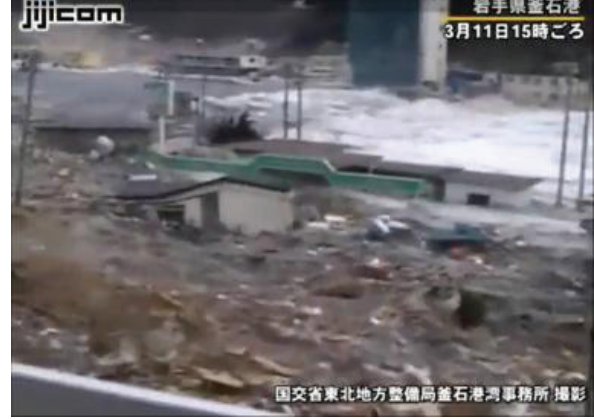
Photo 14. Yanoura bridge 5m under water

A video was taken by Kamaishi Port Office, Ministry of Land, Infrastructure and Transportation, located at the left bank 140m from the bridge. At about 15:00, the first tsunami reached the bridge as shown in Photo 14. The spans were already completely underwater. Based on the fact that tsunami reached the mid-height of the second story of a building close to the bridge, it is known that the deck surface was 5m underwater. Though a large amount of wooden house originated debris was included in tsunami which propagated upstream along both sides of the river, few debris was transported by tsunami which propagated in the river because the bridge was located the most downstream.
