Fill-Depths Estimation of Developed Hill Area Using GIS and the Predominant Frequency of the Ground Caused Housing Damage

S. Iwai

*Department of Architectural Engineering, Faculty of Engineering,
Hiroshima Institute of Technology, Japan*

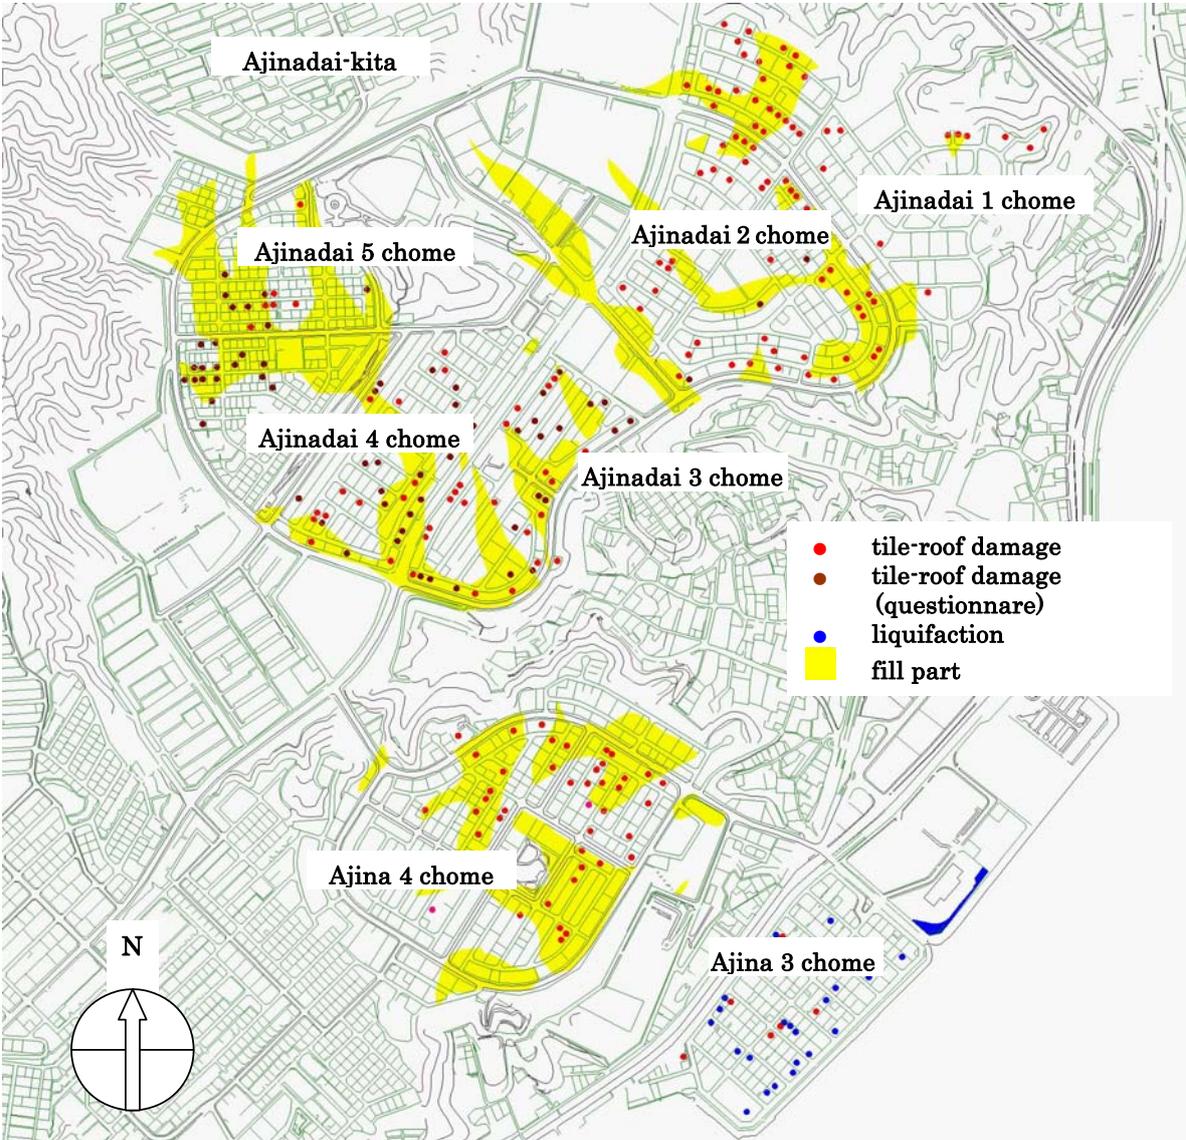
The roof damage states of the residential quarter in Ajina and Ajinadai, Hatsukaichi City, were investigated on the 28th April and 8th of May, on which one month passed from the earthquake occurrence. Figure 1 shows the tile-roof damage states [Iwai, S. and Asano, T. (2002, 2004)]. A red small round point indicates a house observed roof damage, a brown round point a house with roof damage reported due to a questionnaire survey, and a blue round point liquefaction occurrence, respectively.

The fill part of yellow area in Fig. 1 shows the results that Asano, T. (2002) distinguished the cut and fill according to difference of the altitude data of each 10m of the geographical features before and after improvement. The fill thickness is thought to be about 5-10m in average. The maximum thickness of the fill shows 20m under some circumstances. The tile-roof damage by a questionnaire and a site investigation confirmed the considerable correspondence. A lot of tile-roof damage on the fill land is obviously recognized.

Figure 1 Housing damage state (Ajina and Ajinadai, Hatsukaichi City)

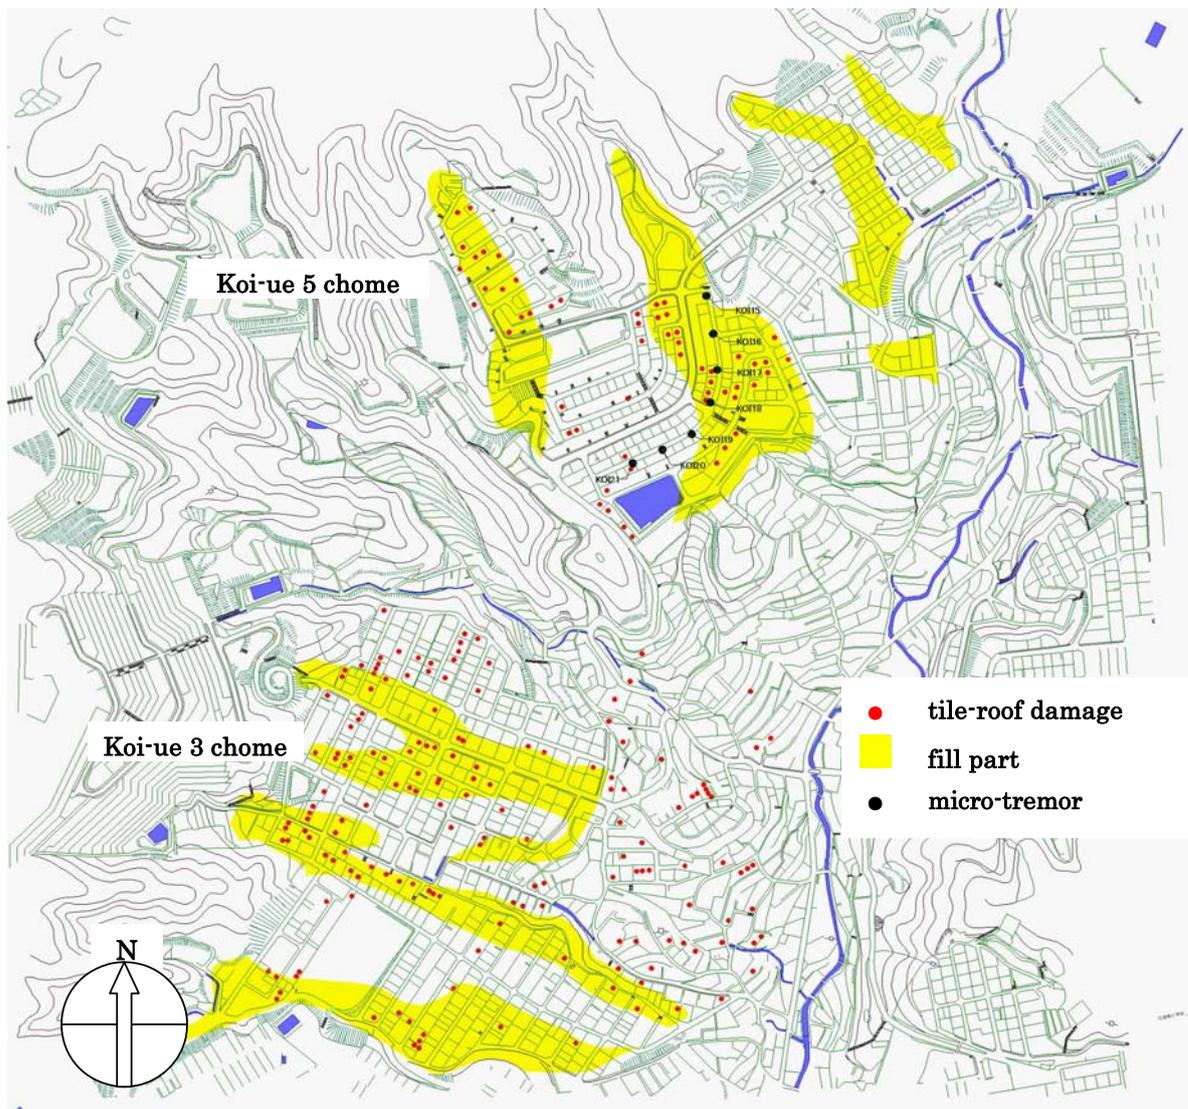
The damage of the wooden house tile-roof was surveyed in 3-chome and 5-chome areas on Koi-ue district in Hiroshima City, on April 4th of about ten days after the earthquake occurrence. Figure 2 shows the housing damage state [Iwai, S. and Asano, T. (2002, 2004)]. The red small round mark shows the house with damage, whose roof is covered by a blue waterproof seat. The houses were made on the hill ground, and passes about 30 years at the earthquake. As for tile-roof damages, there is considerably a lot of damages in the Koi-ue district compared with damages in the delta soft-subsoil region in the center of Hiroshima City, where the house damages were hardly seen. The house site is piled up with the retaining wall, and damage is caused by the crack and the collapse of the retaining wall. The classification of the cut and the fill ground in the Koi-ue district was shown in Figure 2. A lot of tile-roof was damaged also in the fill part than in the cut part.

Figure 2 Housing damage state (Koi-ue, Nishi Ward, Hiroshima City)

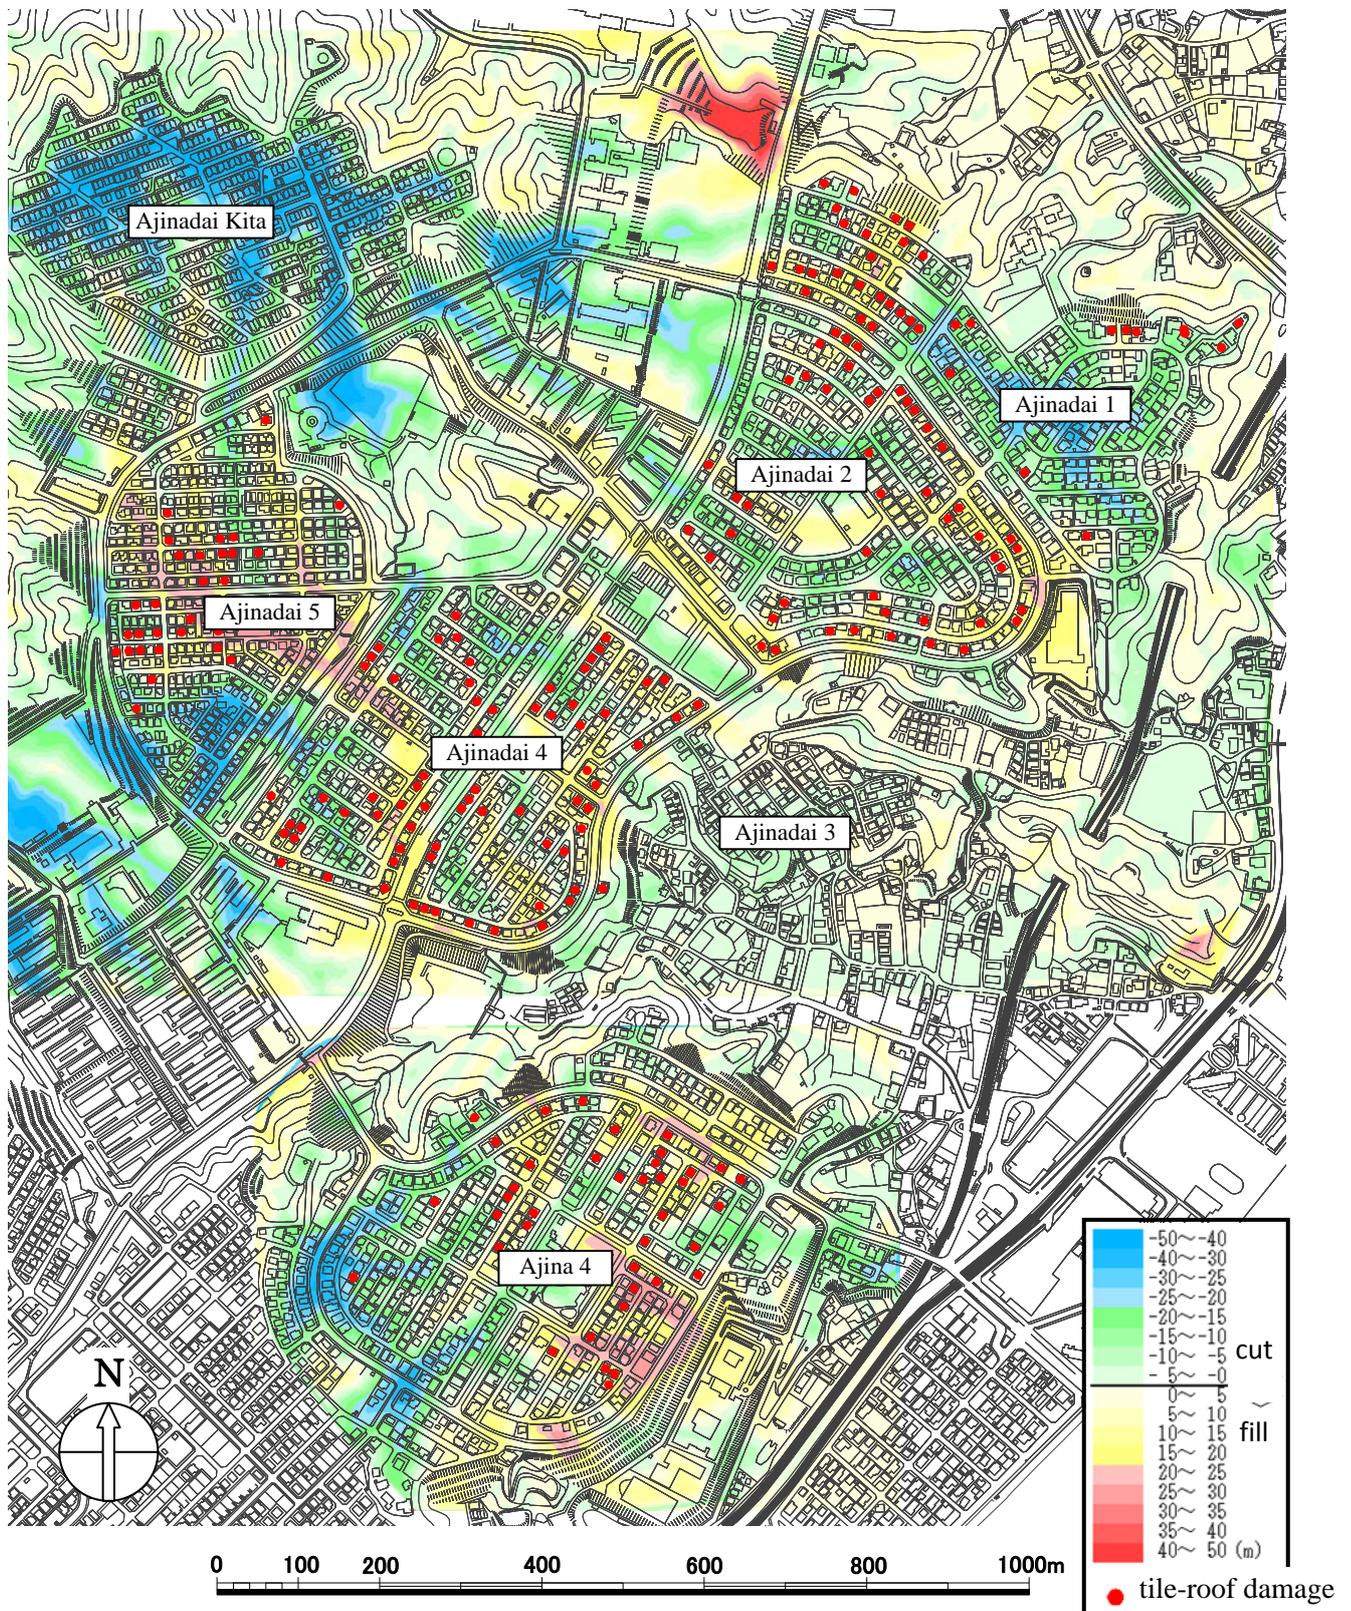
Figure 4 Fill-depth and cut-height coloring based on GIS estimation and tiled roof damage of houses at developed hill residential area (Ajina and Ajinadai, Hatsukaichi City)

The altitude (vertical) drop of the cut or fill ground affects the tiled roof damage of houses, as shown in Figs. 4 and 5. Many tiled roof damage of wooden houses by the 2001 Geiyo Earthquake appeared in the fill ground area, where the predominant frequency shows low and does not reach to 3Hz, as shown in Fig. 9. On the other hand, the tiled roof damage was not seen in the cut area where high predominant frequency is obtained as to exceed 10Hz. The vertical drop of the cut and fill ground affects predominant frequency of the ground, and it is possible that the difference of the predominant frequency of the ground influenced the tiled roof damage of the house. Moreover, about 2-4Hz in frequencies of the fill ground was predominant, and it is so considerably near the natural vibration of wooden houses that it be possible to relate with the amplification of vibration by the resonance. This ground vibration property corresponds to larger roof-tile damage of wooden houses in fill ground on improved hills. Based on survey of the data base on a wooden building, the average value of natural periods was between 0.3-0.4 seconds through many two-story wooden houses of conventional Japanese-style frame construction in many cases. The standard deviation through conventional frame houses is as considerably large as 0.2 seconds. The predominant frequency in the fill is near the natural frequency of a wooden house, and it is possible that the vibration amplification by the resonance caused the tiled roof damage of a wooden house.

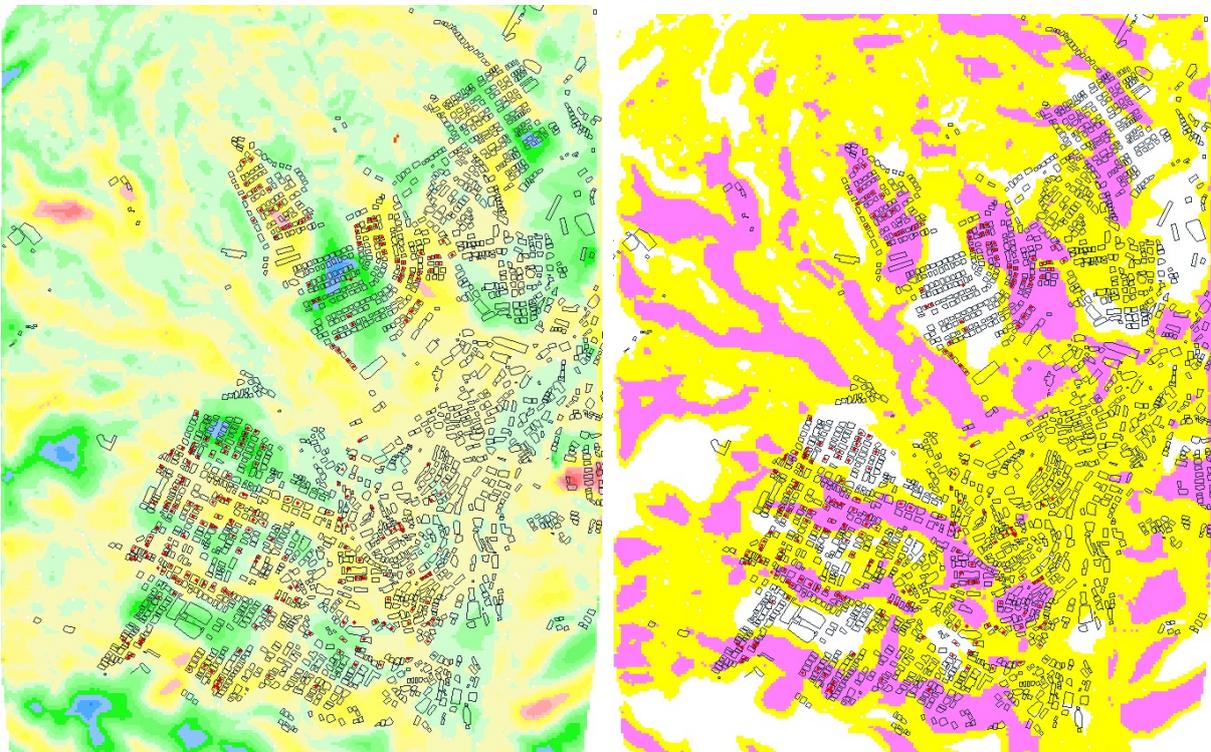
Figure 5 Fill-depth and cut-height coloring based on GIS estimation and tiled roof damage of houses at developed hill residential area (Koi-ue, Nishi Ward, Hiroshima City)

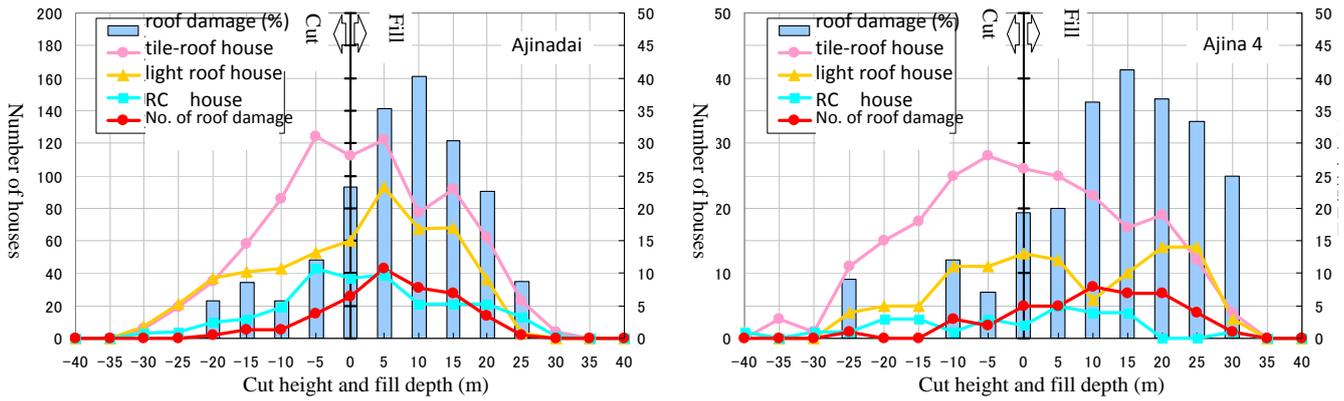
Figure 6 Cut and fill soil thickness and the tiled roof damage ratio (Ajina and Ajinadai, Hatsukaichi City)

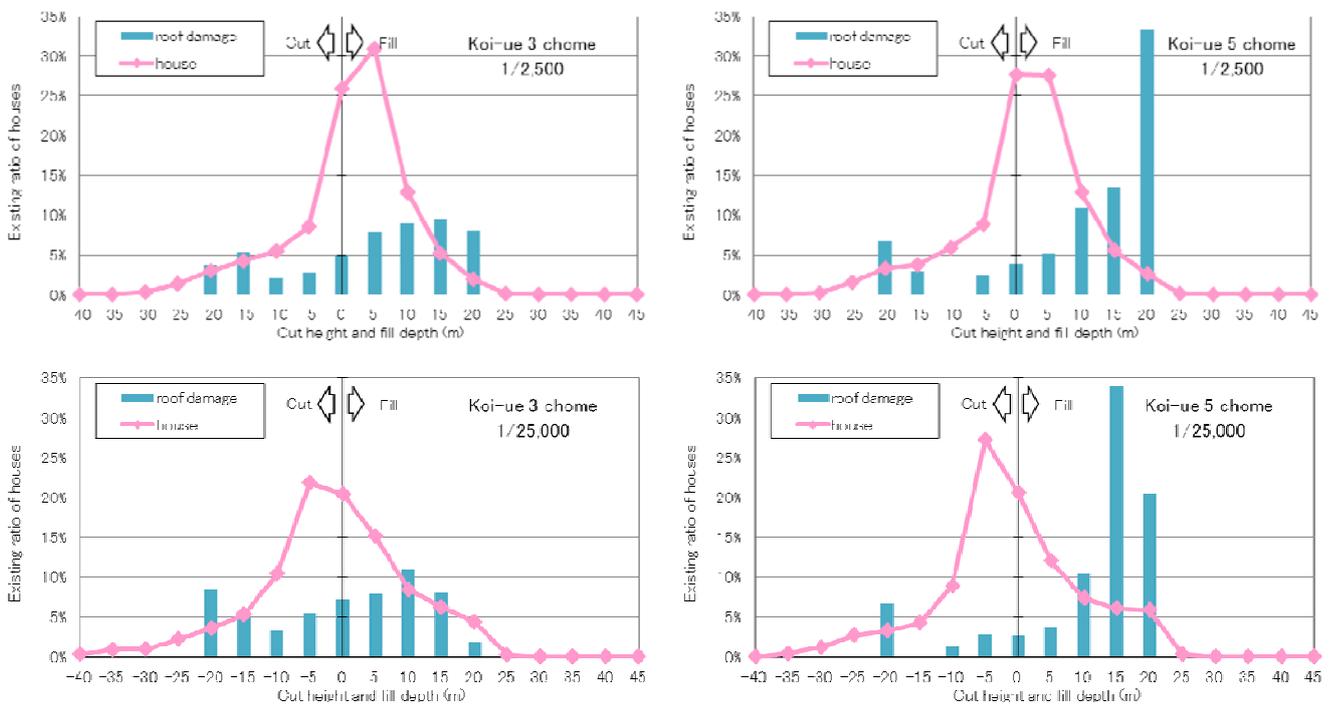
Figure 7 Cut and fill soil thickness and the tiled roof damage ratio (Koi-ue, Nishi Ward, Hiroshima City)

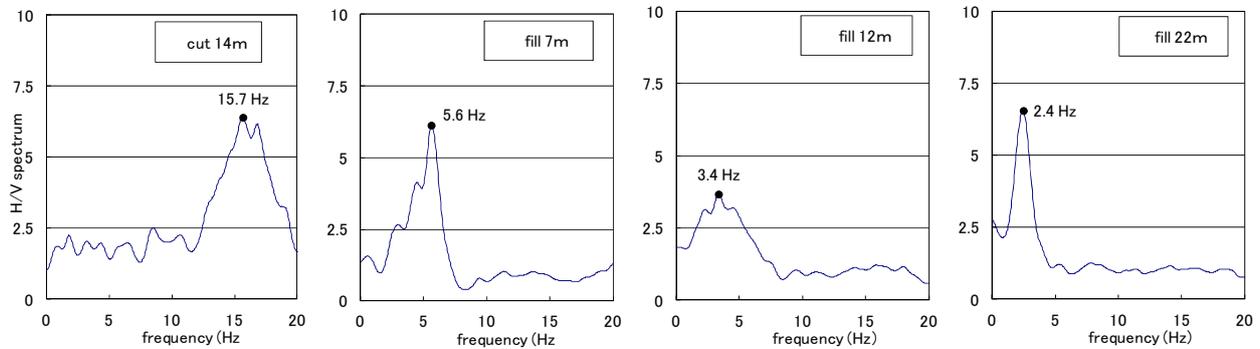
The power spectrum of the velocity record of these horizontal east-to-west (EW) component and north-to-south (NS) component were analyzed shown in Fig. 8, corresponding to the type of the ground, respectively [Iwai, S. (2008)]. The power spectrum is displayed by the order of the ground depths (unit in meters) in turn from the left to the right. An H/V spectrum (a ratio of horizontal spectrum to vertical one) based on the micro-tremor measurement is found to have clearly different characteristics between the fill part and the cut part in the improved hill ground. The vibration characteristic at the site on cut ground is almost flat in frequency range about from 0.5Hz to 20Hz, except a little predominant frequency from 14Hz to 18Hz range. On the other hand, the H/V spectrum has a clear peak in about 3Hz on the fill ground. It is understood to have combined vibration characteristics of both ground in the boundary area between the cut and fill. Thus, the difference between the cut and fill appears to reveal the characteristic of the H/V spectrum. As mentioned above, it has been understood that a spectrum and spectrum ratio characteristics have the pattern by which each feature correspond to three categories dividing by (1) the cut, (2) the fill and (3) their border area. Moreover, a south-to-north component showed the tendency that roughly looked like the east-to-west component. Those features may relate old geographical features before improvement of housing lot. Predominant frequency of surface soil known as "1/4 wave length" law tends to correspond with this result.

Figure 8 H/V spectrum of velocity record of horizontal to vertical component against fill or cut soil thickness and the predominant frequency [Iwai, S. (2008)].

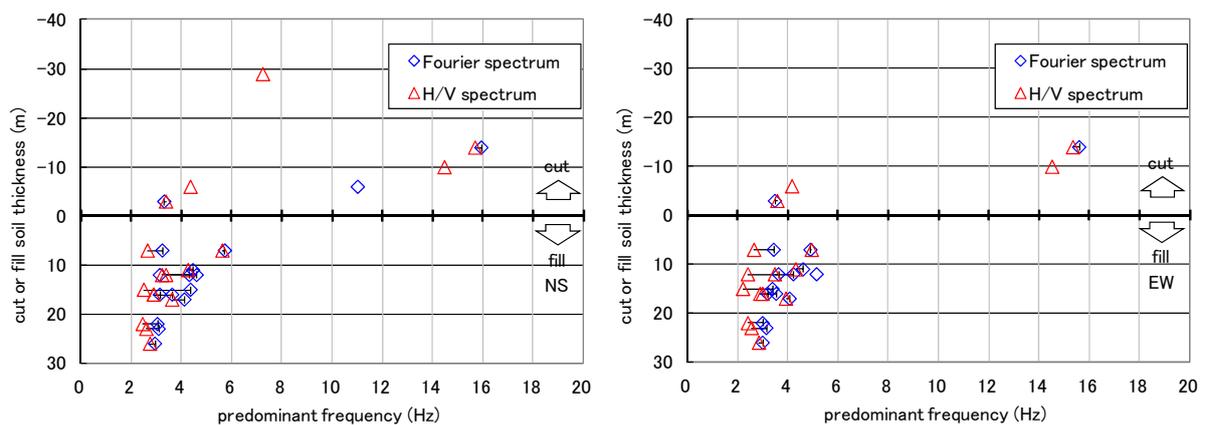
Figure 9 The relationship between fill or cut soil thickness based on GIS estimation, and predominant frequency of the ground in a developed hill residential area.
