# Macro and micro scale assessment and quantification of Ground damage following the Canterbury 2010/2011 Earthquake sequence

**S.C. Wallace & A.J. Macdonald**

*Tonkin & Taylor Ltd. 33 Parkhouse Road, PO Box 13-055, Christchurch, New Zealand*

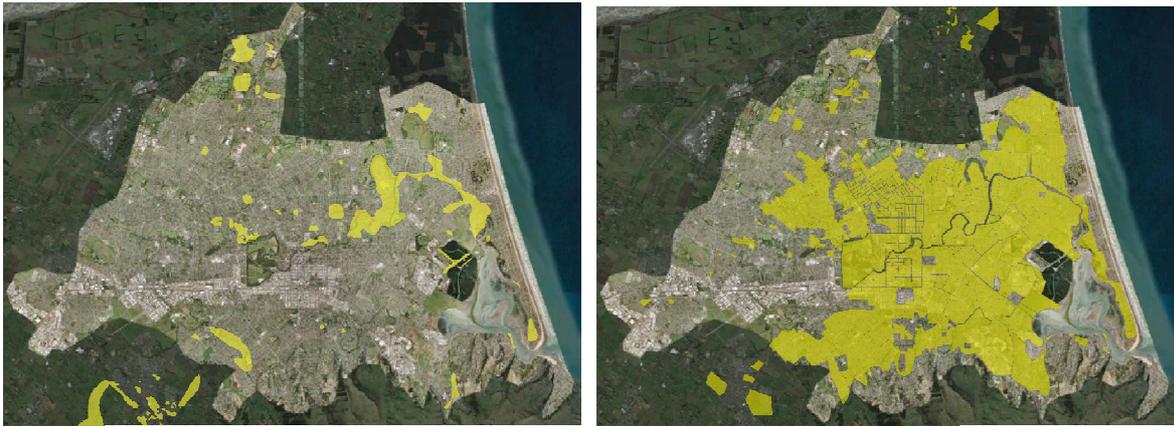
**Figure 1.** Macro scale ‘Regional’ mapping undertaken from aerial survey identifying areas where sand was observed at the surface following the 4 September 2010 (left image) and 22 February 2011 (right image) earthquakes

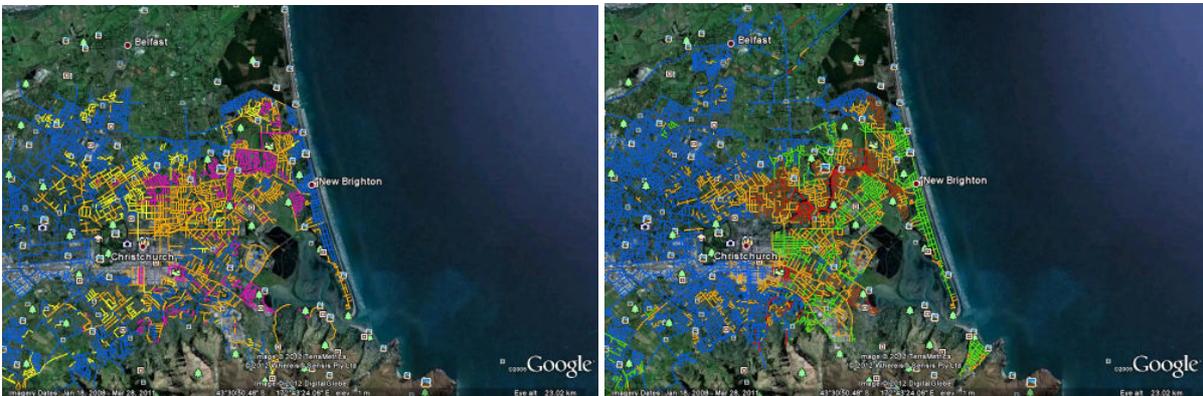
**Figure 2.** Macro scale ‘Vehicular’ road based mapping undertaken to identify severity of land damage following the 22 February 2011 (left image) and 13 June 2011 (right image) earthquakes (Refer to Table 1 for legend description)

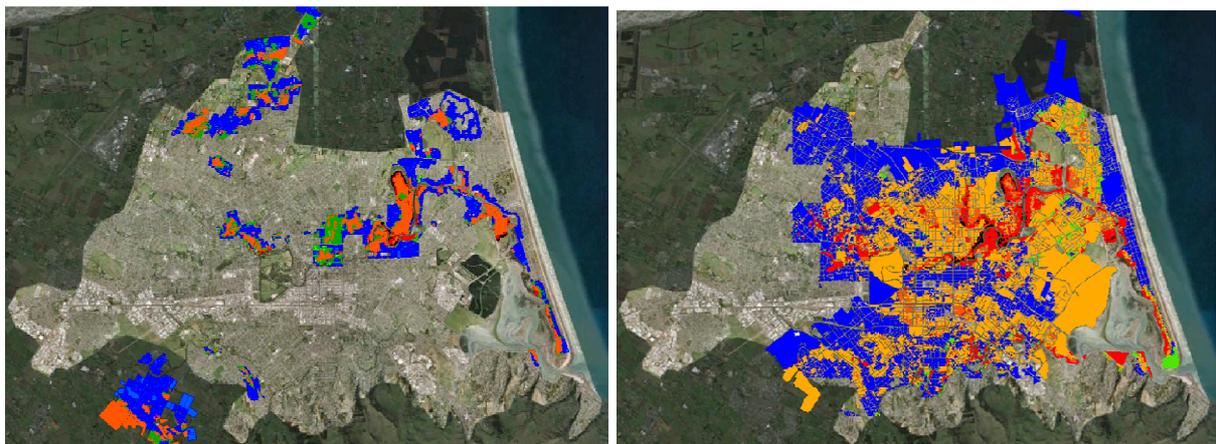
**Figure 3.** Macro scale ‘Local’ mapping undertaken as a foot based road level assessment identifying the severity of the land damage observed on flat land following the 4 September 2010 (left image) and 22 February 2011 (right image) earthquakes

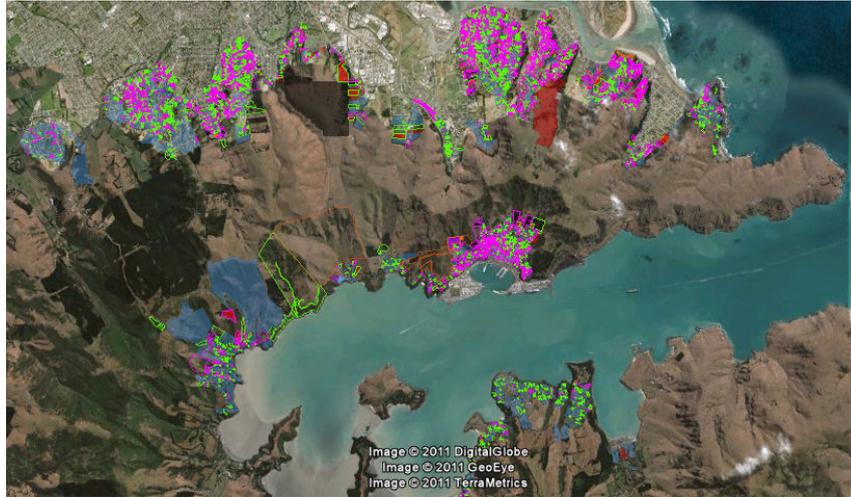
**Figure 4.** Macro scale ‘Local’ mapping undertaken as a foot based road level assessment identifying the severity of the ground damage observed on sloping land following the 13 June 2011 earthquake

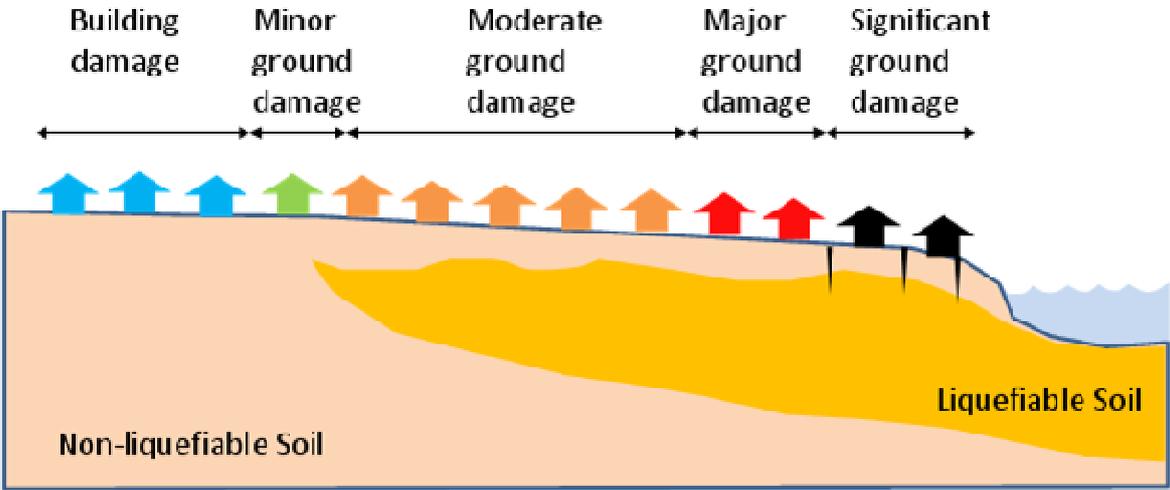
Following the 4 September 2010 earthquake ‘typical’ patterns of observed land damage were noted. In general it was found that the damage was worst around existing and former river and stream channels, and adjacent to beach and estuary areas, where the most recent (and typically loose) deposits were located. Specific, relatively isolated streets and suburbs were severely affected by liquefaction, resulting in very deep (300 to 500 mm) layers of ejected material, and locally, what was then considered to be significant lateral spreading. Generally, the land damage category was observed to decrease in a manner that was somewhat proportional to the distance the property was from the river or beach interface (‘channel’). Greater/more significant damage was generally recorded on properties on the inside of bends and meanders in the rivers/former river channels, than was recorded on properties immediately opposite, on the outside of the river bends/meanders.

**Figure 5.** Typical observed pattern of severity of land damage caused by the earthquakes to land adjacent to existing and former channels
