Chronological Construction Sequence, Creep, Shrinkage, and Pushover Analysis of an Iconic 1960s Reinforced Concrete Building

O.A. Rosenboom, T.F. Paret and G.R. Searer

Wiss, Janney, Elstner Associates, Inc.

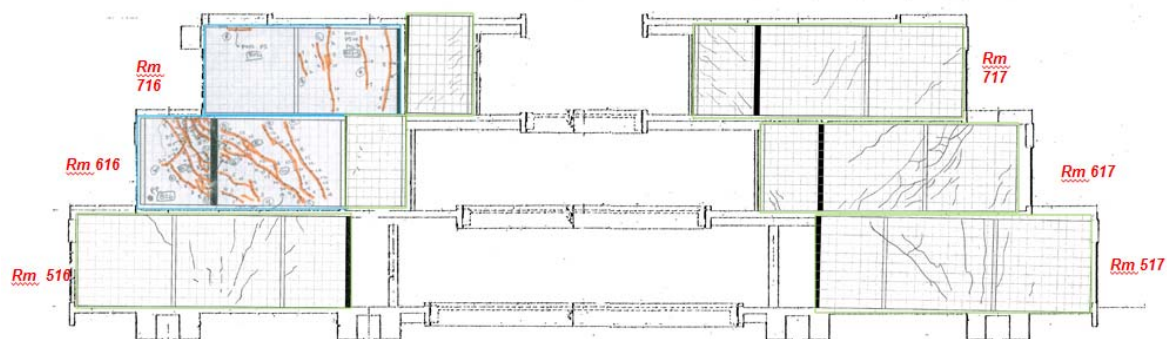
After the earthquake, distinctive patterns of inclined cracking were noted in most of the painted shear walls, and assessment of the condition of the building was initiated by multiple parties. The authors' investigation, seeking to understand the cause and significance of the cracking, approached the subject from a variety of perspectives, but detailed physical examination of the cracking immediately after the earthquake was not possible due to the owner's decision to immediately grind finishes from the surface of the walls along every visible crack. As crack maps along typical reinforced concrete wall lines were prepared and conceptually evaluated, however, patterns that were inconsistent with the stress fields normally associated with seismic ground shaking began to emerge. For example, "identical" wall segments on opposite sides of the central atrium exhibited mirror-image inclined crack patterns and some of the inclined cracking, particularly on discontinuous cantilevered wall segments, seemed much more likely to be associated with gravity stress fields rather than that induced by an earthquake (Figure 2). In any case, in the relatively few areas in which existing wall surfaces were not removed, many of the cracks exhibited surface repairs, indicating that even cracks that might be associated with seismic ground shaking pre-dated the 2006 event. These cracks were later demonstrated through testing to be deeply carbonated.

Figure 2. Crack map of typical wall line on ocean side (left) and mountainside (right) towers.

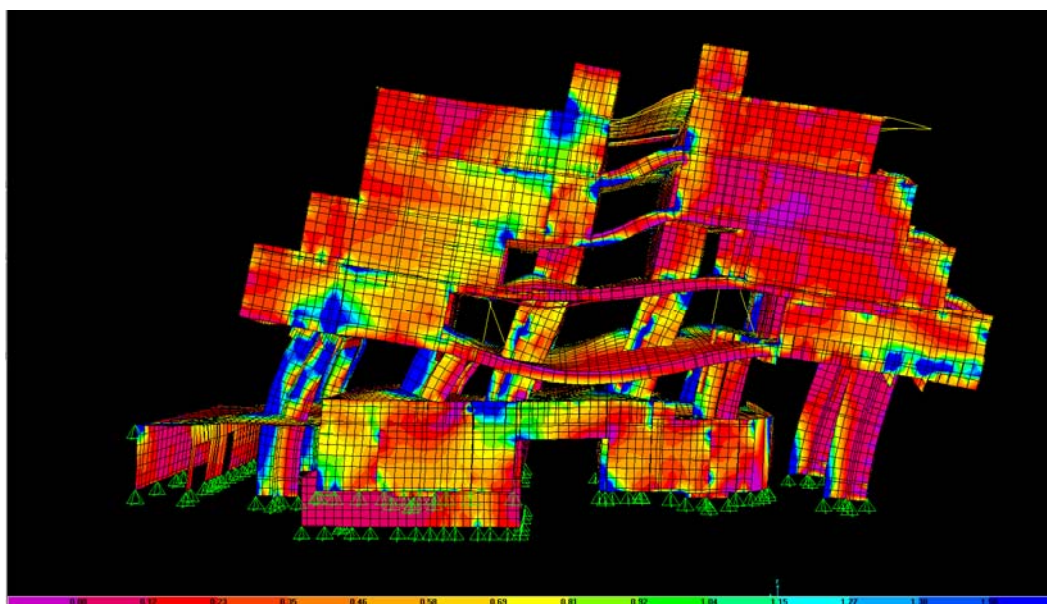
Figure 3. Principal tensile stresses in linear model of south wing under amplified seismic loading

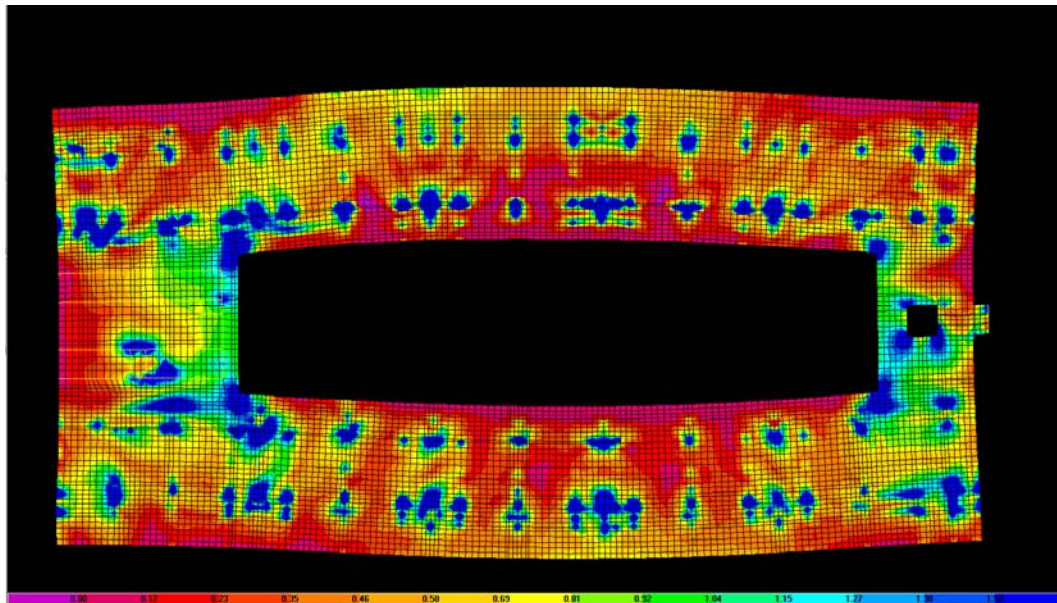
Figure 4. Principal tensile stresses at 5th floor under amplified seismic loading towards bottom of page

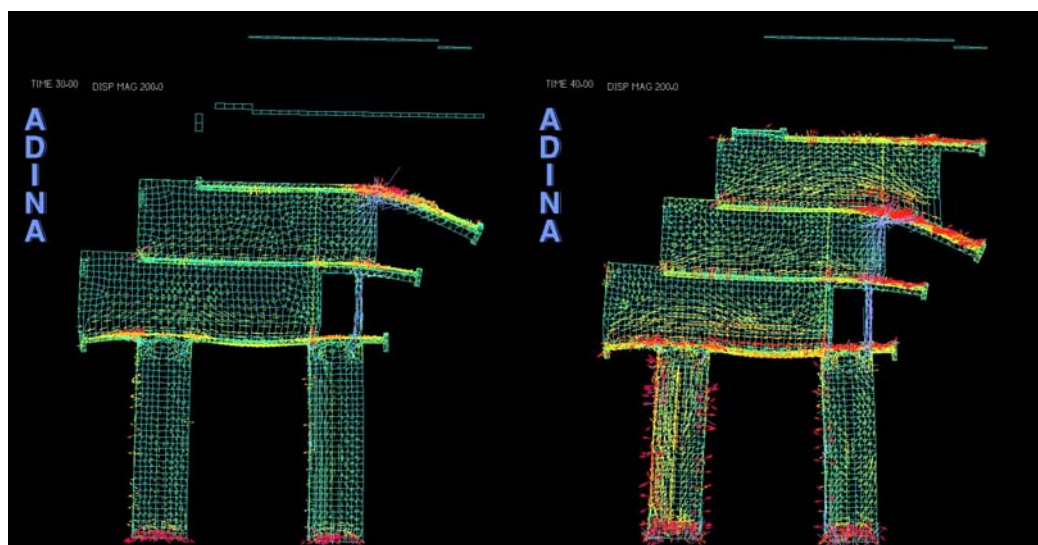
The gravity stress field combined with the ramp-applied shrinkage regimen to each structural component after birth, but absent applied lateral forces, revealed the patterns of tensile stress vectors shown in Figure 6. The addition of each stacked, offset floor altered the horizontal center-of-mass of the building, shifting it towards the courtyard with each floor addition. The final shift occurred in 1972 when the 8th floor penthouse was constructed atop discontinuous walls (Figure 7). The pattern of cracking in the walls revealed in the gravity plus shrinkage analysis was essentially identical in every wall, regardless of whether the stacked walls are supported by tall cruciform piers (ocean side), short cruciform piers (mountain side), or are located between the pier and are supported by transfer girders. This nearly invariant crack pattern from dead load replicated observations in building after the 2006 earthquake.

Figure 6. Principal tensile vector plot. Construction sequence to 6th floor (left) and to the 7th floor (right)

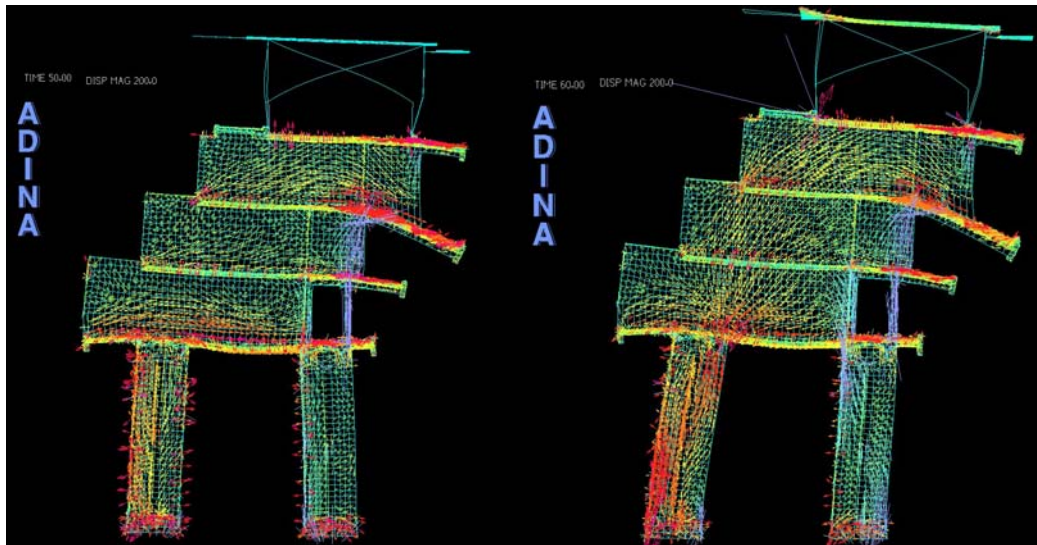
Figure 7. Principal tensile vector plot. Construction sequence to 8th floor (left) and after applying seismic pushover loads calibrated to the recorded accelerations at the Waikoloa Hotel (right)

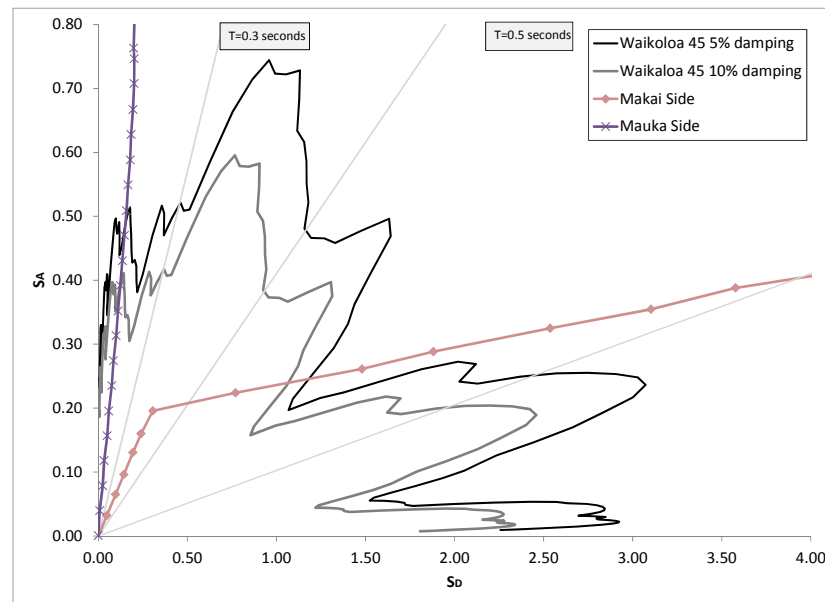
Figure 8. ADRS pushover for mountain side (mauka) and ocean side (makai) submodels

maintained on a floor-by-floor basis, enabling calculation of damage rates and direct comparison of the calculated rates to published fragilities and to floor response accelerations predicted by the structural analyses. The comparisons demonstrated that the response accelerations must have been substantially less than those predicated on the Waikaloa Hotel records, which also helped to explain why the predicted yielding in the cruciform piers did not occur.
