Steel Rigid Frame Structural Behaviour at El Mayor Cucapah (Baja California) Earthquake April 4, 2010.

SUMMARY:

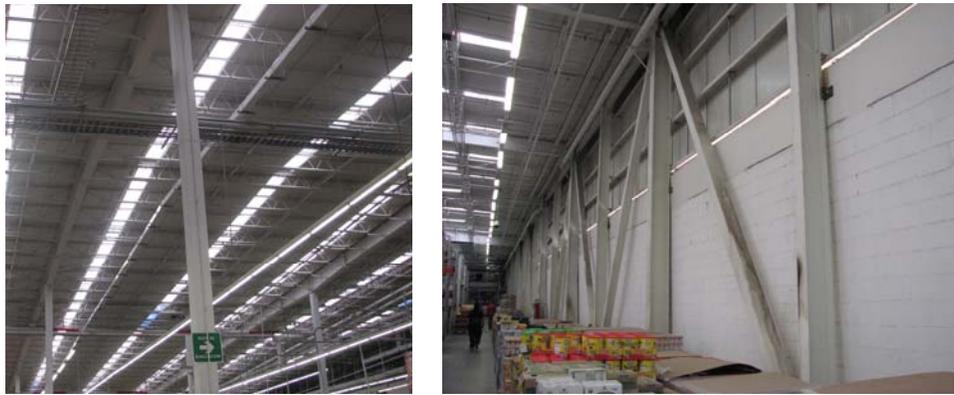
Figure 5. Gable steel system structure.

In photographs at figure 5 the building with a semi-rigid frame steel structure is shown. The columns are thin (254 mm x 254mm) and beams only simply support over them. The maximum height of this structure is 10 m. The facade wall was lateral restrained by connecting to the steel frames, this connection was only made to avoid displacement problems of the wall; in this case, the walls became part of the seismic resistant system, avoiding to reach displacements that could have produce a collapse of the structure. Also the roof at the moment of the earthquake had a minimum live load, helping to decrease the mass over the structure.

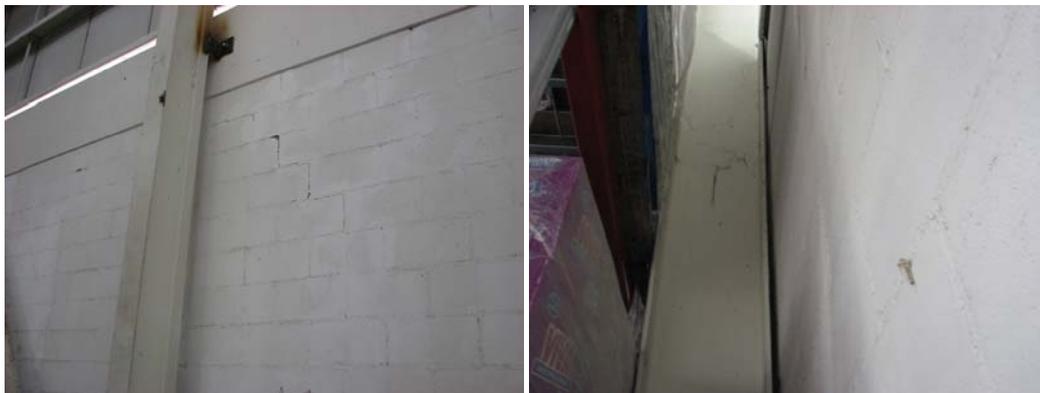
Figure 6. Gable steel system structure after the Cucapah Earthquake.

The external columns of the frames are Wide flange type. The steel frames pushed out de facade wall, moving it around 15 cm in the most affected zone that was at the centre of the building. This wall also

helped the structural system to reduce drifts in the other direction, producing diagonal cracks.

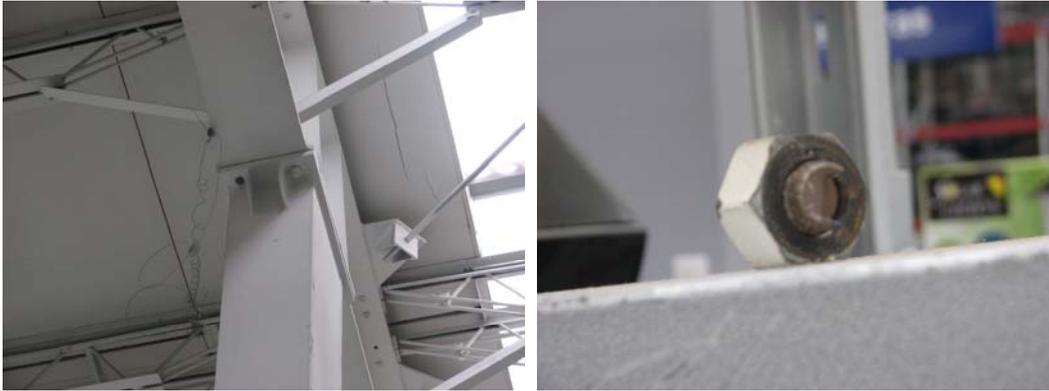
Figure 7. Semi-rigid connections at the gable structural system.

The displacement level was at the top roof the maximum suffered; figure 7 shows a bolt found at the floor level after the earthquake, it had a shear failure at the beam-column simple connection.

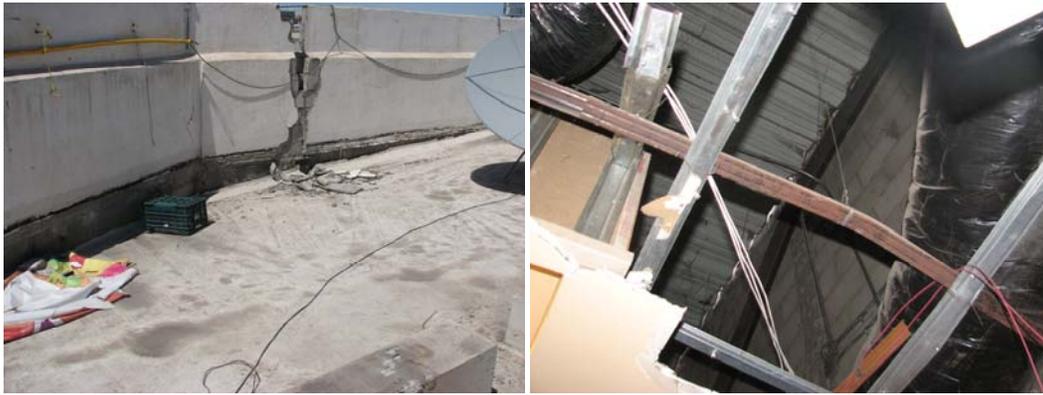
Figure 8. Shear wall- steel frame building after the Earthquake.

Torsional problems and excessive displacements were suffered by the structure presented at figure 8. Steel columns buckle and steel beams moved toward the lower level, making that the roof (composite slab) move down around 15 cm as it can be seen at left picture of figure 8. Right image is the same spot but from down under.

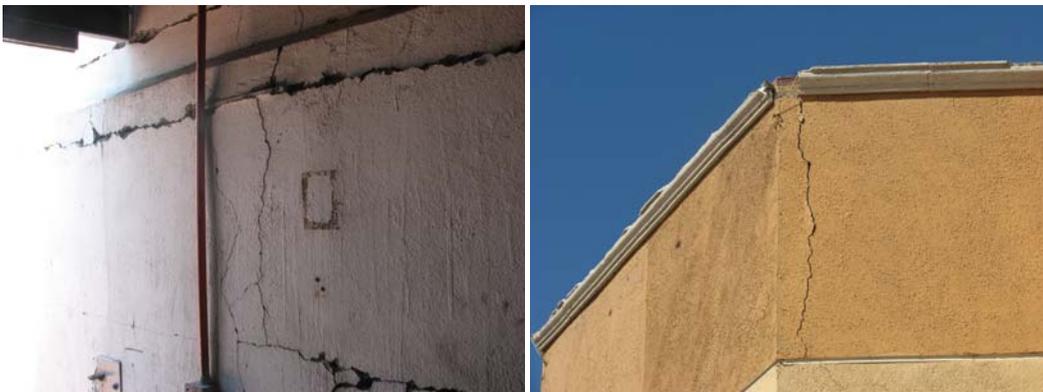
Figure 9. Shear wall- steel frame building with serious damages in shear walls

In figure 9 it can be seen that shear wall system produced torsional effect and cracked everywhere, damaging also the steel structure by increasing displacements and loads.
