SEISMIC PERFORMANCE ASSESSMENT OF EXPANSION JOINTS FOR WATER LIFELINES

SUMMARY:

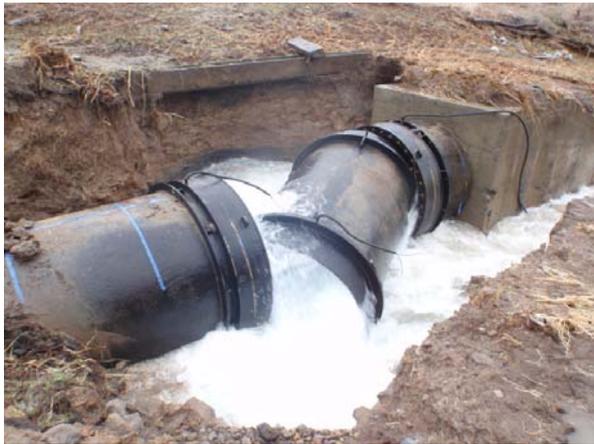
Photo 3.1. Water leakage from expansion joint

Photo 3.1. shows the large-scale water leakage from the expansion joint in the 2400mm diameter water pipeline immediately after the main shock. The accident occurred at both sides of the concrete encased pipeline under-crossing a water stream, as shown in Figure 3.1. It must be noted that this leakage occurred at the same time from both expansion joints. The concrete encased structure moved 700mm in the anticlockwise direction at site A and 100mm at site D.

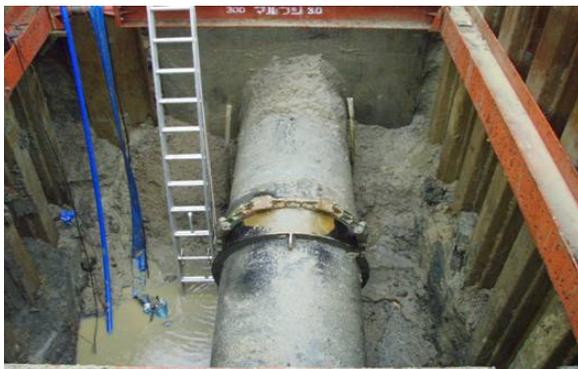
Photo 3.2. Excavation of joint failure portion

Photo 3.2. shows the damaged expansion joint in which leakage failure occurred at the upper portion of the expansion joint. This expansion joint belongs to closer type, which has housing and rubber ring, as shown in Fig. 3.7. The sealing bolt and ring at the upper portion were hydro-blasted by high pressure water and the half portion was worn out, as shown in Photo 3.3. Fig. 3.8. shows the worn portion and its volume corresponds to 6.3% of the original volume.

From this, the following failure mechanism could be deduced: (1) The main shock of March 11, 2011 produced high pressure water leakage from a small gap in the joint; (2) this water leakage started to wear the metal portion of the sealing parts, and this wear continued for one month; (3) the deteriorated sealing ring could not stop the large scale leakage caused by shaking due to the aftershock of April 7th. In order to confirm this failure scenario, the possibility that these failure steps could occur as a result of the main and aftershocks must be evaluated by the numerical approach.

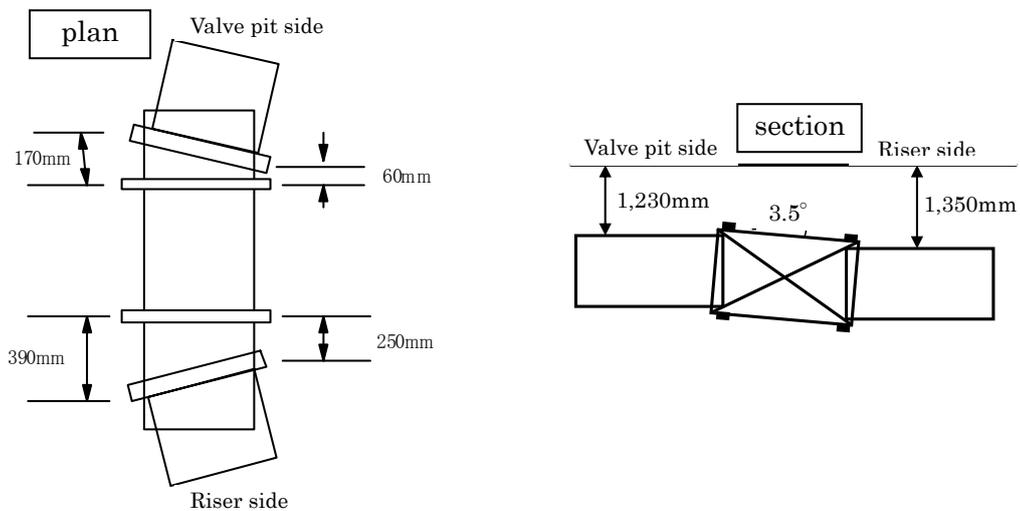
Figure 3.10. Site allocation of expansion joint after leakage

The expansion joint, which is located between the valve pit and the riser structure as shown in Figure 10, had a potential risk of uneven settlement, so that the expansion joint was forced to absorb vertical displacement. As a result of this settlement, the residual allowance for the seismic effect was limited. Based on the site investigation on April 7th, 2011, different vertical settlements were measured at the two ends of the expansion joint, as shown in Figure 3.10. This suggests that the joint had rotated to an angle of 3.5 degree before the earthquake. Using the site soil conditions shown in Figure 3.11., the seismic response of the concrete riser was analyzed with a single-degree-of-freedom system as follows.
