# Effects of Seismically-Isolated Buildings during the Huge 2011 Earthquake in Japan

## SUMMARY

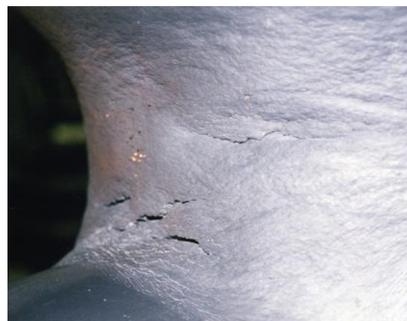
Cracks are caused by repetition of the micro-amplitude excitation, a kind of striation of which is characterized fatigue fracture was observed in sectional views of lead dampers (Photo 1.) by electronic microscope.<sup>5)</sup>

**Photo 1.** Lead damper used conventionally      **Photo 2.** Cracks on the surface of lead damper

Even if fissuring occurs (shown in Photo 2.), the lead damper will not break immediately. It will not break until it undergoes by the repetition of 30 times - 40 times of the repeated time which cracks are produced.

The capacity of lead dampers in which cracks are produced, is equivalent to the effective area, what remains after subtracting the doughnut-shaped area by the crack depth assumed along circumference from total area. <sup>6)</sup>

When abnormality of lead dampers is not recognized by emergency inspections, it is assumed that the SI performance of the building is intact. Abnormalities were discovered, such as cracks on the surface of lead dampers. If the maximum depth of the crack is less than 10 mm: U180, 15mm: U2426, by crack-depth test, they have 90 % of residual capacity to the usual capacity.

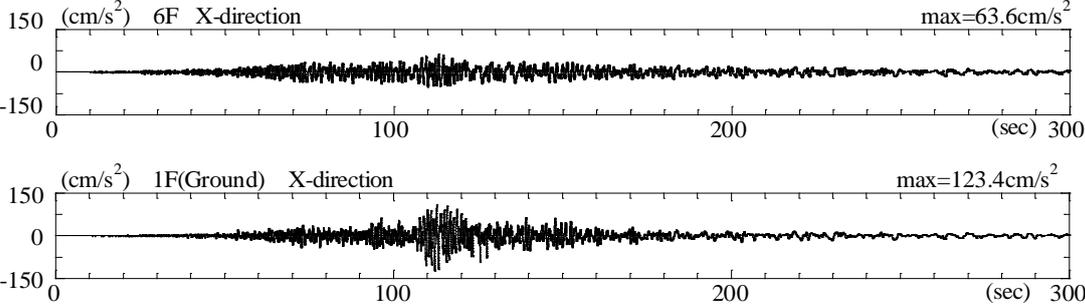
The relative displacement of the SI layer was observed by a displacement gauge. The accelerograph in the ground and one on the sixth floor are shown in Fig. 2. The maximum accelerations of the superstructure were reduced to about half, compared with the ground (shown in Table 3.).

Figure 2. Observed acceleration of the sixth floor and the ground

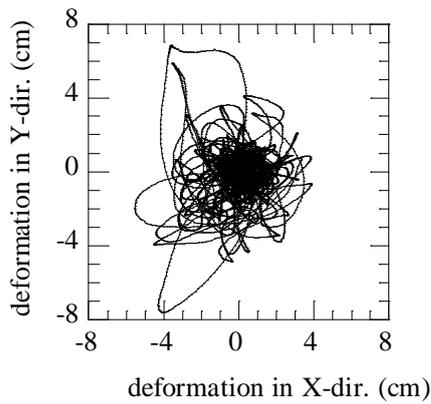
The horizontal deformation of an LRB is shown in Fig. 3. The maximum was 8.6 cm. The transfer-functions of the observed accelerations on the sixth floor to those on the ground are shown in Fig. 4.<sup>7)</sup>

**Figure 3.** Deformation trace

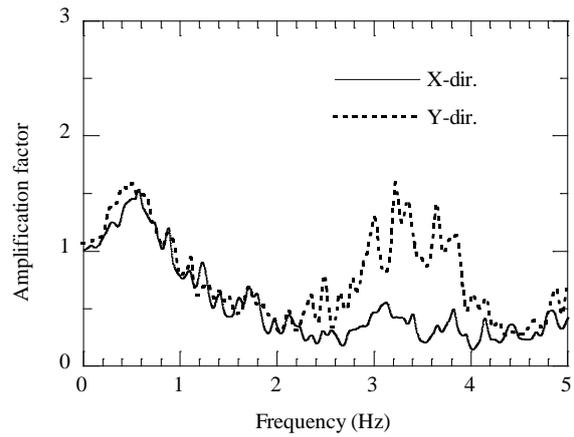
**Figure 4.** Transfer-function

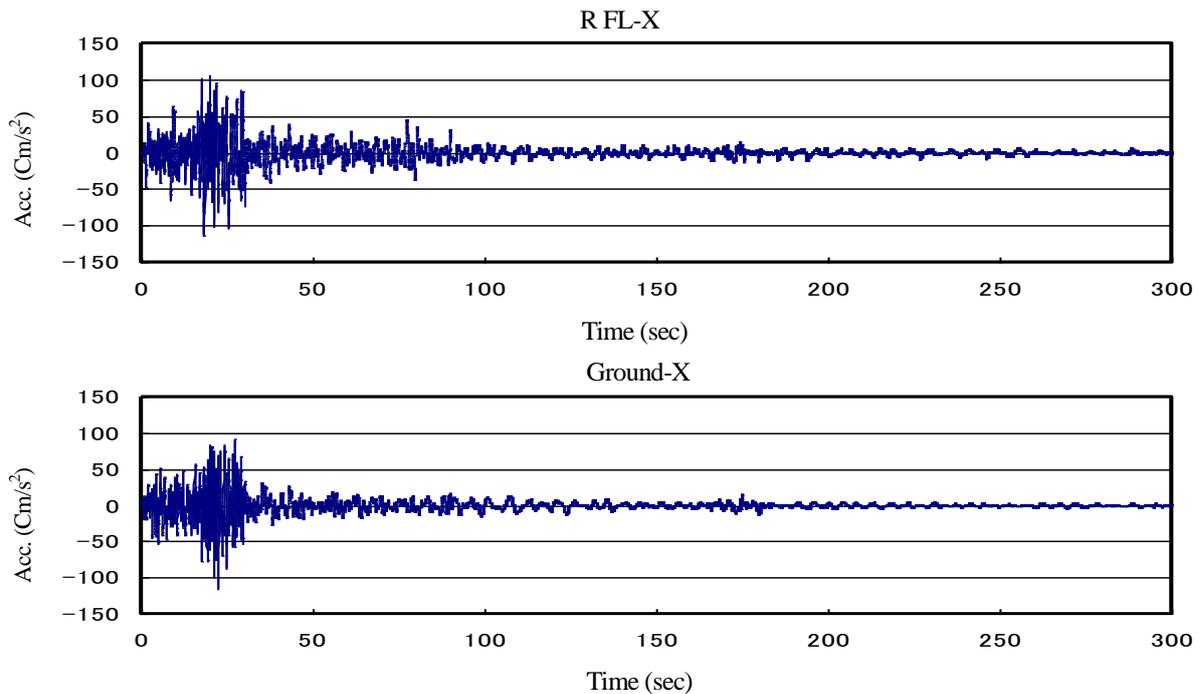
**Figure 5.** Observed acceleration of the roof floor and the ground

Observed accelerations, such as on the roof level and on the ground are shown in Fig. 5. Table 4. indicates maximum accelerations. The maximum acceleration under the SI layer 115gal (the JMA seismic intensity was lower five), the acceleration of the superstructure of the first floor was 87 gal, and the roof level was 116 gal. The acceleration of the top floor was approximately at the same level as the ground.

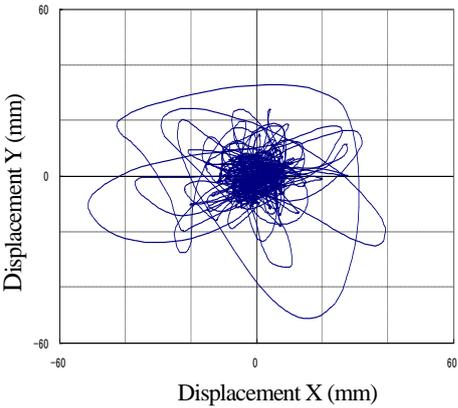
**Figure 6.** Displacement trace

A displacement graphic-meter is installed in the SI layer. The maximum amplitude of the SI layer was approximately 5cm (Fig. 6.).

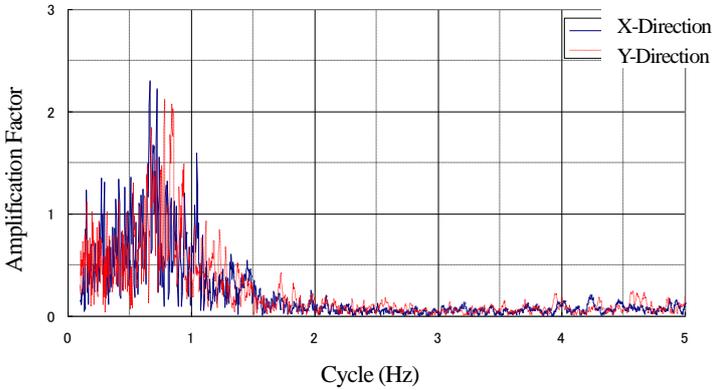
**Figure 7.** Transfer-function

The transfer-function amplitude from accelerations is shown in Fig. 7. In the first peak, it is thought that the natural period of the SI layer was approximately 0.7Hz. (1.5 seconds). This earthquake did not lead to the original seismically-isolated cycle for 0.4 Hz (2.5 seconds).
