Damage analysis due to 2010 Chilean earthquake in Viña del Mar residential buildings

SUMMARY:

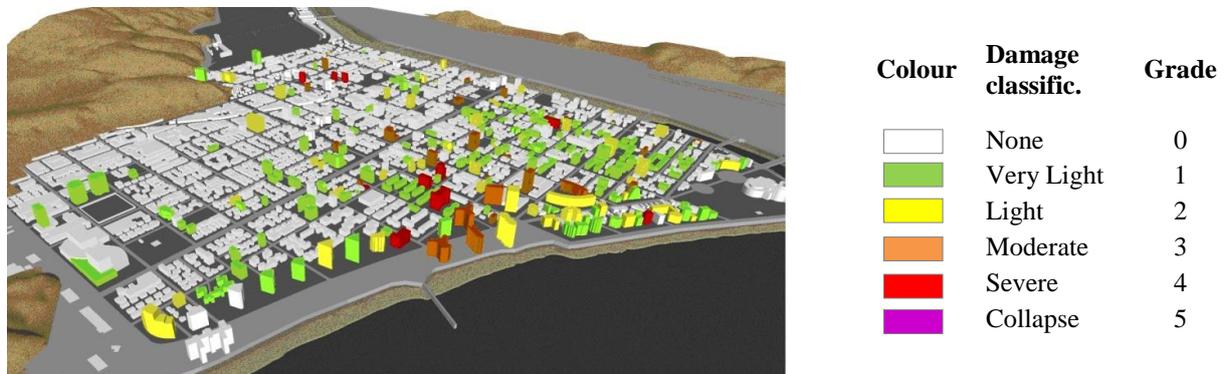
The more damaged buildings, having moderate or severe damages (grades 3 and 4 of EMS scale), are located in the city area with the softest soils, alluvial deposits belonging to the Marga Marga river mouth delta and to marine deposits (Fig. 4). This damage distribution was also observed by the EERI work teams who visited the damaged areas. On the ground, longitudinal cracks were detected, both in sidewalks and roads and in buildings patios and car parks. Centimetric settlements were also observed.

Figure 4. Viña del Mar city 3D image (from NW) showing the damaged buildings. Damage dependence with the buildings height and location on the softest soils is observed.

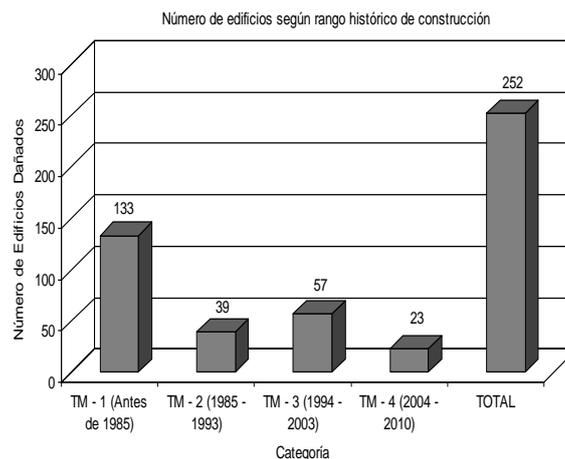
The dependence of the damage level with the building date of construction, height and stiffness parameter has also been analysed. The results indicate that 52.7 % of all of the damaged buildings were built before the earthquake of 1985, 15.5 % date from 1985-1993, 22.6 % date from 1994-2003 and finally 9.1 % date from 2004-2010 (Fig. 5).

Figure 5. Damaged buildings distribution according to different date of construction (TM).
