USABILITY OF TSUNAMI PRA BASED ON ACCIDENTS OF FUKUSHIMA DAI-ICHI NPP UNDER 2011 TOHOKU TSUNAMI

Katsumi Ebisawa, Hideharu Sugino, Yoko Iwabuchi and Masahide Nishio

Japan Nuclear Energy Safety Organization, Japan

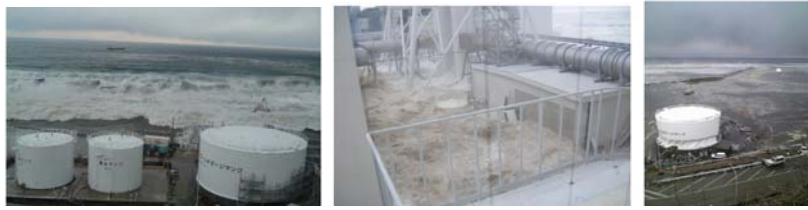
Figure 2. Situation of tsunami (by Tokyo Elec. Power Co., 2011)

F1-NPP was attacked by tsunami about 46 minutes after the earthquake as shown in Fig. 2. The tide level observation system consists of the tide gauge and the recording device at building. The arrival time and tsunami height of first big wave were 41 min after the main shock and O.P. about 4 m respectively. The arrival time of second big wave was 8 min after the first big wave and the water level by the second big wave was unknown due to tide gauge failure. The maximum scale of the tide gauge is 7.5 m. The tsunami height was more than 10 m according to the experts' estimation from the picture showing the overflow status of tsunami seawall (10 m).

TEPCO evaluated the design tsunami height based on Japanese Society Civil Engineering (JSCE) guide (JSCE, 2002), assessing Shioyazaki EQ. (M7.9) as M8.0 voluntary, and the highest water level of each unit was set as 5.4 to 5.7 m. The design tsunami height (5.7m) is lower than the tsunami height (10m). The site height (10 m) is lower than the inundation height (14m).

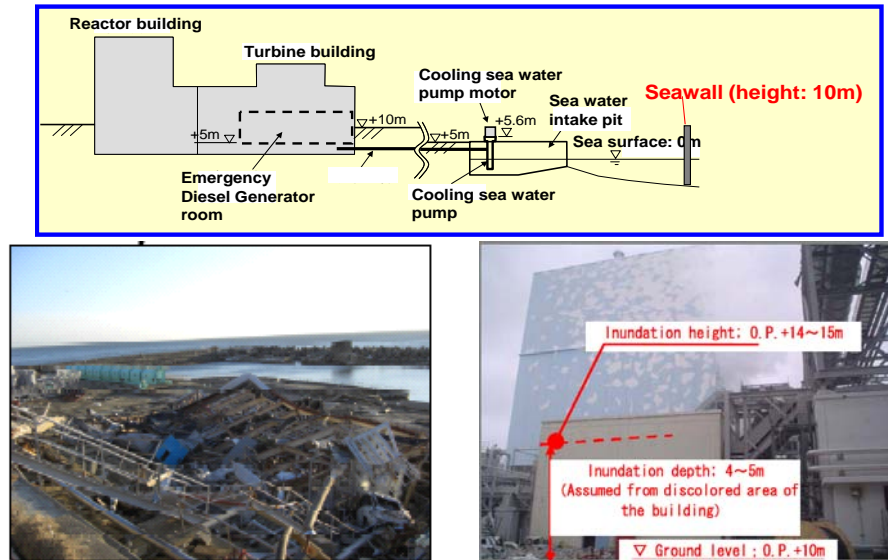
Figure 3. Illustration of sea water supply system and situation of tsunami disaster at Fukushima Dai-ichi nuclear power plant (by Tokyo Elec. Power Co., 2011)

As to the sea water pump facilities for component cooling (height: 5.6 to 6 m), all units were flooded by tsunami as shown in Fig. 3. Whether or not they were damaged by wave power is under investigation. The Emergency Diesel Generators (EDGs) and switchboards installed in the basement floor of the reactor and the turbine buildings (height: 0 to 5.8 m) were flooded except for Unit 6, and the emergency power source supply (EPS) was lost. Regarding Unit 6, two out of three EDGs were installed in the first basement of the RB and were flooded, but one DG installed on the first floor of DG building was not flooded and the EPS supply was possible. A transmission line tower out of the site was collapsed, and offsite power supply was lost.

On the other hand reactor core isolation cooling system (RCIC), which is steam-driven cooling system, in the front line (FL) was operated during a certain time but it stopped after a short time operation. Cooling systems in FL other than RCIC (and high pressure coolant injection system (HPCI) or isolation condenser (IC)) were not operated due to loss of AC power. Failure of reactor core cooling resulted in core damage (core melt) in about 5 or 6 hours. Temperature and pressure in the primary containment vessel rose up, and radioactive materials were released through seals to the on-site and the off-site. The land in wide area was contaminated by the radioactive materials. Information relevant to the accidents has not always been provided to the public in a proper manner.

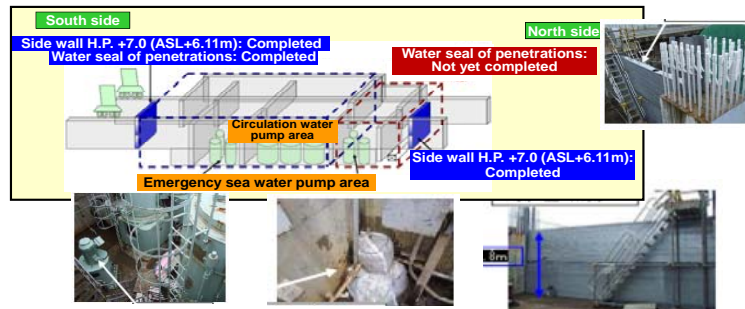
Figure 4. Illustration of sea water supply system and situation of tsunami disaster at Tokai Dai-ni nuclear power plant

The Tokai-Daini-NPP of Japanese Nuclear Elec. Power Co. is a single unit site with BWR. The arrival time and tsunami height of first big wave were 30 min after the main shock (14:46) and O.P. about 5.4 m respectively. The record of tide gauge was not recorded because the power supply was disrupted from 16:40 and the tsunami height exceeded the tsunami measurement scale.

The design tsunami height was H.P. +5.8 m. The design tsunami height (5.8m) is lower than the inundation height (6.3m). The site height (6.1 m) is lower than the inundation height (6.3m). When the earthquake hit the site, the north emergency seawater pump room was under leveling construction of its sidewall as protection against tsunami. The construction work put in place a new sidewall up to H.P. +7.0 m outside the existing sidewall, but the waterproof sealing of the penetration of the wall had not been completed as shown in Fig. 4. The tsunami flooded the north emergency seawater pump area in the seawater pump room through the small holes. One of three seawater pumps for EDGs was submerged, and one of three EDGs stopped. The other two EDGs were able to operate, successfully ensuring emergency power supply.

Tokai Dai-ni plant where inundation was slight and light enough was able to avoid total loss of the terminal heat sinks.

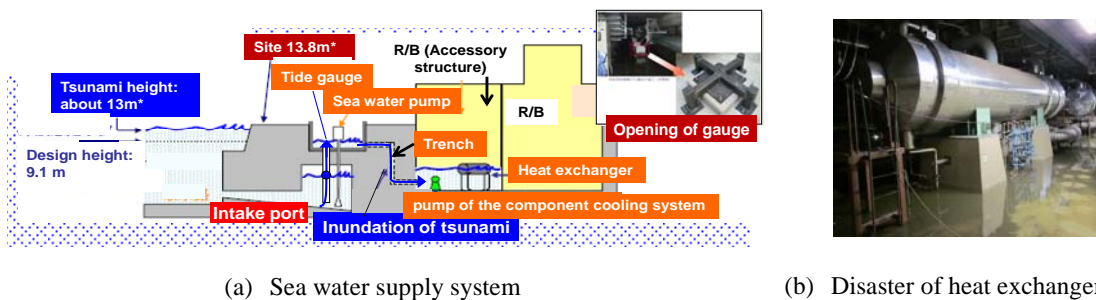
Figure 5. (a), (b) Illustration of sea water supply system and situation of tsunami disaster at Onagawa nuclear power plant (by Tohoku Elec. Power Co., 2011)

Component cooling system consists of intake channel/seawater pump/ seawater pump room/ heat exchanger room as shown in Fig. 5 (a), (b). The seawater pump room was designed as the height of 14.8 m and about 100 m away from the coast to prevent the inundation by run-up tsunami as shown in Fig. 5 (a). Inside the room, the tide gauge is installed with an opening. Tide gauge is to allow the automatic stop of the seawater pump in short of seawater due to the backrush of a tsunami. The tsunami did not attack the seawater pump room directly. The seawater overflowed in the room through the opening of gauge. Then the seawater flowed from the pump room, via the trench, into the basement floors of the reactor buildings, causing the heat exchanger room of the component cooling water system in the second basement to be submerged as shown in Fig. 5 (b). The component cooling water pump of Unit 2 was also submerged, which thereby caused the cooling function of EDGs to be lost, with two units stopped out of those three generators.

Tohoku Elec. Power Co. Inc. took measures to prevent the piping penetrations and the cable tray penetrations from the seawater pump room to the trench. They would set up a flood barrier around the seawater pump room. Then the seawater flowed from the pump room, via the trench, into the basement floors of the reactor buildings, causing the heat exchanger room of the component cooling water system in the second basement to be submerged.

The component cooling water pump of Unit 2 was also submerged, which thereby caused the cooling function of EDGs to be lost, with two units stopped out of those three generators. Tohoku Elec. Power Co. Inc. took measures to prevent the piping penetrations and the cable tray penetrations from the seawater pump room to the trench. They would set up a flood barrier around the

The Onagawa NPP where inundation was slight and light enough were able to avoid total loss of the terminal heat sinks.

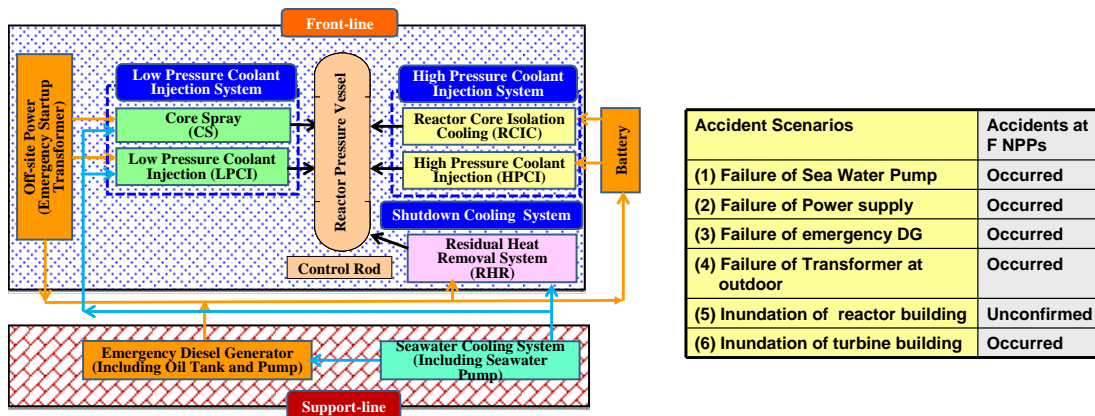
Figure 14. Illustration of contents of accidents at Fukushima Dai-ichi nuclear power plant and comparison between accident scenarios by tsunami PRA

The contents of accident at F1-NPP show in Fig. 14 as follows (Ebisawa, 2012, Takamatsu, 2012).

- Functional failure of seawater supply system (seawater pump, switchboard (switchgear) / signal-processing board (motor control)) for seawater pump
- Functional failure of emergency power supply system (diesel generator (DG), DG switchboard (switchgear) / signal-processing board (motor control)) for emergency power
- Functional failure of breakers and emergency transformer in the switchyard
- Functional failures of transmission line tower out of the site and offsite power supply

(v) Function failure of interconnected power supply between neighboring Units (Units 1 and 2, Units 3 and 4, and Units 5 and 6).

(i) All of seawater supply systems and (ii) emergency power supply systems were lost in function simultaneously. These results from (i) to (v) led to loss of all AC power (Station blackout). As a consequence, functions of reactor cooling system was lost, core damage occurred and radioactive materials were released to the off-site area.

The table 1 shows the comparison results between the accident scenarios by tsunami PRA in 4.2 and accidents at F1-NPP in 4.3 (Ebisawa, 2012). The contents of tsunami PRA developed more than a year ago identified well about the points occurred at the F1-NPP. It clearly showed further usability of tsunami PRA method.
