# Behavior of RC Structures Under Tsunami Triggered by The Great East Japan Earthquake

**S. Ishiyama & C.H. Cuadra**

*Akita Prefectural University, Japan*

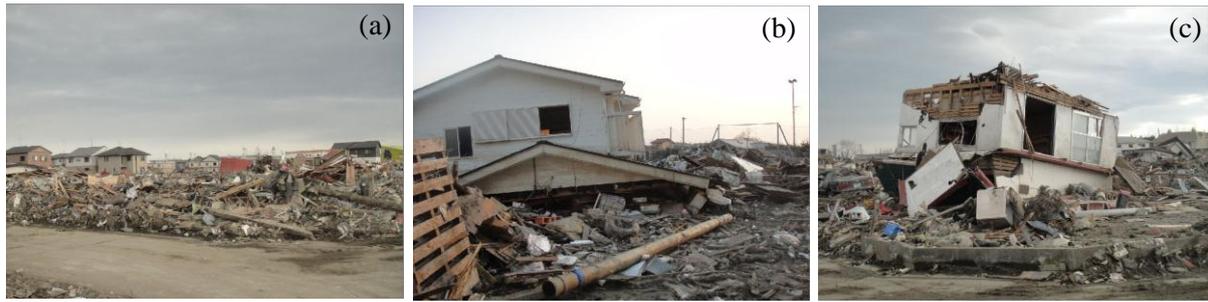
**Figure 6.** Damages on wooden houses

Figure 6 shows some typical damages on wooden houses that were produced by the tsunami. In Figure 6(a) it can be observed that wooden houses were completely destroyed by the tsunami action. It can be also observed that houses located on high sites are not affected. In Figure 6(b) the first floor was destroyed by the tsunami and the upper part of the house was transported and then left by the tsunami on a different place from their original location. In the case of Figure 6(c) the tsunami destroyed the first floor and also produced the overturning of the remaining upper floor.

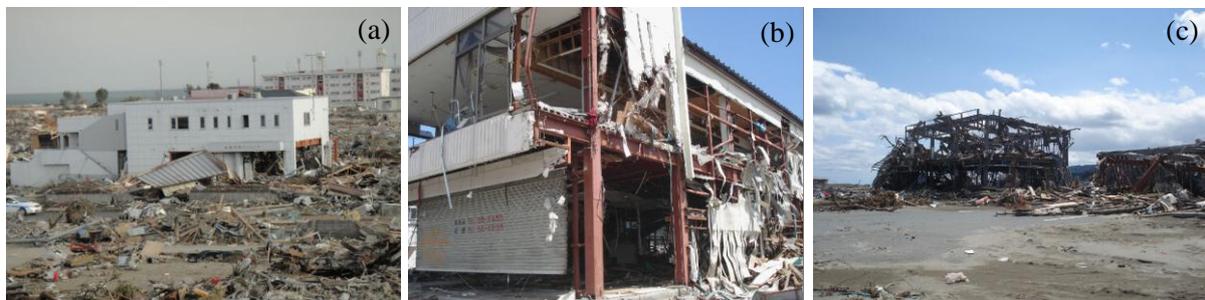
**Figure 7.** Damages on steel structures

Damages on Steel structures can be observed in Figure 7. When the inundation depth reaches only the first floor the structure remains almost intact however the wall panels of the first floor suffer some damages as can be observed in Figure 7(a). In Figures 7(b) the inundation depth reached the second floor and wall panels and ceiling are destroyed. In this case the structure remained stand up however some local failure of the structural elements were observed. Figure 7(c) shows a total collapse of steel structures. In this case the building was completely covered by the water.

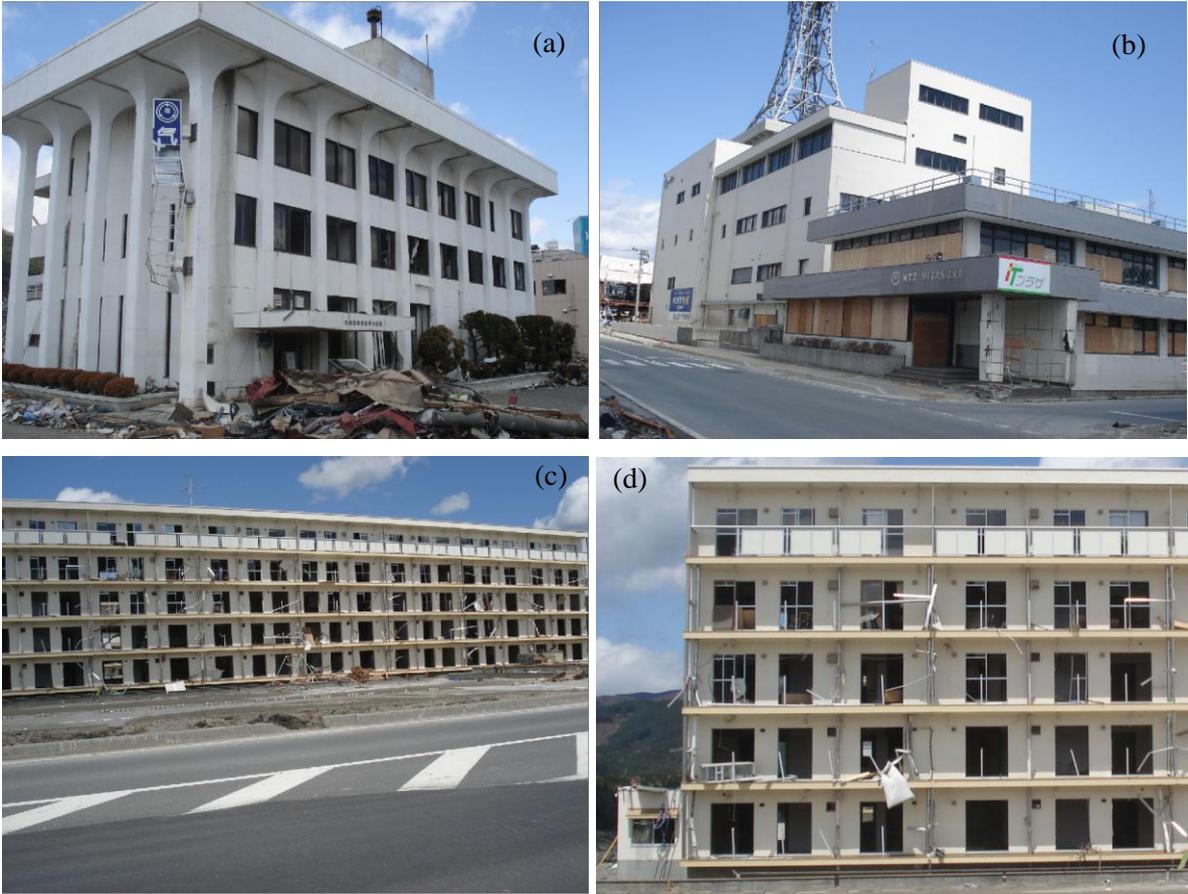
Figure 8. RC buildings after tsunami attack

Many reinforced concrete structures resisted the tsunami action without collapse as can be observed in Figure 8. Figure 8(a) is the building of a local bank located at Funato city, and it can be observed from the damages of the windows and the damage of the advertisement panel of the left corner of the building that the tsunami reach the third floor. In Figure 8(b) it is also inferred that the tsunami covered the 2-story building by observing that the windows glasses were destroyed and now are replaced by wood panels. Figure 8(c) is an apartment building located at Rikusentakata city and from the damages of the balconies it is inferred that the tsunami reaches the fourth floor. Detailed of the damages of the balconies can be observed in Figure 8(d), where the panels of the balconies of the fifth floor are intact while the panels of the lower floors are completely destroyed.

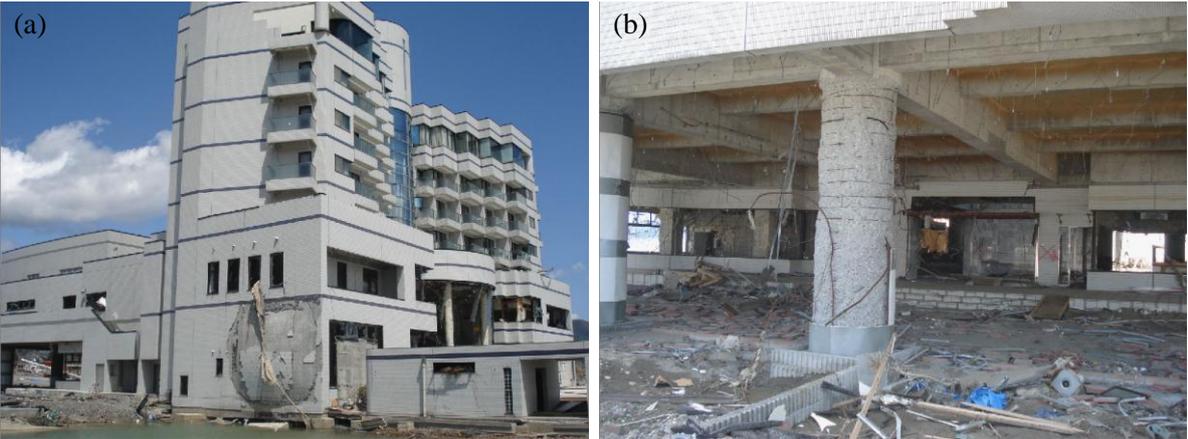
Figure 9. Condition of RC Building (hotel) near shoreline

Figure 9 shows the condition of a hotel building located very near the shoreline in Rikusentakata city. The building resists the tsunami attack however the lower floors suffered the destruction of the non-structural elements and also, as it is observed in the Figure 9(a), the damage of a reinforced concrete wall due to the lateral water pressure. In this building it was also observed that the cover

concrete of structural elements of columns was spall-out probably due to a combination of earthquake vibration action and posterior tsunami as can be observed in Figure 9(b).

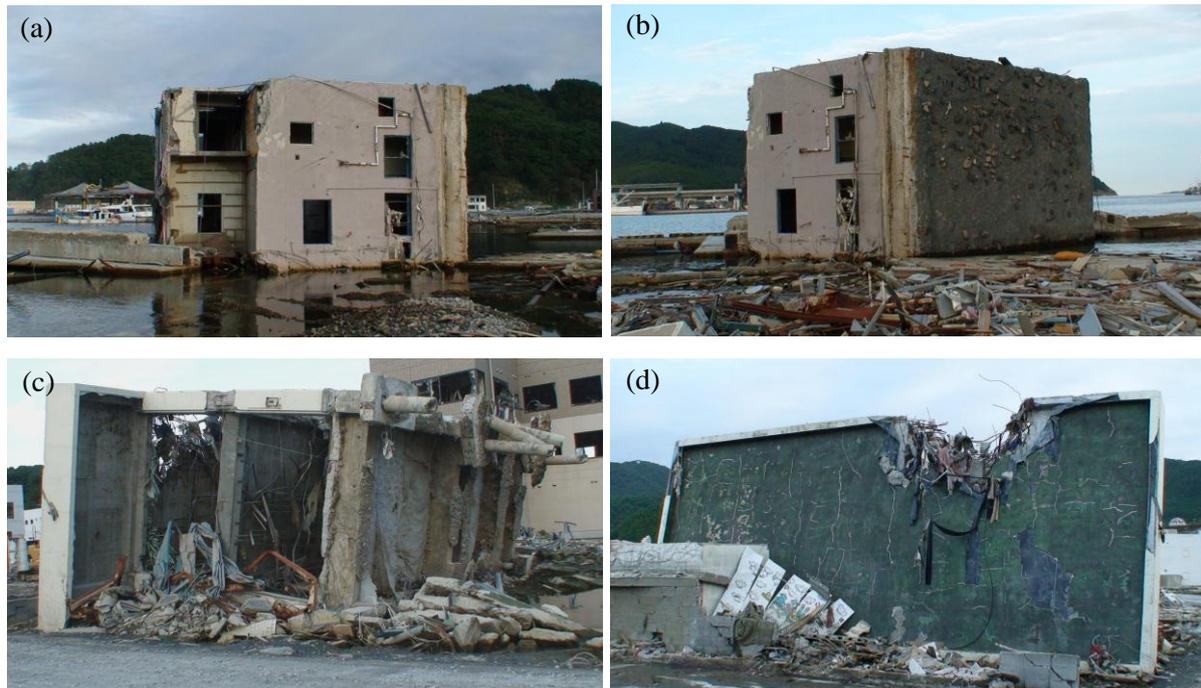
**Figure 10.** Damages on RC structures

In general reinforced concrete buildings did not collapse however under certain conditions the tsunami attack caused the overturning and even the translation of building from its original location. This was reported by a survey team of the Tohoku Branch of the Architectural Institute of Japan (March 29, 2011) and verification survey was carried out by the authors. These damages occurred at Onagawa town and the affected buildings were buildings with weak foundation, and with shape like boxes that

do not permit the transit of the water and facilitate the action of the floating force. In Figure 10 damages of these buildings are shown.

Figures 10(a) shows an overturned 3-story building with a shape of box and few openings. This building was completely covered by the tsunami water and as it is shown in Figure 10(b) it has a shallow slab foundation that together with the shape of the building facilitates the action of the floating forces. Figure 10(c) shows the overturning of a 2-story building with exposition of the pile foundation. The use of piles for lower rise buildings indicates the poor quality of the foundation ground. On the other hand in the Figure 10(d) it can be observed that the building has suffered the impact of a body (probably a ship) that could originate the overturning of the building.

If reinforced concrete buildings are intended to be used as refuge, buildings of more than four floors or more than 15 meters are recommended. It is also important to check the condition of the foundation of the structures that are designated as refuge since the failure of the foundation could originate the overturning of the building. Additionally, this selected building must be verified to resist some impact forces or in any case must be located in places where the impact of displaced ships or other building can be avoided.
