The seismic performance of unreinforced stone masonry buildings during the 2010-2011 Canterbury earthquake sequence

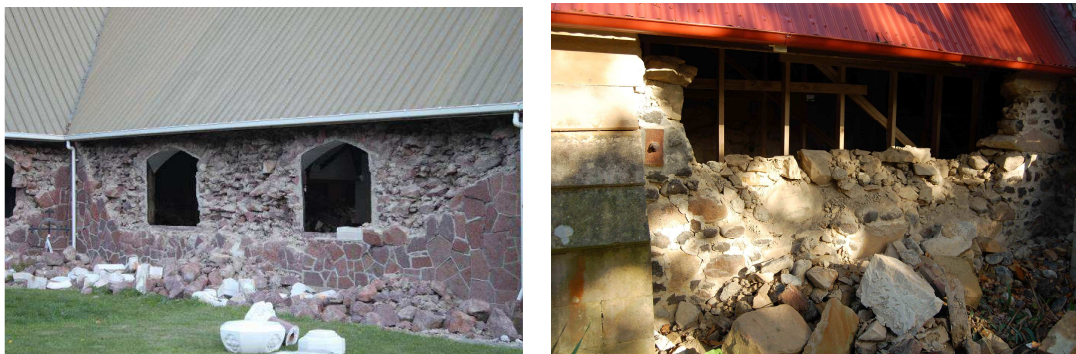
The quality of construction materials played a key role in the response of stone URM buildings. As previously described, one of the typical features of stone URM buildings in Christchurch is the different types of stone and mortar quality present in structures built with three-leaf walls. The use of soft limestone, such as Oamaru stone or the red tuff extracted in the Banks Peninsula, in conjunction with the use of low strength lime mortar, often led to poor earthquake response. Examples of such behaviour, frequently caused by hammering of the roofing system on the walls, include the Holy Trinity Church in Lyttelton, which is one of the oldest buildings in Canterbury, and St. Cuthberts Church as represented in Fig. 4.

Figure 4. Lyttelton Holy Trinity Church (left) and St. Cuthberts Church in Governor's Bay (right).

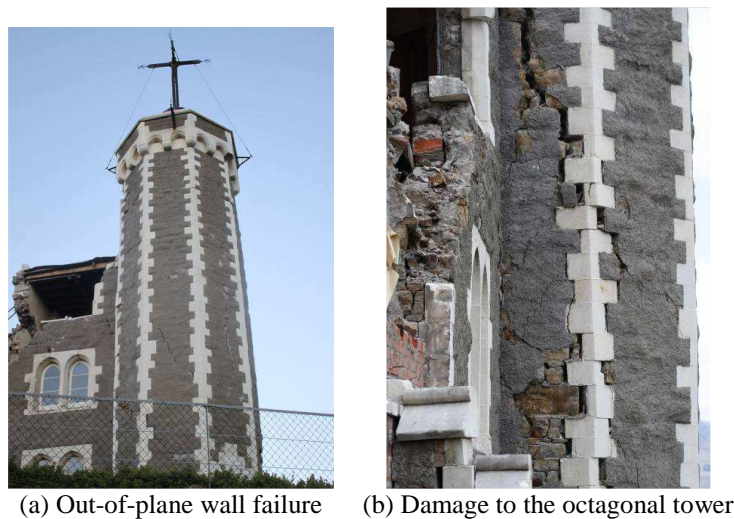
(a) Out-of-plane wall failure (b) Damage to the octagonal tower

Figure 5. Damage in the Time Ball Station tower.

The Time Ball Station in Lyttelton is another example of poor performance during a seismic event, due to the very weak mechanical properties of the local scoria and Oamaru stone used for its construction. The lack of connection between the stone walls is shown in Fig. 5. It was reported that after the 13th June 2011 earthquakes, the remaining parts of the Time Ball Station and of Lyttelton Holy Trinity Church completely collapsed as did several other unreinforced masonry buildings in Lyttelton that were in a similar state of damage (Ingham and Griffith, 2011, Appendix C).

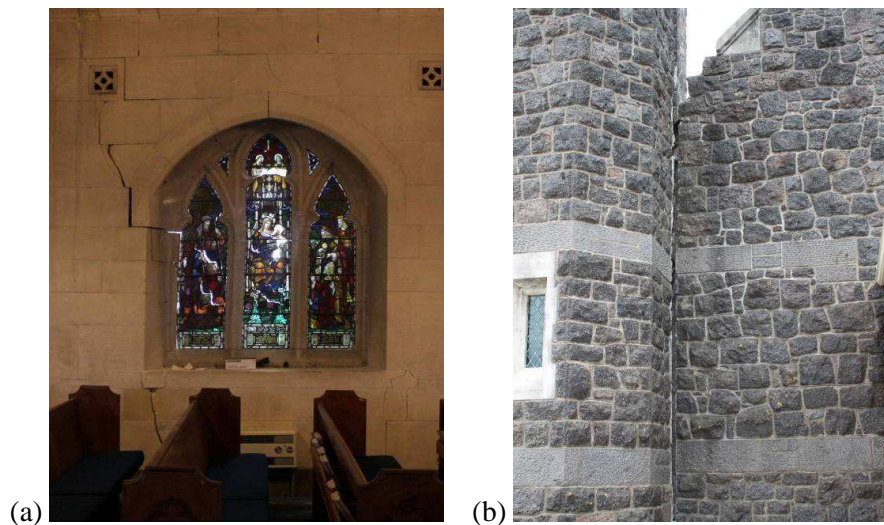
Damage that was attributable to plan irregularity was frequently observed, particularly for stone churches, due to interaction between adjacent structural elements at the intersections between walls. In most churches where the bell tower or low annexes are connected to the nave, damage developed at the intersection of the different structures (Fig. 5).

Figure 5. (a) St. Barnabas' Church, internal view. (b) St. Mary's Anglican Church: detachment of the bell tower from the nave

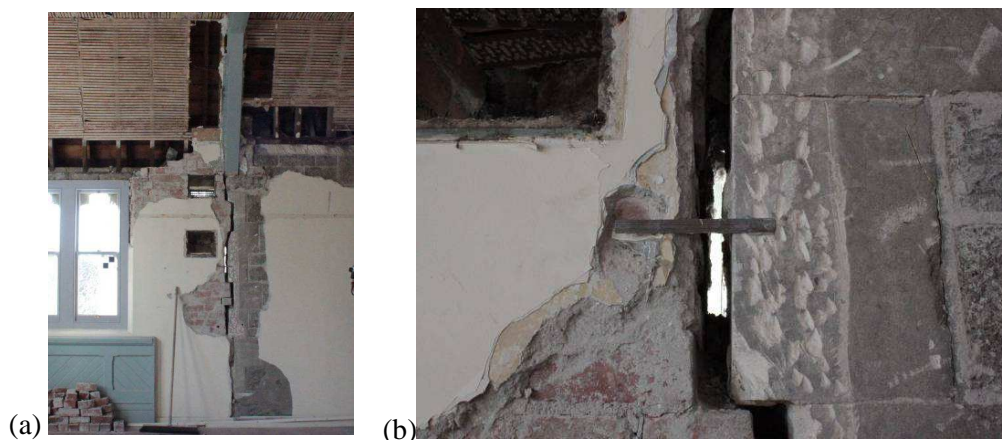
Another distinct example of damage due to plan irregularity in association with differential foundation settlement was observed at the former Old Boy's High building in the Arts Centre. Fig. 6 shows the vertical crack that formed at the intersection between two buildings constructed in successive phases, attributable to the lack of connectivity between the structural walls and to their separate foundations.

Figure 6. Interior views of Old Boy's High, showing interaction between adjacent buildings: (a) distant view, (b) close up view.

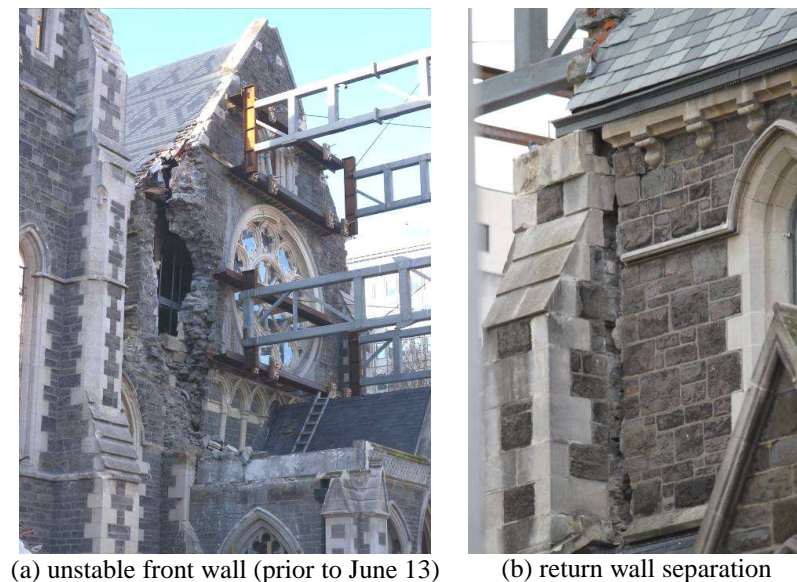
Examples of out-of-plane failures are shown in Fig. 7 and Fig. 8 relative to the main façade of the Anglican Cathedral (now partially collapsed after the 13 June 2011 earthquake and aftershocks), and the Rockvilla dwelling that experienced complete collapse of the north and east façades. All of these buildings appeared to have poor connections between the walls at their corners, leading to return wall separation and subsequent out-of-plane failure of entire walls, as in the case of the Rockvilla house (Fig. 8).

Figure 7. Christchurch Anglican Cathedral: out-of-plane overturning of the front façade

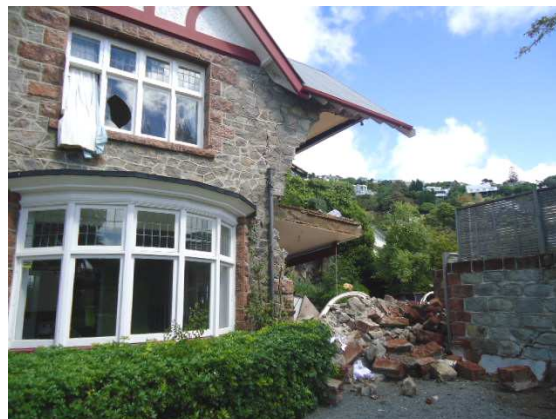
Figure 8. Rockvilla dwelling with complete collapse of the north and east façades

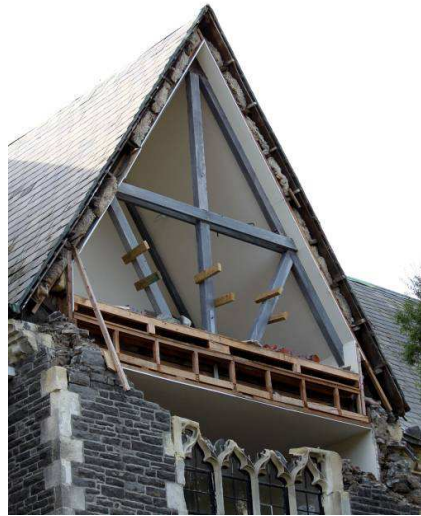
Many of the stone masonry buildings that were constructed in the Gothic Revival style sustained partial damage to their gable ends, with many cases of complete collapse of the gable. As shown in Fig. 9, the absence of significant gravity loads and inadequate connection between the gable and roof

trusses are primary contributing factors to this failure mode, along with increased accelerations experienced at the top levels of the structure.

Figure 9. Cramner Court, showing complete collapse of a gable

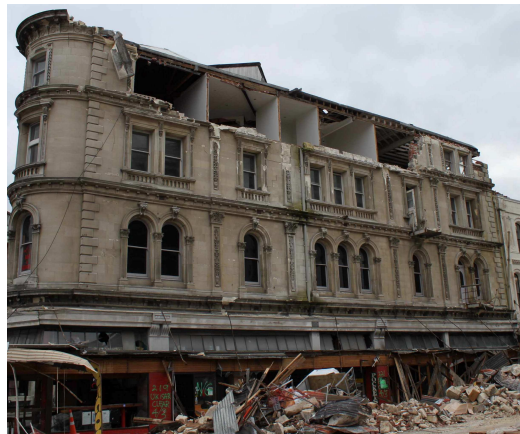
In some cases, when the façade span was rather wide and internal bearing walls exerted almost no restraining action, a horizontal arch mechanism occurred. In the example presented in Fig. 10, where the north-west façade of Strange's Building in High Street is pictured, it is clear that the formation of a cylindrical hinge along the floor level of the top storey and the complete lack of proper connection between the perimeter wall and the roof structure resulted in a trapezoidal portion of the façade plane overturned around the cylindrical hinge.

Figure 10. Strange's Building at the corner of High street and Lichfield Street

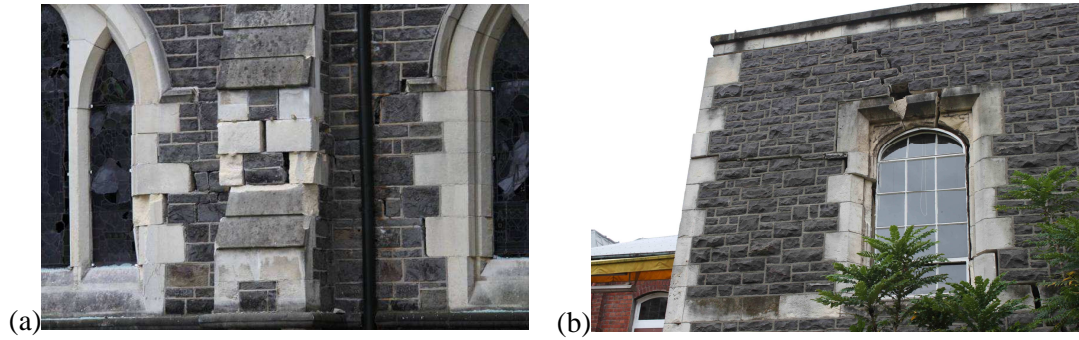
Because the 22 February 2011 earthquake was predominant in the east-west direction, and because many of the buildings in the CBD were primarily oriented in the same direction, evidence of in-plane wall damage in the east-west running walls was reported in conjunction with overturning of façades oriented in the orthogonal direction. An example of a recurrent damage pattern is shown in Fig. 11a, where masonry piers of many of the stone masonry churches exhibited a shear type of response, evident by diagonal cracks that in some cases involved the buttresses. Also, a rocking behaviour was exhibited by the masonry piers (Fig. 11b). Light to substantial damage to masonry spandrels was also reported, such as diagonal cracking due to shear (Fig. 11b) but also a flexural type of response such as for the Cramner Court buildings.

Figure 11. (a) Christchurch Anglican Cathedral: diagonal cracks in the south façade piers.
(b) Canterbury Provincial Chambers: diagonal crack in the top spandrel and horizontal cracks of the left pier in south façade of the East annex

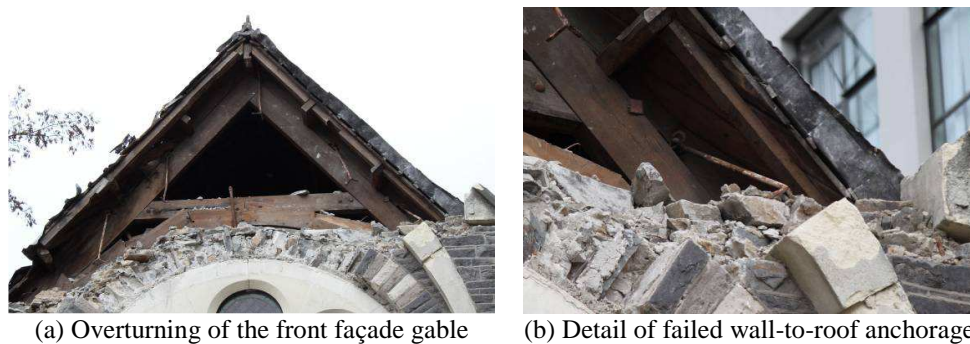
A close inspection of buildings that suffered out-of-plane wall failures revealed that in many instances some anchors were present in the walls that failed, or that the inadequate securing of walls and diaphragms using wall-diaphragm anchors could not prevent portions of walls from overturning. In some cases anchors were either absent or were spaced too far apart to prevent bed joint shear failure of the masonry at the location of the anchorage. In those cases where anchoring had been seismically designed, or were sufficiently closely spaced to resist lateral loads, the overturning of gables and other portions of walls was prevented. Different examples could be given of a seismic response of a structure that was highly influenced by the effectiveness of wall-to-floor connections. For instance, Fig. 12a shows the damage resulting from overturning of the gable of the main façade of the former Trinity Church in the Christchurch CBD while the detail in Fig. 12b illustrates how the anchoring was insufficient in size and spacing to secure the wall in place.

Figure 12. Former Trinity Church, showing details of gable ended out-of-plane wall failure

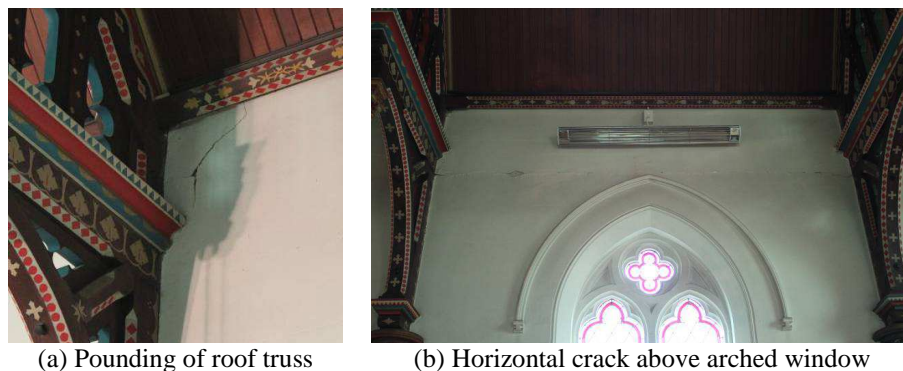
Figure 13. St James' Church, showing pounding of roofing elements on the walls of the nave

In the case of churches, pounding of roof trusses was reported as for the case of St. James' Church shown in Fig. 13.

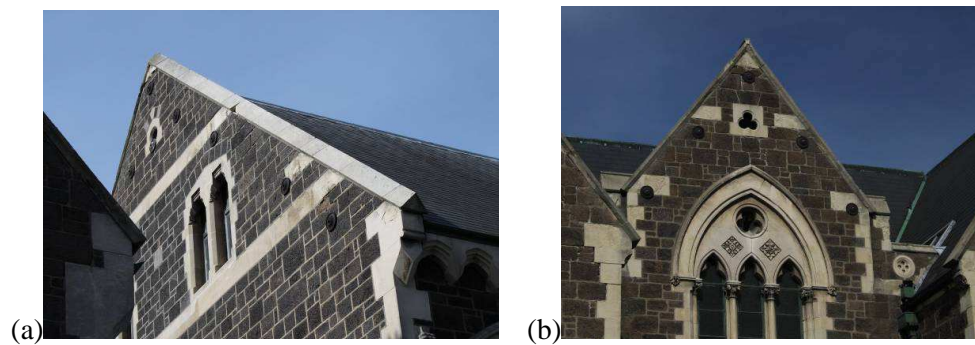
One of the main objectives of the damage surveys of stone masonry structures was to investigate the response of structures that had been seismically retrofitted or strengthened at the time of the September 2010 earthquake. As previously illustrated one of the most common factors that contributes to the vulnerability of unreinforced masonry structure is the lack of connection between walls and diaphragms. However, a proper design of anchoring and the insertion of steel tie rods at floor and roof level helped reducing the likelihood of local failures due to out-of-plane collapse of walls and gables. Fig. 14 shows some examples of successful wall-to-roof anchoring in the Arts Centre building complex, showing respectively the former Old Girl's High (Fig. 14a) and the former Canterbury Engineering Department (Fig. 14b).

Figure 14. The Christchurch Arts Centre, showing successful use of wall-diaphragm anchorages

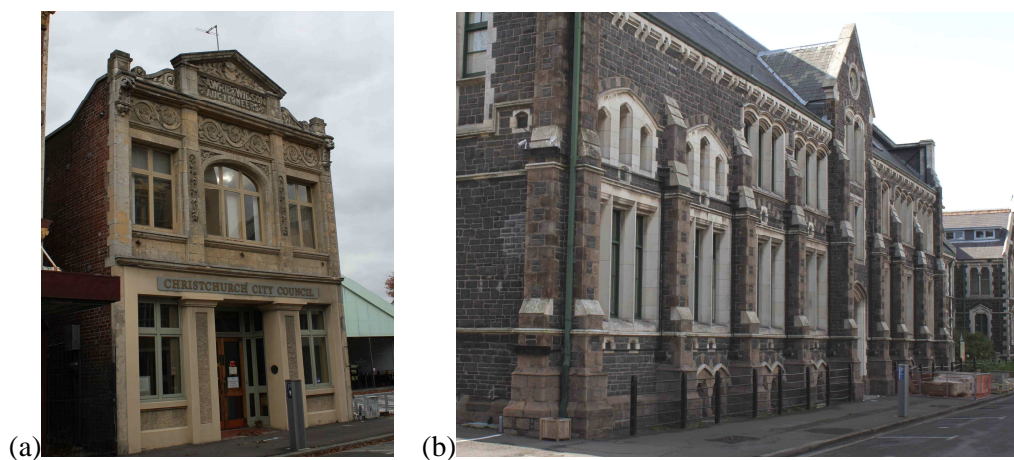
Different types of strengthening techniques were also applied to enhance the global response of buildings and to restrain the activation of possible local failure mechanisms. For instance, the use of steel moment frames as a retrofit strategy proved to be efficient in the case of the former Lawrie and Wilson Auctioneers Building (Fig. 15a). Considering instead the former Chemistry Department that is now part of the Christchurch Arts Centre complex, the insertion of vertical post-tensioned tendons in collaboration with buttresses and of horizontal tie rods in collaboration with floors improved the global response of the structure (Fig. 15b.) Nonetheless, the building was badly damaged because of the partial collapse of the tower that was not retrofitted.

Figure 15. (a) Former Lawrie and Wilson Auctioneers building. (b) Former Chemistry Department, Christchurch Arts Centre.
