# Characteristics of Reinforced Concrete Shear Wall Buildings Damaged During 2010 Chile Earthquake

**R. Jünemann, M. Hube & J.C. De La Llera**

## SUMMARY

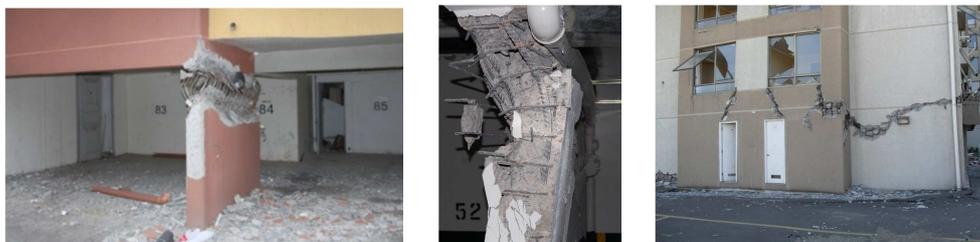
A large majority of reinforced concrete (RC) buildings performed well during the earthquake, but extensive localized damage occurred in some of these structures. Close to 2% of the estimated 2,300 RC buildings taller than 9 stories suffered substantial damage during the earthquake. Some examples of the typical “unzipping” (bending-compression) failure observed in the shear walls at lower elevations are shown in Fig. 1. Considering that other buildings with similar structural concepts performed rather well during this earthquake, it behooves to elucidate some of the reasons underlying one type of behavior over the other.

**Figure 1.** Examples of typical failure in walls

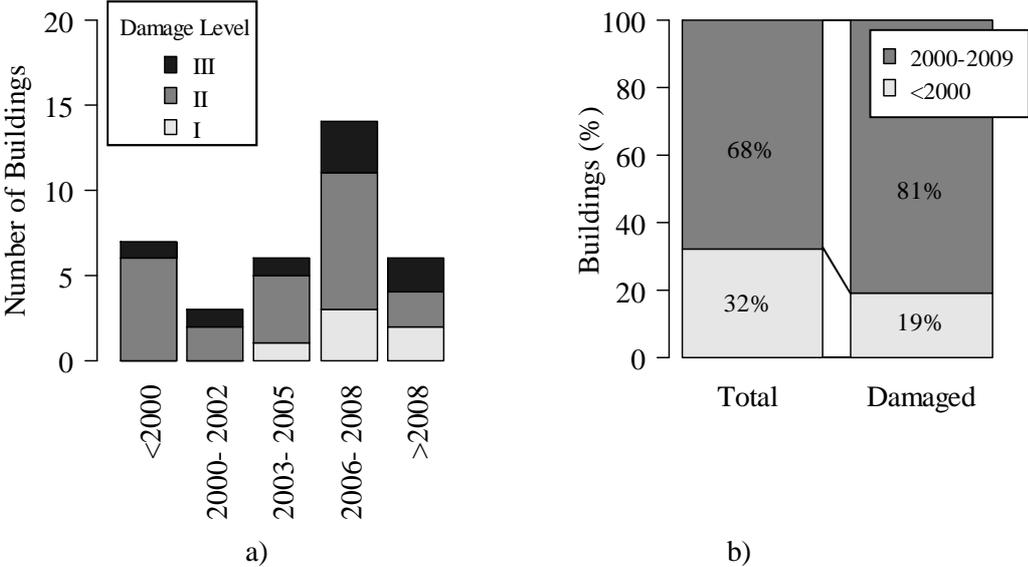
On the one hand, analysis of data indicates that most of damaged buildings are mainly new structures. Fig. 3a) shows that although most damaged buildings (Damage Level III) are well distributed by year of construction, most of the inventory was constructed after the year 2000. In fact, 81% of the inventory of damaged buildings (considering all damage levels) was constructed from year 2000 compared to 68% in the case of the inventory of total buildings<sup>1</sup> (Fig. 3b)). This leads us to conclude that as of the date when the earthquake struck, there was a huge number of medium to high-rise structures constructed before year 2000 which did not suffer as much damage as the newer ones. Thus, the earthquake affected mainly relatively new structures.

**Figure 3.** Distribution by year of construction. a) Distribution of damaged buildings by damage level. b) Comparison of total buildings versus damaged buildings

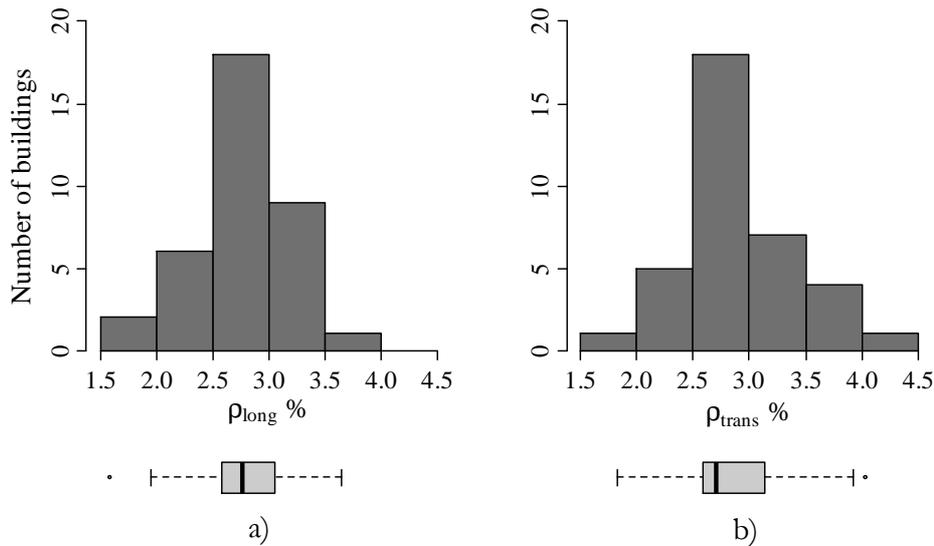
On the other hand, analysis of data indicates that the average wall density has not changed over the time. Moreover, it has also remained fairly constant for the buildings constructed in the past decade and is similar to those observed during 1985 earthquake. In the case of damaged buildings, wall densities in both directions have mean values which are very close: 2.76 and 2.87% for the longitudinal and transverse directions respectively (Fig. 4). These values are similar to those provided in past reports by other authors who have studied Chilean RC shear-wall buildings (Calderón 2007, Gómez 2001, Wood 1991).

**Figure 4.** Wall density distribution in damaged buildings. a) Longitudinal direction. b) Transverse direction.

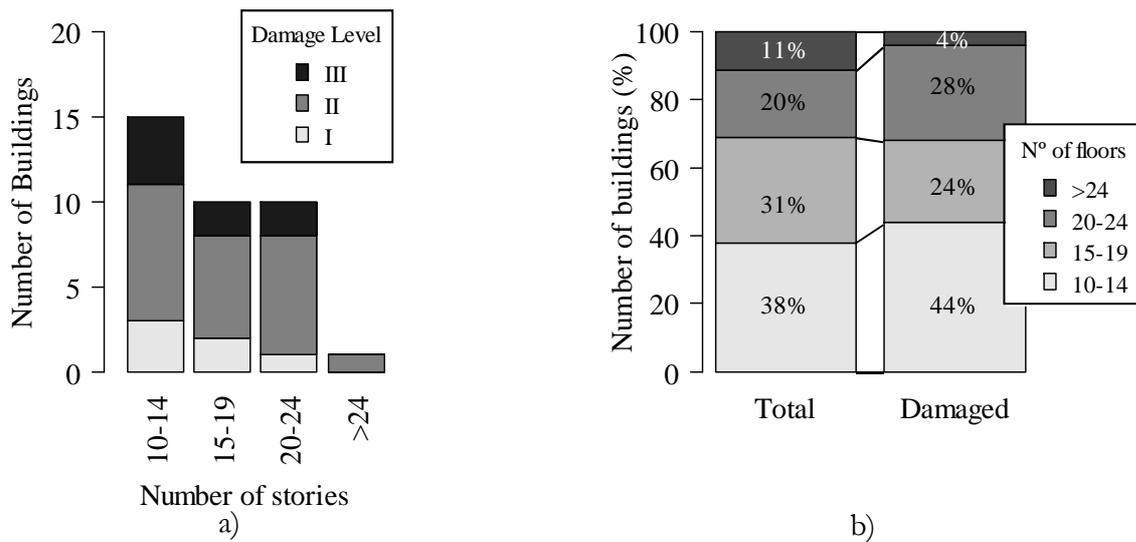
Indeed, construction practice in Chile has evolved and current RC buildings tend to be taller. In fact, the percentage of dwelling units in buildings of 9 stories or more over the total number of dwelling units has increased from 7% in 2001 to 20% in 2009 (INE 2001-2009), according to available national data. However, looking at the distribution by number of stories of the inventory of damaged buildings (Fig. 5a), most buildings had between 10 and 14 floors, and with one exception, none was taller than 24 stories. Fig. 5b) compares the distribution by number of stories of total inventory of buildings versus the inventory of damaged buildings constructed in the period 2002-2009 since in that period available data is found. As can be observed, there is a larger proportion of buildings in the damaged inventory in the range 10-14 floors and 20-24 floors than there is for ranges 15-19 or > 24 floors when compared to the total inventory of buildings. Particularly interesting to observe is the low percentage of damaged buildings of more than 24 floors, which begs the question as to why. Most probably, because of their status as iconic structures as well as their expense, such buildings may have received a more careful, conservative design, may have relied on modern devices for motion control and energy dissipation, and may have employed better materials. For example, Titanium Tower was the highest building in Chile at the time of the earthquake (52 over ground floors plus another 7 underground floors), and its dissipation devices were responsible in part of the outstanding behavior.

**Figure 5.** Distribution by number of stories. a) Distribution by damage level. b) Comparison of total buildings versus damaged buildings in the period 2002-2009

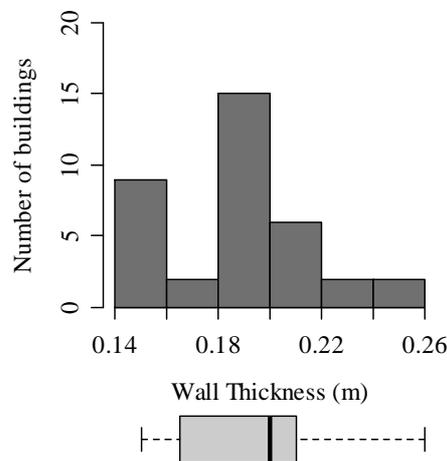
Second, wall thickness has decreased and the average value in the inventory of damaged buildings is 19 cm, with the distribution shown in Fig. 6. It is shown that 25% of the inventory has wall thickness lower than 17 cm and 80% of the building inventory has values lower than 21 cm. This thickness-dimension is very low when compared with the thickness of 30 to 50 cm observed in buildings in Viña del Mar whose date of construction preceded the 1985 earthquake i.e. buildings that date back to a time when Chilean codes required at least 20 cm thick walls (Wood 1991).

**Figure 6.** Wall thickness distribution in damaged buildings

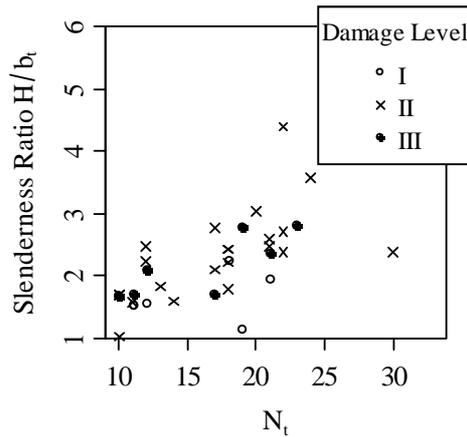
Third, the average slenderness ratio calculated as the total height of the building versus average maximum transverse dimension of the plan ( $H/\bar{b}_t$ ) is 2.2 and the value of more damaged buildings tends to be higher than the ratio for less damaged ones (Fig. 7).

**Figure 7.** Slenderness ratio in damaged buildings

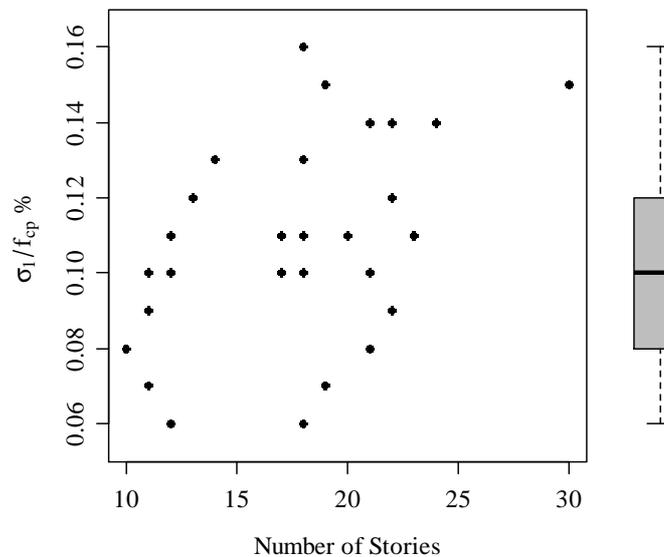
As a result of the combination of these three factors, the initial state of stress of walls in the first floor is on average  $0.10f'_c$  (Fig. 8), which is relatively high considering that axial loads increase considerably due to seismic overturning forces.

**Figure 8.** Average axial stress in first floor as a fraction of concrete strength in damaged buildings
