EVALUATION OF THE BUILDING CODE APPLICATION IN MEXICO CITY

E. Reinoso, M.A. Jaimes & M.A. Torres

Instituto de Ingeniería, UNAM, México

15 WCEE
LISBOA 2012

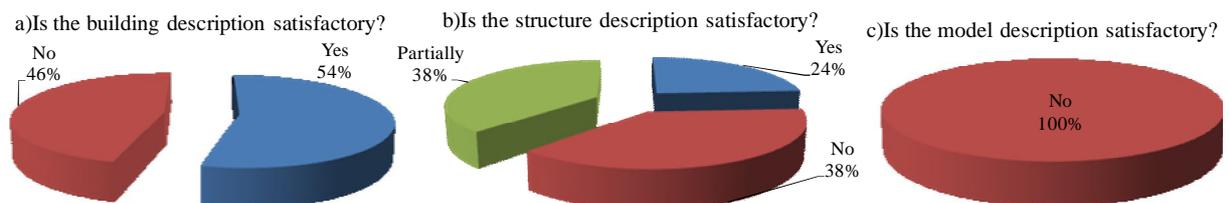
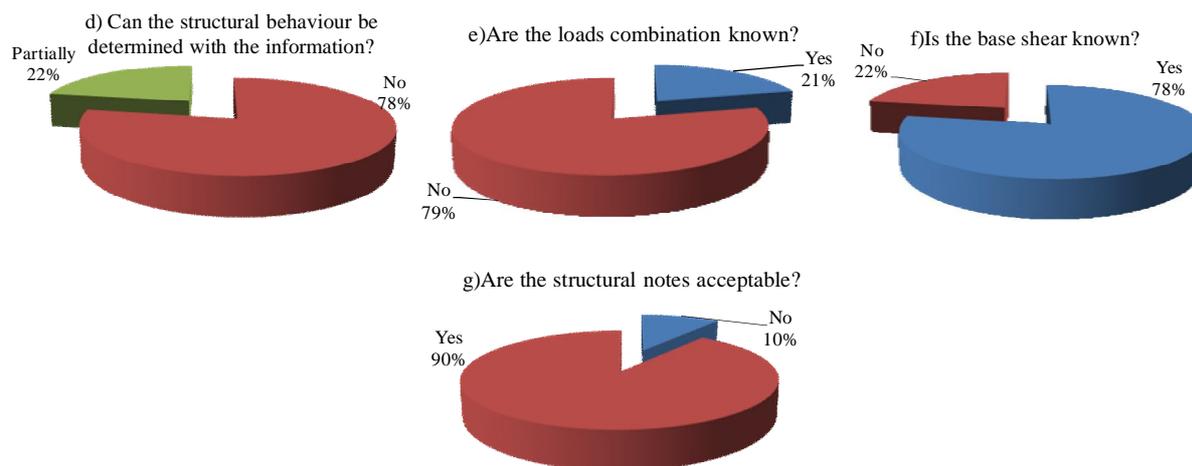
The information of the 20 buildings randomly selected was proportionated by the Government of Mexico City authorities. This information was submitted by the BRDs with the building declaration under penalty of perjury that the MCBC-2004 provisions are achieved. The conclusions of detailed reviews are shown in Fig. 2.

Figure 2. Statistics of inspection of structural notes

Figure 2. Statistics of inspection of structural notes (*Continuation*)

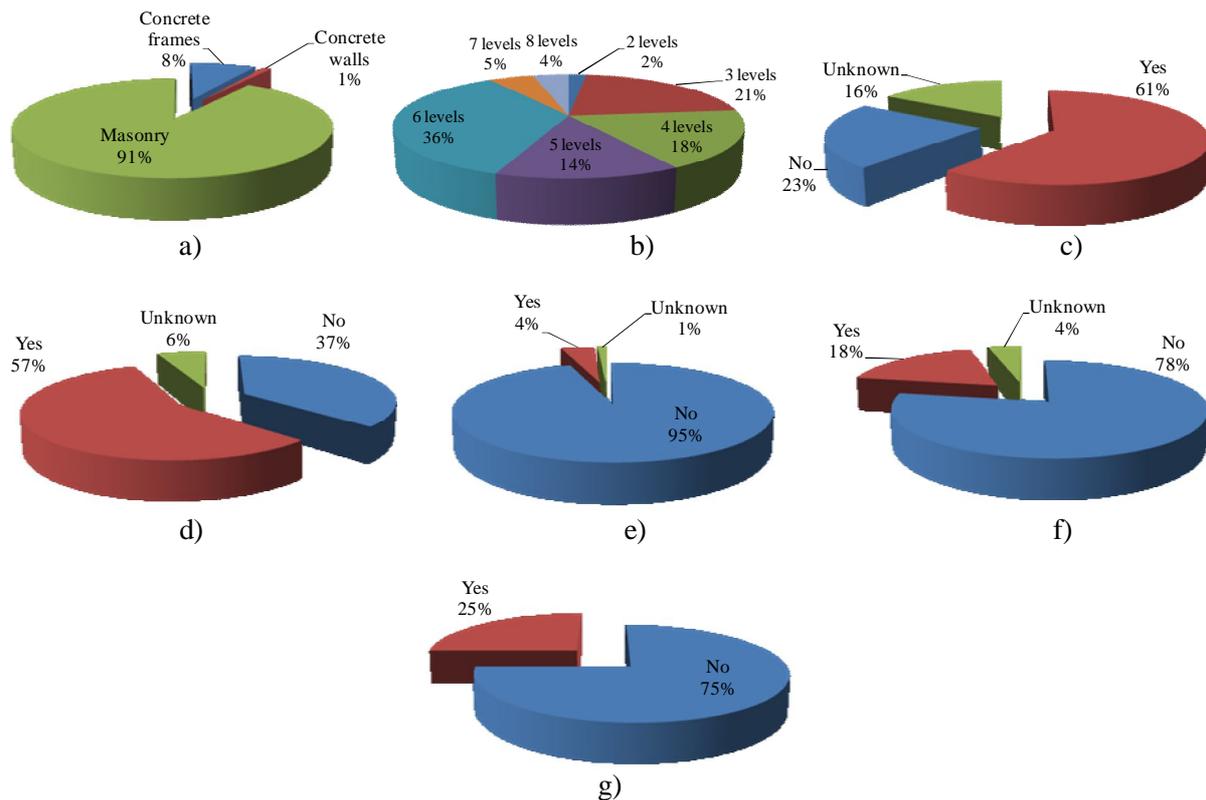
These inspections were done from outside of the buildings, at the sidewalk, because it was considered adequate to observe the main structural characteristics of the sample of 150 buildings. The main structural aspects reported, besides the number of stories and the structural type (masonry, concrete frames, and concrete walls), were irregularity conditions such as: 1) pounding possibility, 2) soft first story, 3) vertical irregularities, 4) short columns, and 5) corner configuration. These conditions have historically caused many structural failures in Mexico City and all around the world (Rosenblueth and Meli, 1986; Esteva, 1988; Esteva, 1992; Searer and Fierro, 2004; Guevara and García, 2005). The statistics result of the sidewalk inspections are shown in Figure 3.

Figure 3. Statistics of structural aspects observed in the sidewalk inspections: a) structural system, b) Number of stories, c) pounding possibility, d) soft first story, e) vertical irregularities, f) short columns, and g) corner configuration.

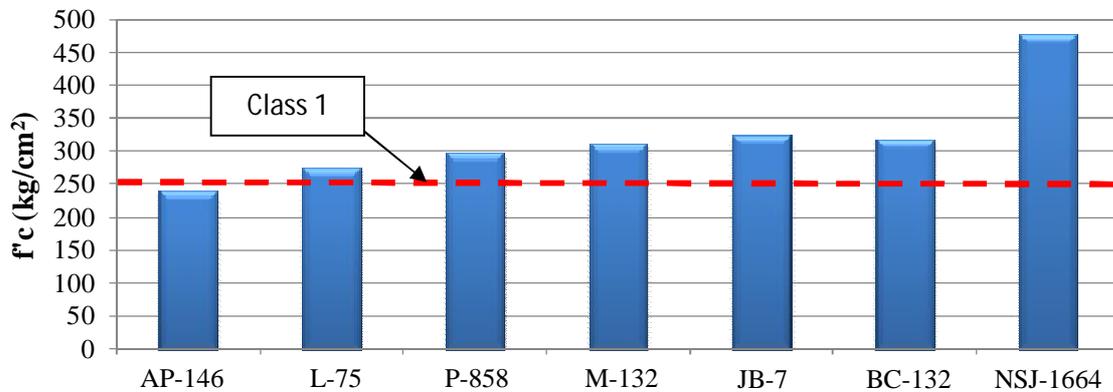
In Figs. 4 to 6 are shown the results of the comparison between the concrete specifications of the projects and results of laboratory tests. It can be seen in Table 2 that only 3 of 7 buildings achieved into specifications of the projects. If the module of elasticity is less than the specified in the project, the stiffness of structure will be minor and the displacements of the buildings will be greater to those estimated in the design, so the risk of damage in elements (structural and non structural) and people will increase.

Figure 4. Mean resistance to compression, $f'c$, obtained in laboratory. The dash represents the limit value established in the MCBC-2004 for concretes Class 1

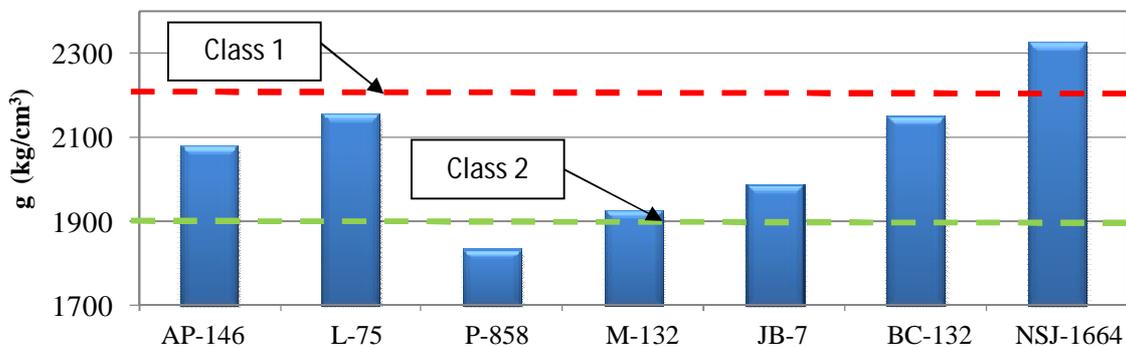
Figure 5. Mean volumetric weight, g , obtained in laboratory. The dash represents the limit value established in the MCBC-2004 for concretes Class 1 and Class2

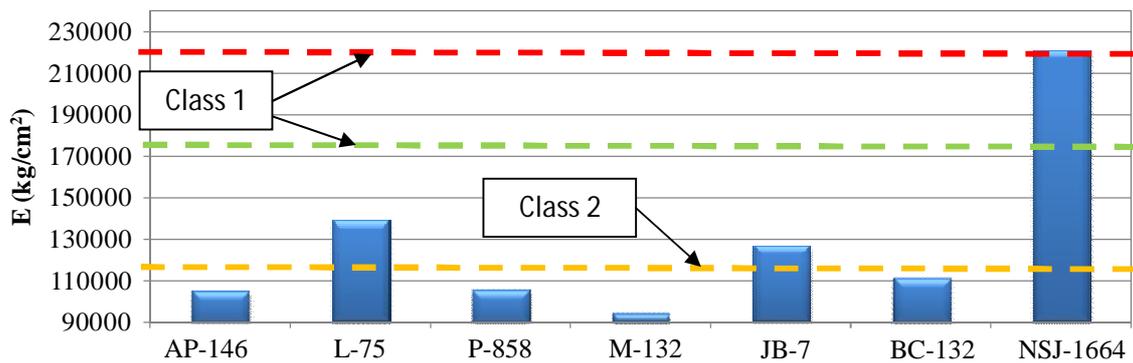
Figure 6. Module of elasticity, E, obtained in laboratory. The dash represents the limit value established in the MCBC-2004 for concretes Class 1 and Class 2

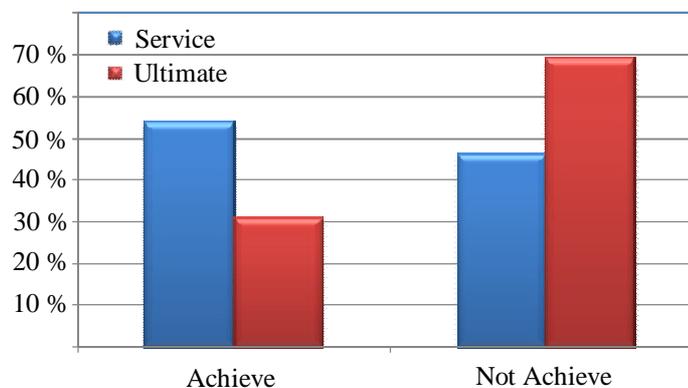
The results of the revisions are shown in Fig. 7. The buildings that do not achieve to any of the limit states could have an inadequate behavior during seismic events.

Figure 7. Achievement frequency of the limit states of: a) service, and b) ultimate of the analyzed buildings by 3D models and according to the seismic guidelines included in the MCBC-2004

5. According to the results of the structural analysis performed, 36% and 71% of the buildings do not achieve with the service and ultimate limit state, respectively, established in MCBC-2004. Even if the collapse of these buildings is something difficult of predict due to all the uncertainties involved, it is for sure that the structures will present an inadequate performance during the strong motion produced by an earthquake. These unsuitable behaviors are related to the abuse of structural configurations evidently irregular and to the values of the module of elasticity obtained from laboratory tests.
