Comprehensive damage analysis of buildings affected by the 2008 South Iceland earthquake

B. Bessason, & J. Sólnes

SUMMARY:

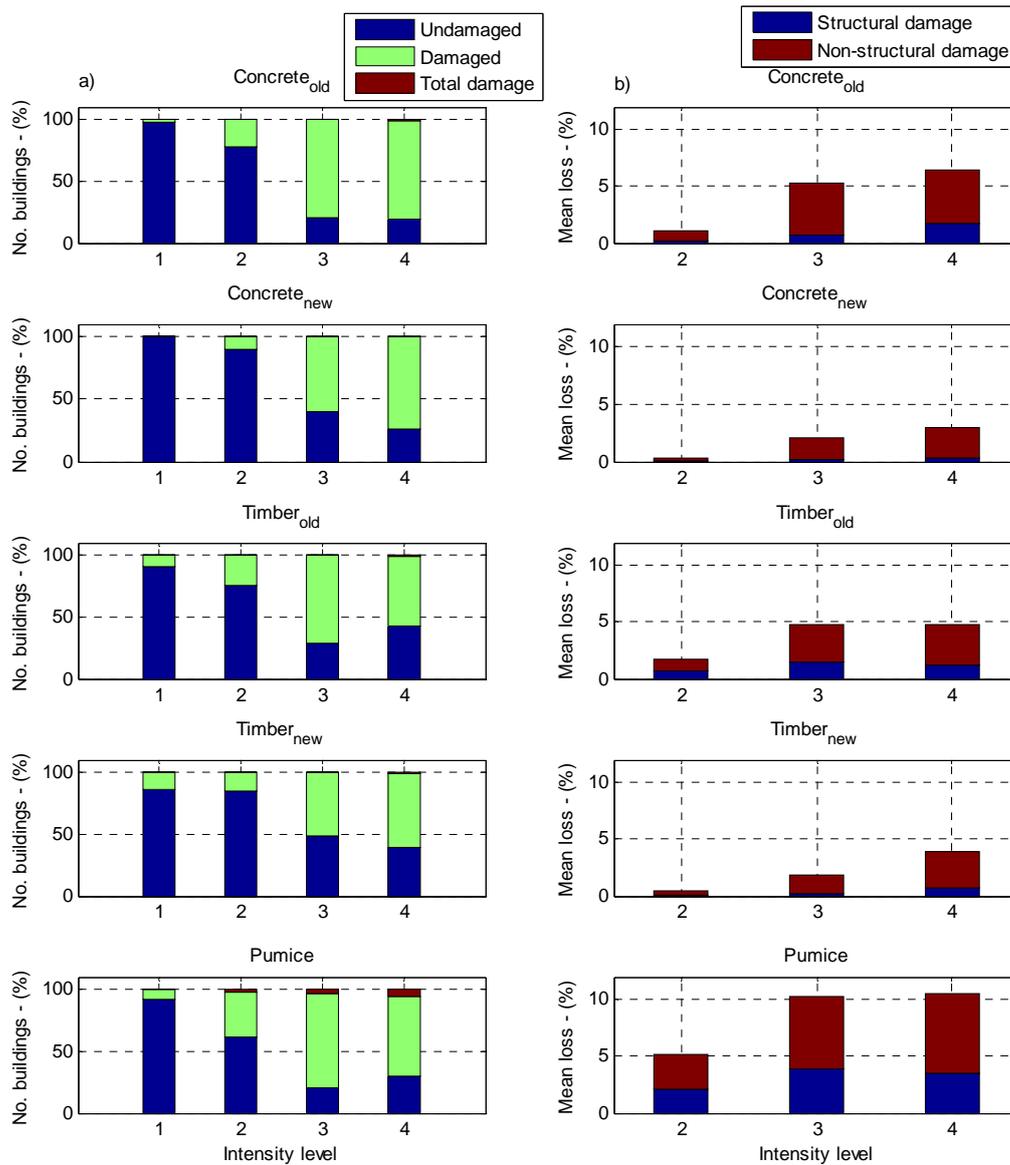
The complete damage database gives the possibility to map the main damage and weakness of the buildings. A number of houses suffered no damage, whilst others had small to severe damage, which in some cases was judged a total loss. In practice the epithet “total damage” was assigned to residential buildings that had repair cost of more than 50 to 70% of replacement value. Table 4.1 shows percentage of damaged buildings (including total loss) in each class and intensity level. The prevalence of damage is highest for pumice and old reinforced concrete buildings, and lowest for new timber buildings. The graphs in Fig. 4.1a show the proportion of undamaged, damaged, and totally damaged buildings for the five building classes as function of intensity level. As an example it can be seen from the figure, that for concrete_{old} buildings at intensity level 3, around 20% of them suffer no damage, while 80% are “damaged”, and none suffer “total damage”.

The graphs in Fig. 4.1b show the mean loss for each intensity level, as well as showing how the damage is split between structural (subcategories 1-5) and non-structural damage (subcategories 6-10). Taking the concrete_{old} buildings as example, the mean loss was found to be 5.3% for intensity level 3, and of these 15% are structural damage while 85% are non-structural damage. It should also be noticed that there is a significant step in mean damage ratio when going from intensity level 2 to 3, but less difference between level 3 and 4. Furthermore, the structural damage in terms of mean loss is small for all the building classes, even at intensity level 4. This is in harmony with the fact that no low-rise residential buildings collapsed in the 2008 Ölfus earthquake. Finally, Fig. 4.1b shows that the damage of new low-rise concrete and new low-rise timber houses is quite similar at all earthquake intensity levels. The average damage ratio for these building types is 3.0% and 3.9% at intensity level 4, respectively. For comparison the damage ratio for old concrete, and pumice buildings are 6.5% and 10.5% at intensity level 4, respectively. This means that expected damage ratio of new concrete building built after 1980 is less than 50% of expected damage ratio of old concrete building.

Figure 4.1. Damage data. a) Number of buildings, undamaged, damaged, and totally damaged as function of intensity level for the five building classes. b) Damage ratio as function of intensity level for the five building classes, and how it is split into structural and non-structural damage.

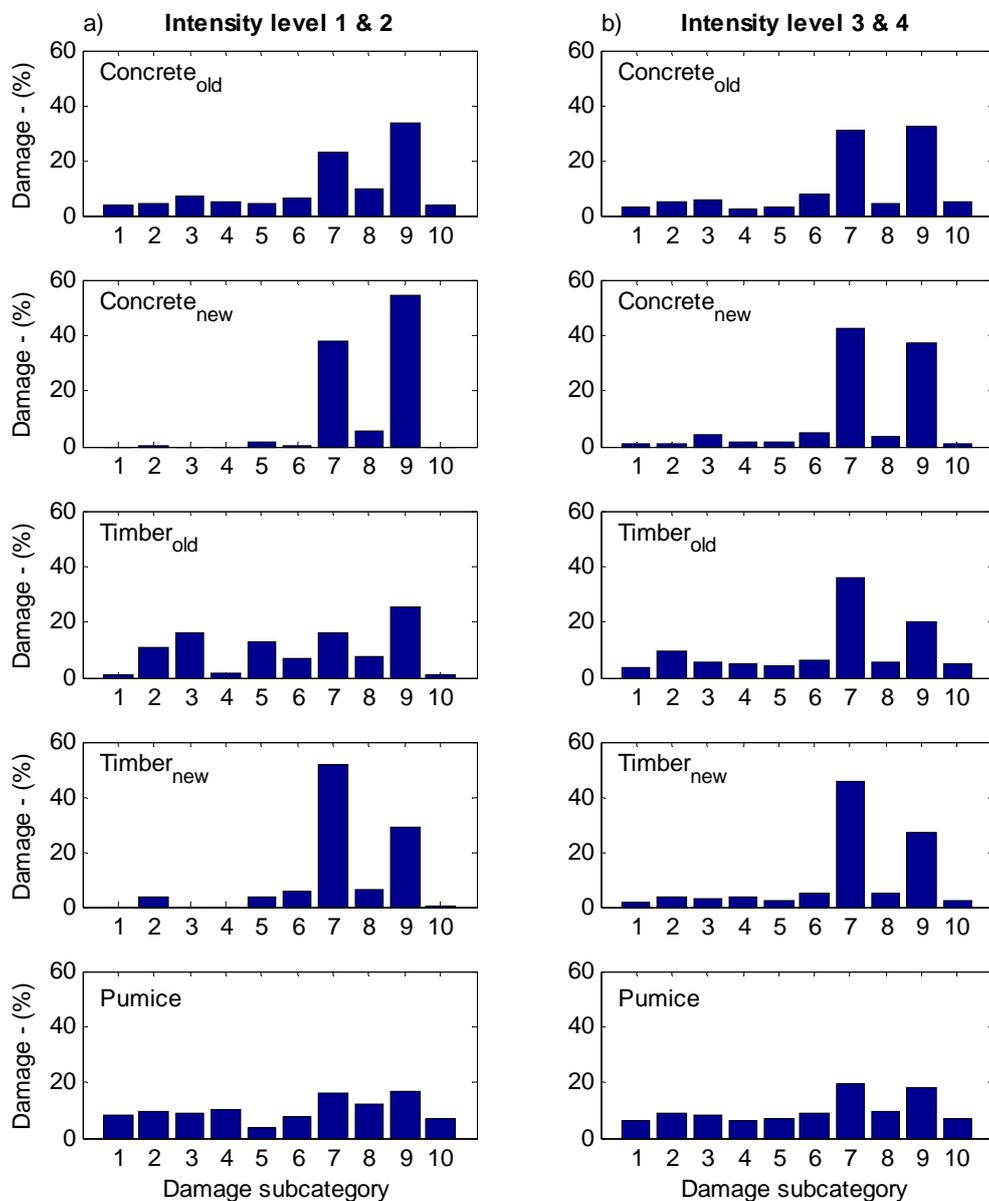
In Fig. 4.2 the damage is classified into ten subcategories as defined in chapter 3.6. Fig.4.2a shows the damage for intensity levels 1 and 2 combined, and Fig. 4.2b for intensity levels 3 and 4 combined. From the figure it can be seen that for all building classes and both the combined intensity levels (i.e. 1&2 and 3&4), columns 7 and 9 are significantly higher than the others. This means that the highest monetary damage was due to interior fixtures, flooring, tiles etc., and cosmetic surface damage that requested paint-work. For instance, for concrete_{new} buildings at all four intensity levels (i.e. 1, 2, 3, and 4) the two damage types contributed to 80% of the total damage. Similarly, 73% for the timber_{new} buildings, 63% for concrete_{old}, 53% for timber_{old}, and 37% for pumice buildings. Figure 4.2a also shows that structural damage of concrete_{new} and timber_{new} buildings is only found within type 2 and 5 damage classes at intensity levels 1 and 2 combined. Since most of the damage is in subcategories 7 and 9, it is interesting to see how this damage can be split up. Focusing only on new concrete and new timber buildings and taking all the four intensity levels together, the results are shown in Fig. 4.3 and Fig. 4.4. The figures show that damage of flooring (>66% of subcategory 7) and indoor paint-work (>84% of subcategory 9) dominate the repair costs for concrete_{new} and timber_{new} buildings.

Figure 4.2. Classification of damage in ten subcategories (see chapter 3.6) for the five building classes. a) At intensity level 1 and 2 combined, and b) at intensity level 3 and 4 combined

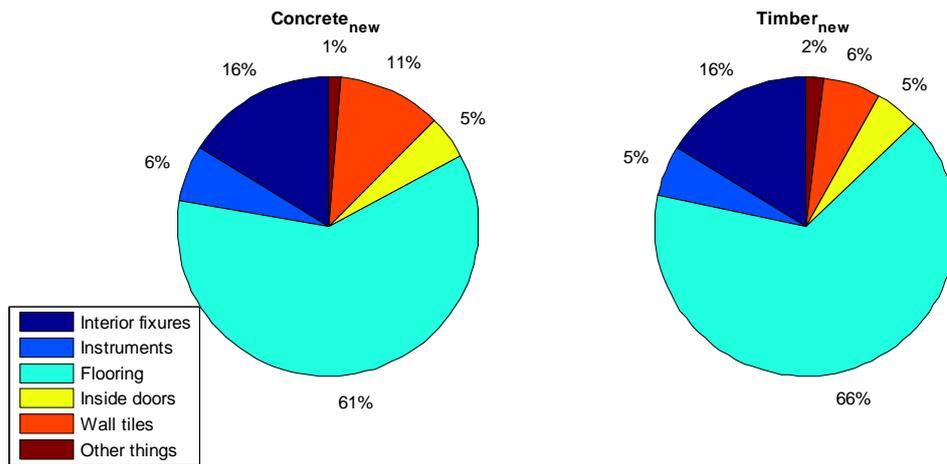
Figure 4.3. Split up of subcategory 7 (see section 3.6) for concrete_{new} and timber_{new} buildings.

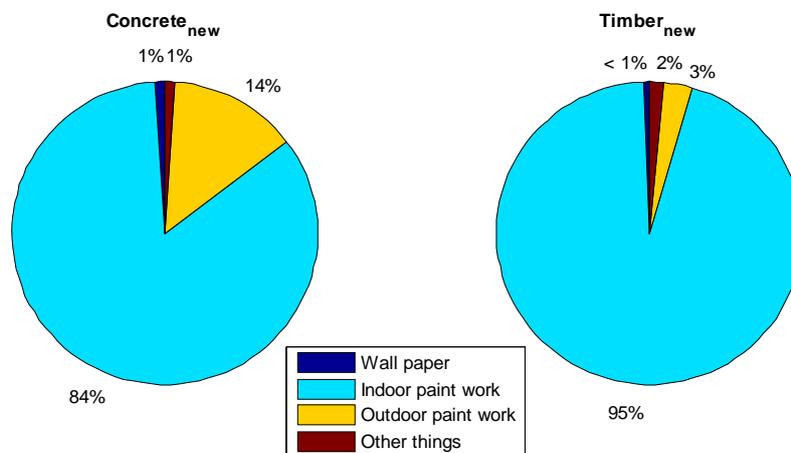
Figure 4.4. Split up of subcategory 9 (see section 3.6) for concrete_{new} and timber_{new} buildings.
