Seismic Retrofitting of Reinforced Concrete Building Damaged by Tucacas Earthquake, Venezuela

A.J. Malaver & D.R. Rodríguez

Facultad de Ingeniería, Universidad Católica Andrés Bello, Caracas, Venezuela

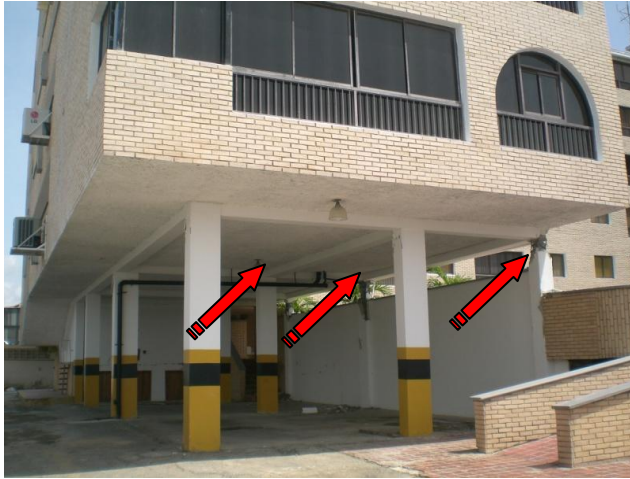
The three units of Miramar building suffered damage in columns and partitions, which are concentrated mainly between the ground floor and first level. In the West Unit severe damage in the four columns of the frame 14 was observed (shoring was required) due to short column effect caused by interaction with the masonry wall that partially confines the frame (Figures 2 and 3); in the East Unit the damage was severe and widespread in columns of ground floor to level 1 from 2 to 6 axes due to the presence of soft-story (Figures 4 and 5), and in the Unit North damage was moderate and localized in the structure of the staircase between axes 4-7 and AB on the ground floor (Figure 6). The beams showed no significant damage. Damage to partitions was similar in the three units of the building and concentrated mainly on the ground floor and level 1 (Figure 7).

Figure 2. View of damage in short column. West Unit (A. Urich)

1(see Figure 1) and (iii) reconstruction of the four columns of the frame 14 by encasing in high strength concrete with appropriate longitudinal and transverse reinforcement and separating them from the masonry wall in order to avoid the effects of short columns.

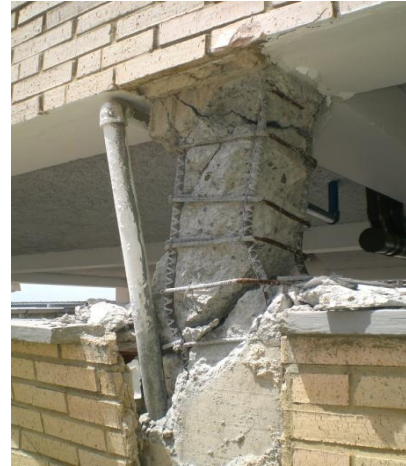
Figure 3. Detail of damage in short column of Figure 2 (A. Urich)

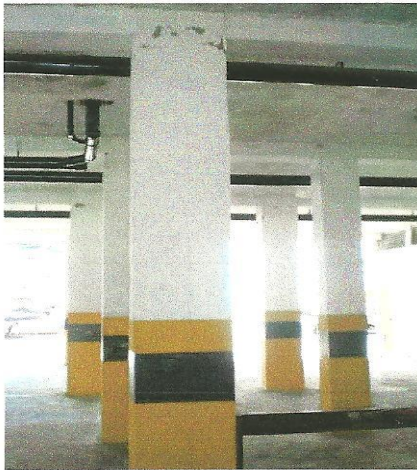
Figure 4. Cracking and crushing of concrete on top of the column (plastic hinge) in East Unit (A. Urich)

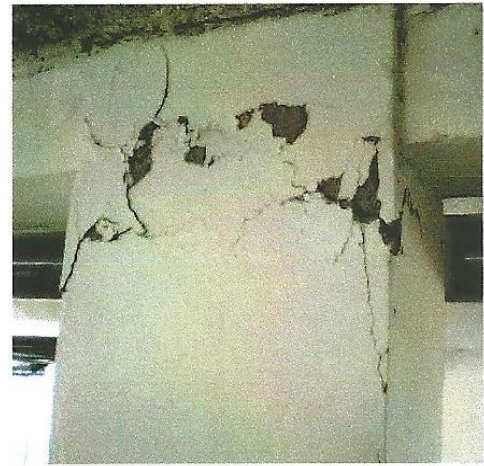
Figure 5. Detail of cracks at the top of the column of Figure 4 (A. Urich)

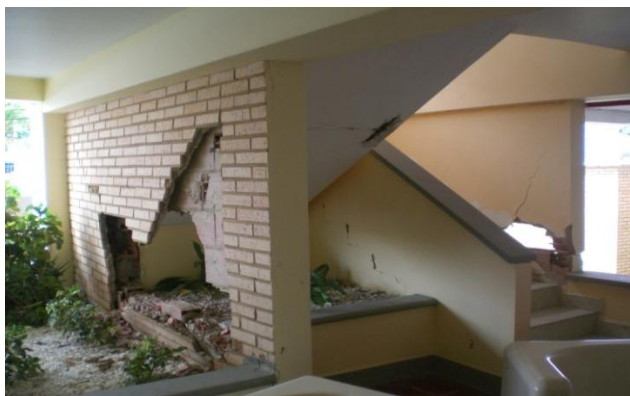
Figure 6. Damage in East staircase in the ground floor in the North Unit

The reinforcement of the leather of the building consists of the following: (i) increasing the cross section (Figure 12) and jacking of columns A-1, B-1, C-1, A-2, C-2, A -4, A-7, A-16 and C-16 from ground floor to level 4 (see Figure 11), (ii) jacking of columns A'-4, A'-10, A'-11, A-12, A-13, C-4, C-8, C-10, C-11, C-12, C-13, C-18 and B-18 from ground floor to level 1 (see Figure 1); (iii) reconstruction of the stair East from ground floor to level 1.

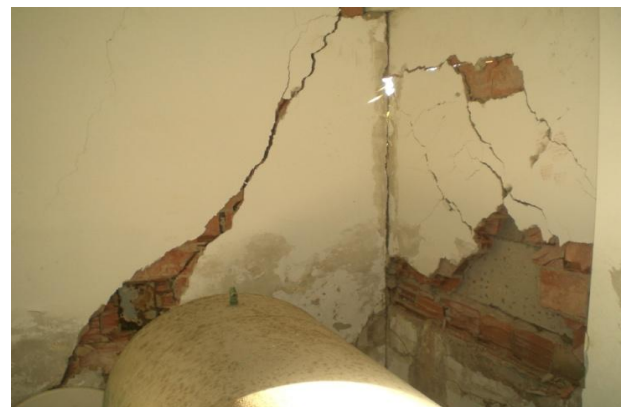
Figure 7. Damages in partitions in ground floor in the North Unit
