Analysis and Repair of an Earthquake-Damaged High-rise Building in Santiago, Chile

SUMMARY:

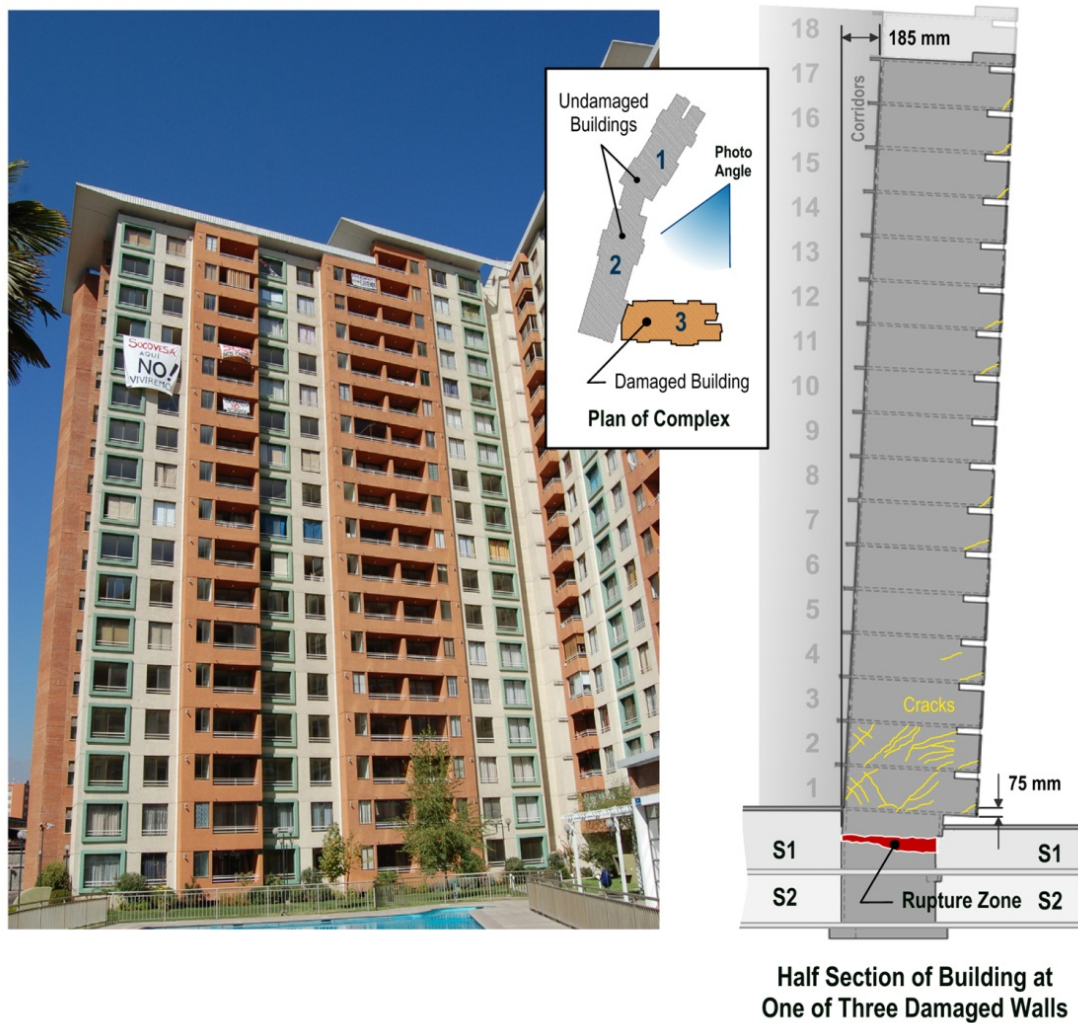
More than one hundred high-rise concrete shear wall buildings were badly damaged during the earthquake that occurred in Chile on February 27, 2010. A common form of damage was compression failure of thin walls in the lower levels of the buildings. In one 18-story building in Santiago, three adjacent shear walls at one corner of the building failed in flexural compression immediately below grade (Fig. 1). This caused the corner of the building to drop down 75 mm resulting in a permanent drift of 0.44%.

Cracking of concrete walls (Fig. 1) and cracking of floor slabs occurred throughout the damaged corner of the building causing the entire building to be distorted. As a result, there was concern that it may not be possible to restore all horizontal and vertical alignments of the building within acceptable tolerances by jacking only at the base of the building. Analyses were done to simulate the building damage and to estimate whether jacking at the base could be used to reposition the building. Estimates of maximum jacking forces were used to design local structural modifications and the new

Figure 1. Earthquake damaged building

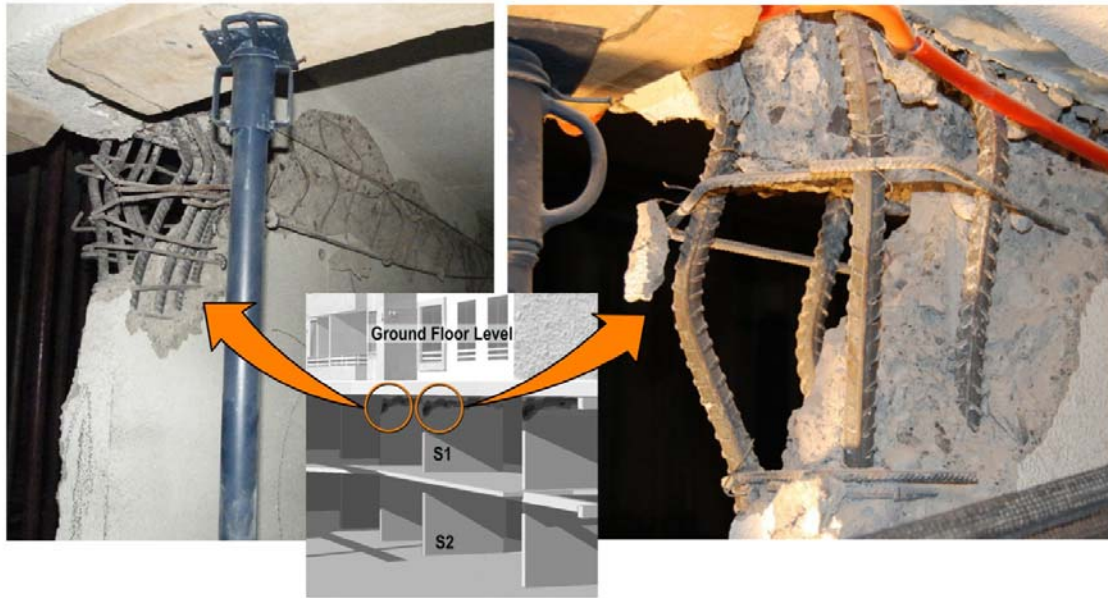
Figure 2. Flexural compression failure of shear walls in first level (S1) below grade

Nonlinear finite element analyses of the concrete shear walls (Adebar, 2012) indicated that the maximum concrete compression strain demands at the level immediately below grade are significantly magnified by a sudden increase in wall length above grade. The overhanging wall above causes a concentration of compression stress and strain at the outside edge of the wall below. This is exactly where the compression failure of the shear walls occurred in the building (Fig. 2).

Recent experiments on concrete shear wall elements have shown that 150 mm and 200 mm thick concrete shear walls with two layers of horizontal reinforcement may fail very suddenly at compression strains less than 0.0015 (Adebar and Lorzadeh, 2012). The reason for the failure at such low compression strains is that the horizontal reinforcing bars parallel to the wall faces create stress concentrations and micro-cracking in concrete surrounding the bars. As the concrete stress approaches the compression strength, the concrete surrounding the bar, and particularly the concrete cover outside of the bar, becomes unstable. In a thin wall, the concrete surrounding the two layers of horizontal reinforcing bars and the concrete cover outside these bars make up a very large portion of the wall thickness and so the wall fails when this concrete starts to become unstable. It is interesting to note that nominal column ties were found to stabilize thin walls and allow the walls to tolerate compression strains greater than 0.003 before failure (Adebar and Lorzadeh, 2012).

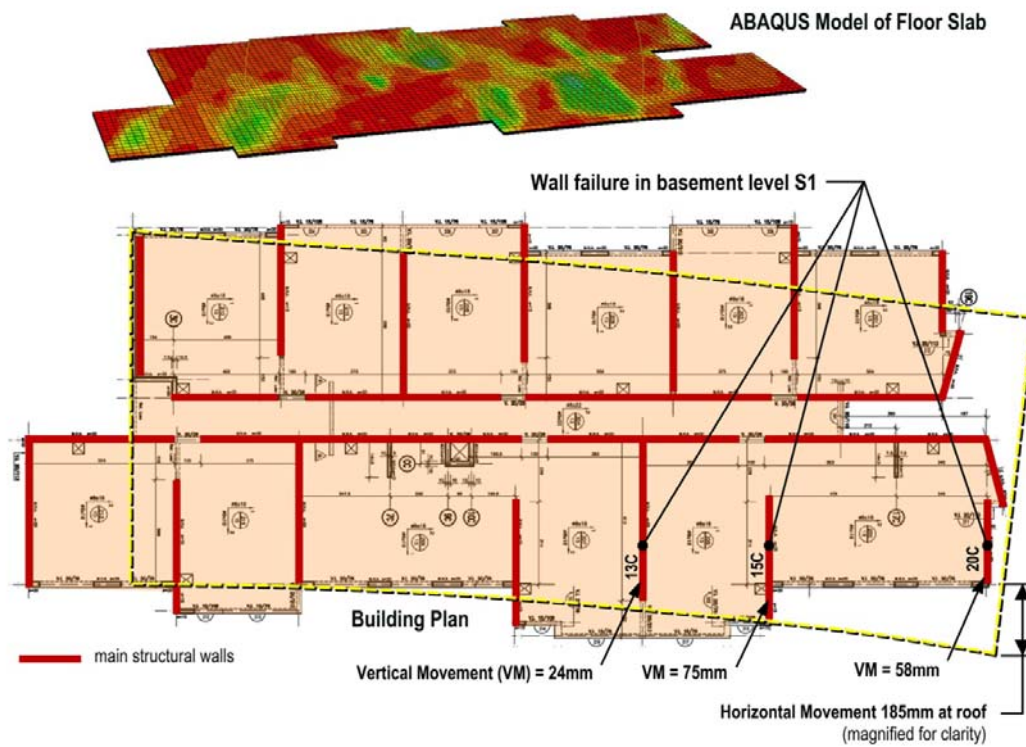
The building has an overall floor plan of about 14 x 37 m. In the long direction, there are two 200 mm-thick concrete shear walls on either side of a 1.6 m wide central corridor that runs the full length of the building. In the transverse direction, there are seven slender shear walls on both sides of the corridor. Most of the transverse shear walls are 200 mm thick; however some are 150 mm thick. The transverse shear walls have a uniform length from above the ground floor to the top of the building; but in the two levels of parking below grade, these walls are narrower. Shear walls 13C, 15C and 20C failed in flexural compression immediately below the ground level (Fig. 2). After the earthquake, the residual vertical displacements of shear walls 13C, 15C and 20C were measured to be 24, 75 and 58 mm at the outside edge of the building (Fig. 3). The horizontal displacements of the building along these three shear walls were measured to be 100, 130 and 185 mm at the roof level.

Figure 3. Plan view of building showing main structural walls, residual vertical movement of walls at grade level above damage, and outline of residual horizontal movement at roof level; finite element model of floor slab (top)

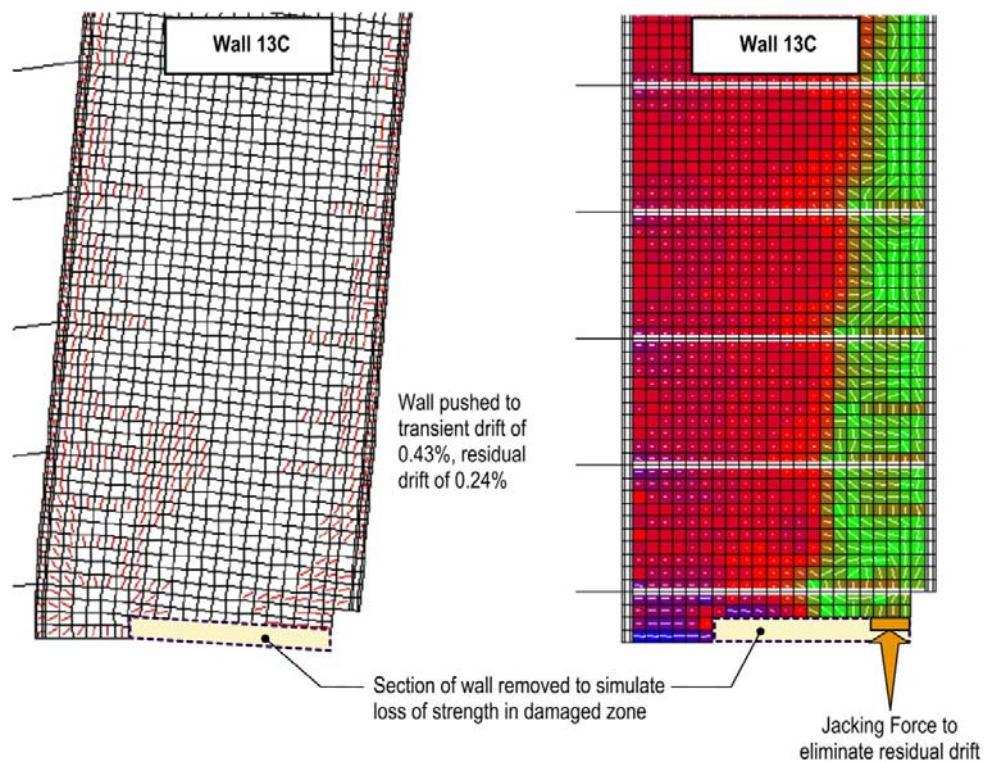
Figure 4. Nonlinear finite element analysis of damaged shear walls (small portion of walls shown): reverse cyclic loading to simulate earthquake damage (left); simulated jacking (right)

The two-wall frames were subjected to a three-step analysis. In the first step, the two walls started as undamaged and were subjected to reverse cyclic lateral loading. The maximum global drift that was applied was about 0.15% and this produced many of the cracks that were observed in the walls after the earthquake. This drift level corresponds to the expected demand based on a linear analysis of the building subjected to a typical ground motion recorded in Santiago during the earthquake. In the second step, elements were removed (Fig. 6) to simulate the damage observed at the base of one wall in each wall-pair. The two walls were then subjected to additional cycles of lateral load to a drift level that produced the correct level of residual horizontal displacement at the roof level and residual vertical floor displacement at the ground floor level. In the third step of the nonlinear analysis, the simulated applied vertical jacking forces were increased until the residual displacements of the walls were eliminated. For walls 15C and 16C the required jacking force was 306 tonnes, while for 13C and 14C the jacking force was 316 tonnes. Note that these are only one component of the total jacking force needed to straighten the entire building.

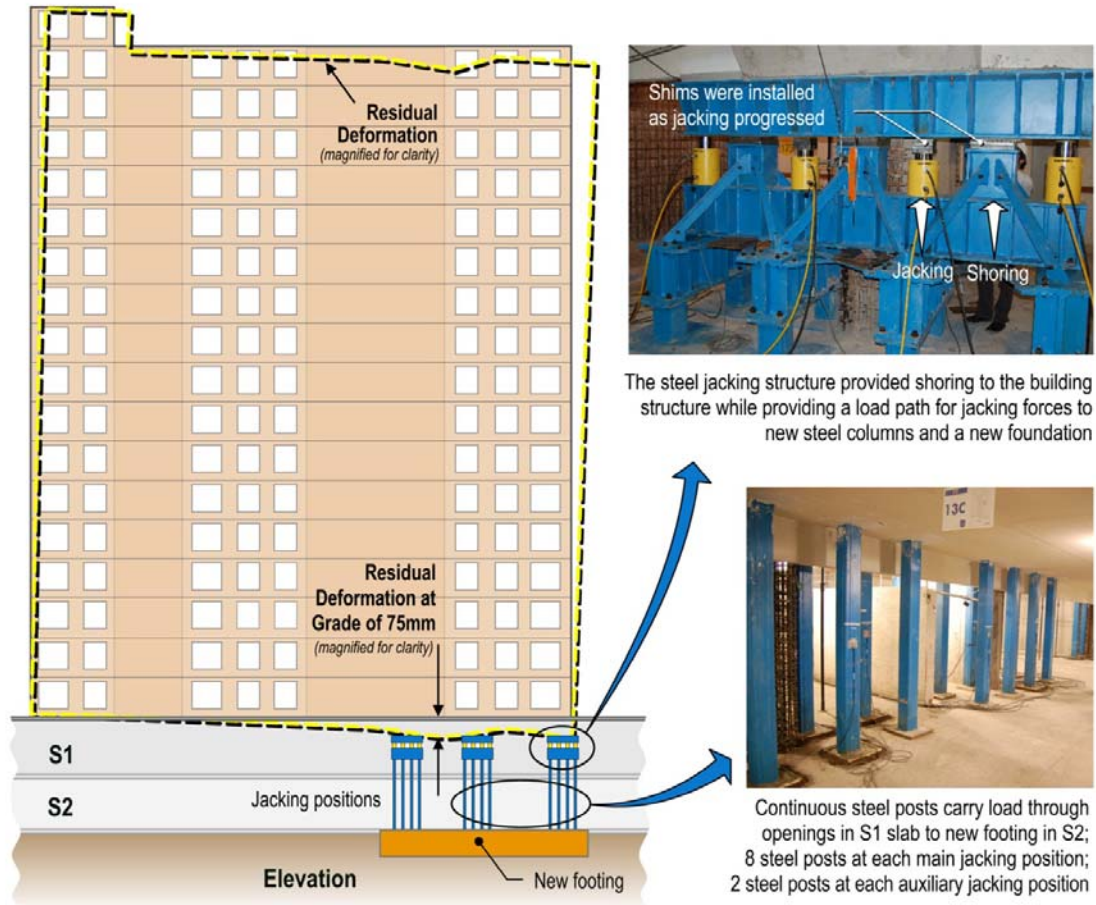
Figure 5. Repositioning of building by jacking at base

New concrete foundations were built around existing foundations of the three damaged shear walls. In addition, a 300 mm thick heavily reinforced concrete slab was cast on top of the new and old foundations. These slabs were used to support eight temporary steel HSS columns that extended through holes cut into the first underground level slab S1. A grillage of steel plate girders was used to transfer the loads from four jacks under each wall to the eight temporary HSS columns. This arrangement for the main jacks was typical at each of the three damaged walls.

The jacking structure was designed so that supports adjacent to the jacks could support the walls when the jacks were lowered (Fig. 5). Shim plates were inserted above these supports as the wall moved upward. The hydraulic jacks were used to lift the structure a certain amount and then shims were inserted, and the force in the hydraulic jacks was reduced to transfer the force onto the steel girder/column jacking/shoring system. Two sets of jacks (Fig. 6) were used for damaged walls 15C and 20C (larger jacks at the outside end of the wall and secondary jacks at the inside end), while only one set of jacks was used for wall 13C. The same structure used for jacking was designed to shore the building while the damaged portions of the concrete walls were repaired.

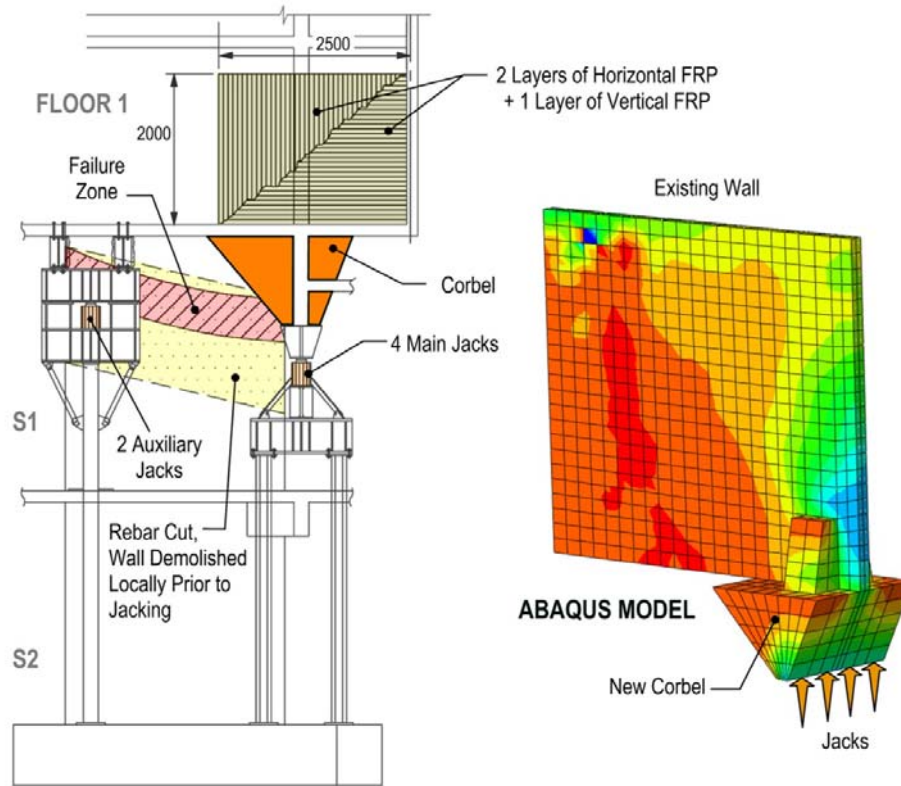
Figure 6. Details of jack set-up (left); finite element analysis of local concrete stresses due to jacking forces

In order to transfer the load from the jacks into the damaged concrete walls without crushing the concrete wall, new reinforced concrete corbels were constructed (Fig. 6). Finite element analysis of the corbels was used to ensure the concrete compression stresses in the walls remained below a safe limit so that the thin walls did not crush.

Analysis indicated that the jacking forces could cause new cracks to form in the concrete shear walls. As the concrete walls are lightly reinforced, carbon fibre reinforced polymer (FRP) fabric was added to the highly stressed areas of the wall (Fig. 6). Together, the plies of FRP on both sides of the wall were designed to resist a total tension force per unit area of wall equal to 2 MPa. The distributed reinforcement within the shear walls had a tension force capacity per unit area of wall equal to 1.0 MPa. In addition to providing crack control, the FRP was also used to increase the ductility (strain capacity) of the walls in compression. FRP fibre-anchors connecting the fabric on the two sides of the wall were spaced approximately at 600 mm in the highly compressed zones of the wall.

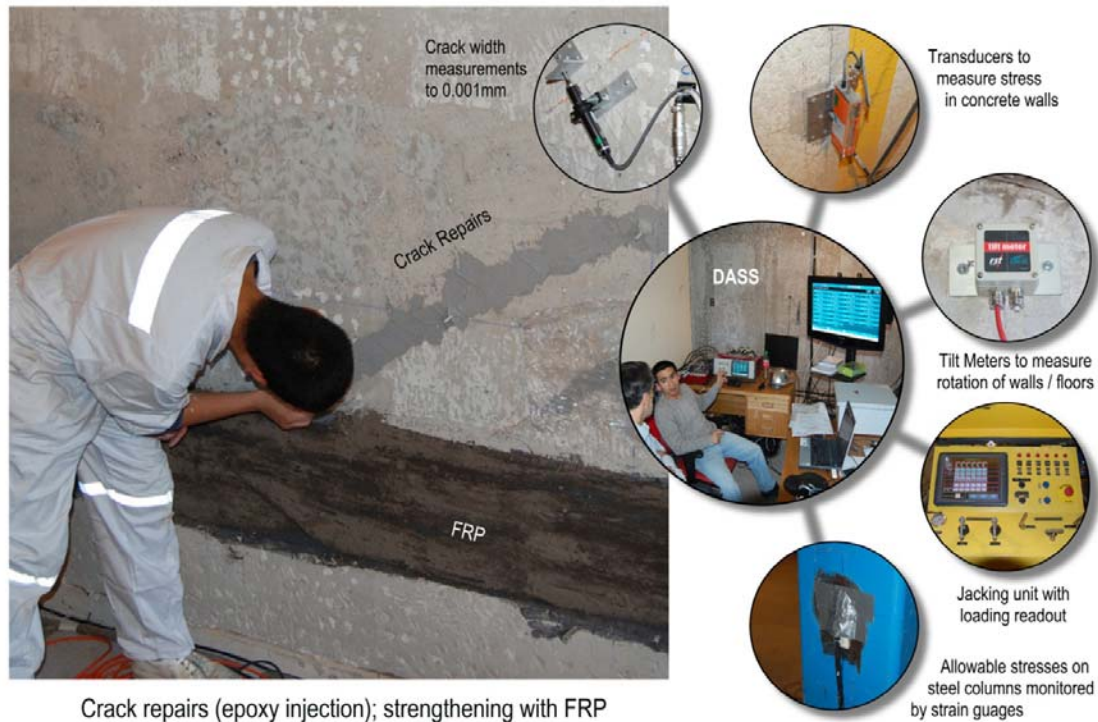
Figure 7. Crack repair (left); instrumentation (right)

All significant cracks in the concrete shear walls were repaired by epoxy injection. As the jacking was expected to close many of the existing cracks, the injection was not done until after the third day of jacking. At that point, the width of most cracks had reduced significantly. All cracks with a remaining width greater than 0.1 mm were injected.
