# Seismic Response of Reinforced Concrete Buildings in Concepcion During the 2010, Maule Earthquake

**B. Westenenk, J.C. de la Llera, R. Jünemann, M. Hube & J.J. Besa**

*Pontificia Universidad Católica de Chile, Chile*

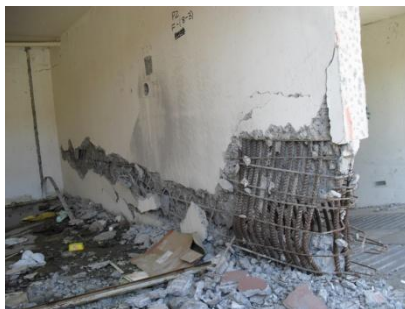
**Figure 3.1.** Typical severe wall damage in buildings (a) CM-3; (b) PR-6; and (c) TO-9

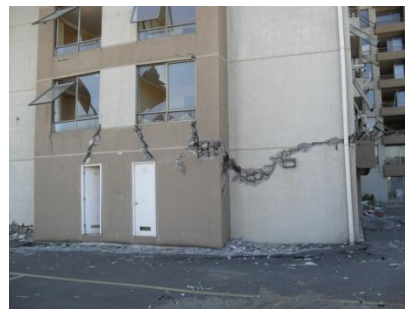
(b)

<i>PR-6</i>	This building comprised two similarly configured wings separated by a construction joint. The wing with longitudinal axis oriented approximately EW, was relatively undamaged. The wing along lines N-S sustained severe wall flexural and shear damage in the EW (transverse) walls, with heaved soils around the foundation suggesting uplift. Figure 3.1.b shows wall damage in this building.
<i>PP-7</i> <i>RT-8</i>	These identical adjacent buildings sustained similar shear and flexure/axial damage, concentrated in the first two stories in EW-oriented walls.
<i>TO-9</i>	This building is unique for its multiple vertical and plan irregularities. Damage was relatively light in the lower twelve stories. Partial story collapses occurred at each of levels 12, 16, and 20, each story with a significant vertical or plan irregularity. Additionally, wall piers sustained shear failures over a significant height of the building (Figure 3.1.c).

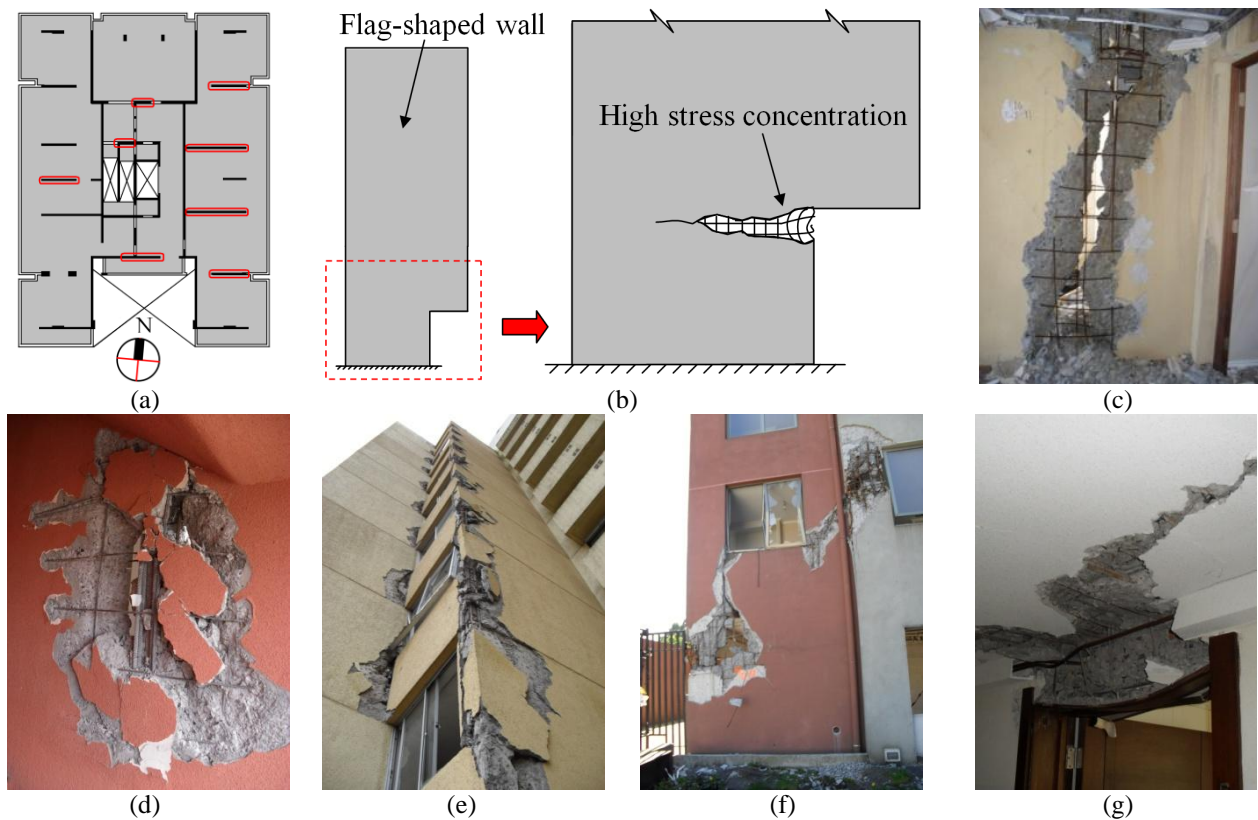
**Figure 3.2.** Trends in seismic building behavior

It is apparent that observed damage in shear walls tends to concentrate mainly in one principal direction of the building. Damage is concentrated in walls oriented in the E-W direction for most cases. This behavior can be attributed to the fact that the E-W direction coincides with the transversal axis of the buildings. Figure 3.2a shows the severely damaged walls of building AH-2.

Vertical and horizontal irregularities were a common factor present in most of the damaged buildings. AA-1 and TO-9 were characterized by having large horizontal and vertical irregularities. A common vertical irregularity pattern observed in most damaged buildings was the flag-shaped walls. This type of walls is characterized by having a reduced length at lower levels, mainly in first stories and parking levels. The flag-shaped walls produce high stress concentrations at the discontinuity region of the wall, which leads to localization of damage (Figure 3.2.b). Another aspect of vertical irregularity is found where two different walls become coupled through lintels in upper and/or lower stories. This irregularity is common as openings are closed in some stories. The coupling shear stresses induced at the continuous wall in top and bottom stories are very high causing both walls to fracture (Figure 3.2c). Moreover, beams supported by orthogonal walls (Figure 3.2d) induced damage to the walls since the cyclic motion tends to pull out the beam and punch the orthogonal walls. Furthermore, damage was also observed in spandrel beams coupled with transverse shear walls (Figure 3.2.e).

Buildings CM-3 and PR-6 evidenced multistory critical sections with damage (Figure 3.2f). The fracture along the critical section follows the simplest and least demanding failure mode. This type of damage is somewhat difficult to capture in design because structural models and design procedures treat building elements as one-story units. Therefore, buildings should always be analyzed and designed as 3D systems, considering all possible failure mechanisms crossing stories and connecting weak elements in neighboring stories. Propagation of damage into orthogonal wall elements and slabs was also observed in building PR-6.

After 1985, the architectural topology changed by drastically reducing or eliminating coupling beams. Among several reasons, this was caused due to the difficulty to convince owners that it was hard to prevent damage in these elements even if they were heavily reinforced. Unfortunately, with this elimination a very good source of energy dissipation in the building was eliminated. Since the building must dissipate energy to reduce forces, in many cases the slabs turned into flat coupling beams and though they underwent severe structural damage, their dissipation capacity was small. Examples of

such behavior are shown in Figure 3.2g. The elimination of coupling beams also increased the flexibility of buildings inducing heavy damage in some non-structural elements.

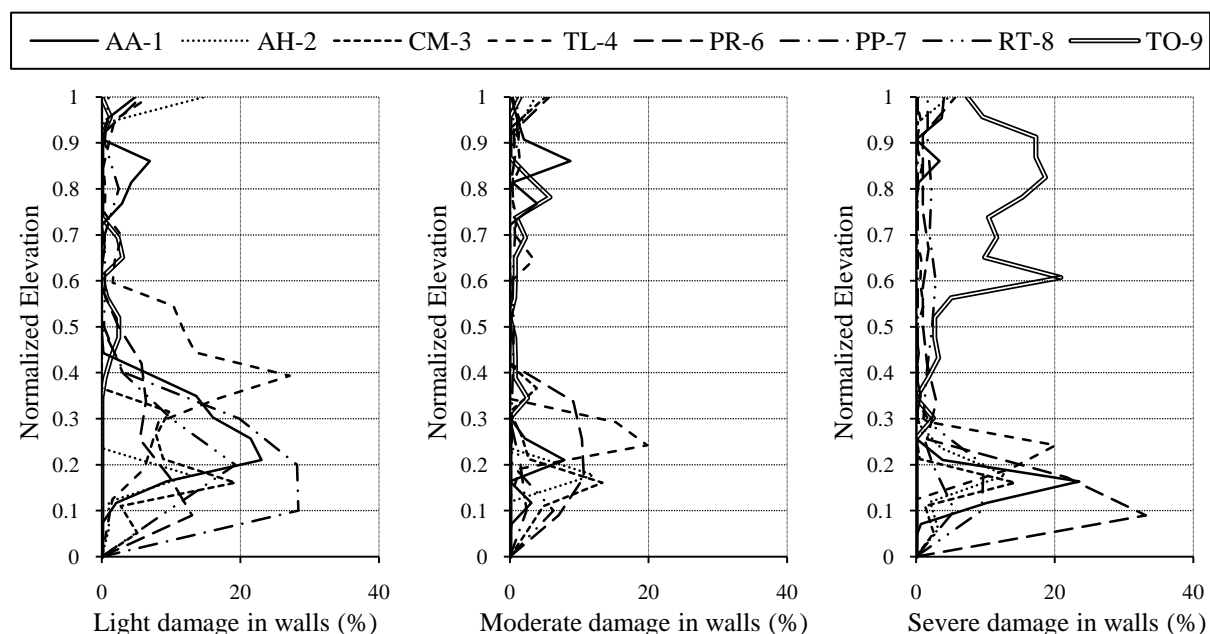
**Figure 4.1.** Distribution of percentages of (a) light, (b) moderate, and (c) severe damage in walls

Figure 4.1 plots damage percentages for shear walls classified with light, moderate, and severe damage versus the normalized height of the structure. The damage is measured by the volume of damaged elements relative to the shear wall volume in each story. Buildings show larger damage in lower stories, with the exception of TO-9, which had a  $12^{\text{th}}$  story failure, with additional damage in upper stories. Table 4.1 shows the total percentage of damaged elements in each building relative to the total volume of elements in the structure, classified by damage category. As expected, damage tends to concentrate in the lower stories, but the damage pattern varies among structures. Consolidated damage is largest in Building AA-1 and TO-9 and reaches values of the order of 12%. Therefore only a small volume of structural elements of any structure was compromised, suggesting inefficiency to distribute damage through the structure.

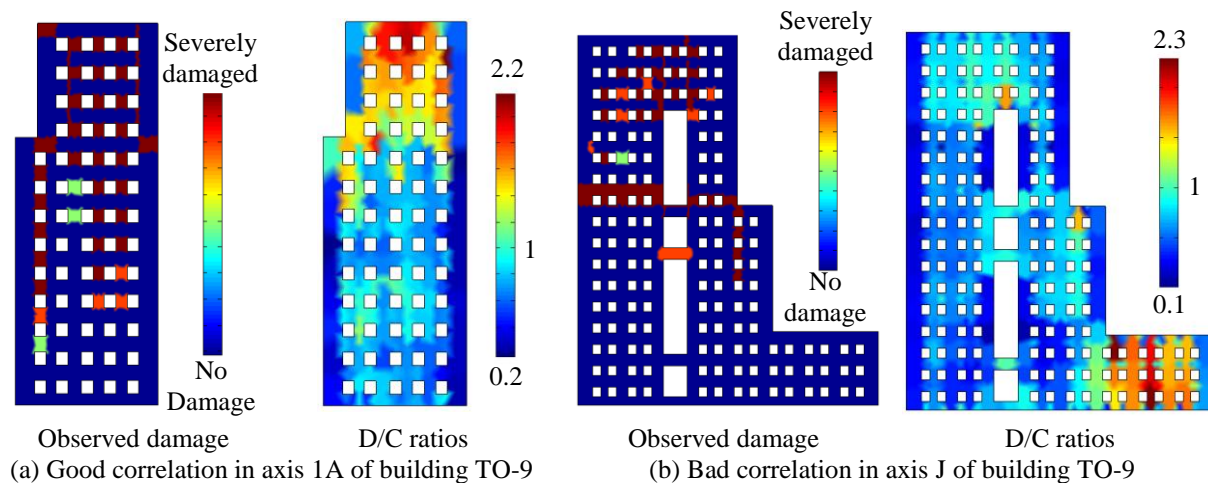
**Figure 5.2.** Comparison of damage correlation results: (a) Good, and (b) bad correlation between observed damage and D/C ratios

Special damage drawings were prepared in order to physically compare the observed damage with that resulting from code analysis results. The comparison revealed that there are several cases in which the design deficit, represented by high D/C ratios, matches the damaged elements (Figure 5.2a). However, there are also cases in which damage cannot be explained by high D/C ratios (Figure 5.2b). This happens due to the load redistribution that occurs between elements: as one element collapses, load is redistributed within the structure.
