# Reduction of static and dynamic shear strength due to the weathering of mudstones

## SUMMARY:

An embankment of Tomei Expressway failed at Makinohara district during an earthquake in Japan. After the earthquake, detailed soil investigations and seismic analyses etc. were carried out to know the mechanism of the failure. One major reason was estimated as the weathering so called slaking of the mudstone filled about 40 years ago. In Japan there are many embankments constructed by mudstones. However weathering speed may be different in those embankments. So, the authors conducted several laboratory tests to study effect of slaking on static and dynamic strength of mudstones. Two types of test, cyclic torsional shear and triaxial tests were conducted for a fresh crushed-mudstone and a filled weathered-mudstone. Artificial weathering was applied to the crushed mudstone by heating and submerging. Test results showed static and dynamic strength decreased with the weathering. Five cycles of heating and submerging caused about 40% and 20% reductions of static strength and dynamic strength, respectively.

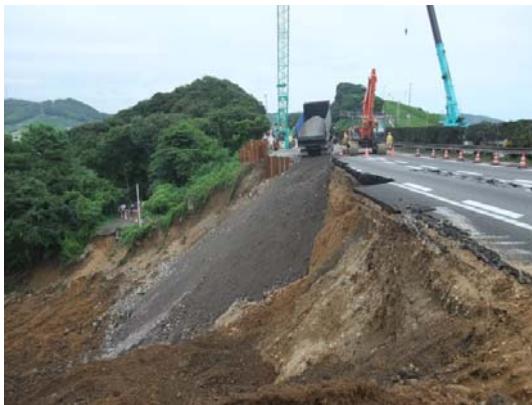
A medium-size earthquake with  $M_j=6.5$  occurred on August 11, 2009 in Japan. Epicenter was under Suruga Bay in Shizuoka Prefecture as shown in Figure 1. Several damages occurred in Shizuoka Prefecture such as collapse of walls, uplift of manholes and collapse of tiles. Of them, an embankment of Tomei Expressway failed at Makinohara district where is about 31 km from epicentre. Ground surface accelerations recorded at two sites near Makinohara were 295 Gals and 488 Gals. Failed slope was about 40 m in width, 28 m in height and 80 m in length as shown in Figure 2. Social impact by the slope failure was very severe because Tomei Expressway had to be closed for four days though the expressway is the most important and crowded expressway connecting major cities Tokyo and Nagoya. The authors conducted site survey immediately after the earthquake to investigate mechanism of the failure, and found weathered mudstones at the toe of the failed slope. The embankment was constructed about 40 years ago by filling fresh crushed mudstones and other soils. However the mudstones observed at the toe were quite weathered dark-blue coloured clayey ones as shown in Figure 3. Some terrace gravels were included in the weathered mudstones. So, it is estimated the fresh crushed mudstones changed to clay due to weathering so called slaking during the 40 years.

**Figure 2.** Failed slope of Tomei Expressway at Makinohara

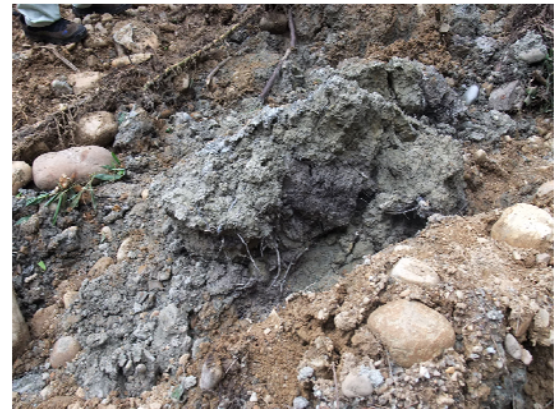
**Figure 3.** Weathered mudstones observed at the toe of the failed slope

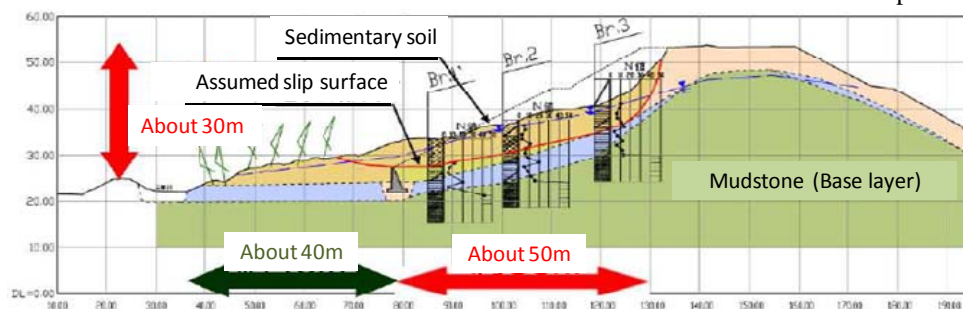
After temporary restoration work, detailed soil investigations and seismic analyses etc. were carried out to demonstrate the mechanism of the failure and study appropriate permanent restoration work by a technical committee chaired by Prof. H. Ohta (Takagi et al., 2010, Nakamura et al., 2010). Figure 4 shows the estimated soil cross section before the earthquake at the failed slope. The road was constructed by filling crushed mudstones and terrace gravels on a base mudstone and a clay layer. The bed mudstone named Sagara Mudstone is convex shape and very hard as SPT  $N$ -value is greater than 50. Red coloured curve marked on Figure 4 is the slip surface caused by the earthquake. As the curve is crossing over the top of a retaining wall which had been constructed to prevent slide failure, it is estimated that the strength of the clay layer did not affect the slide during the earthquake. The SPT

*N*-values of the fill is not high as about 5 though the degree of compaction is more than 90% which is, in general, enough for the stability of the slopes of road embankments. Water table during the earthquake was estimated to be raised up to in the fill. Then the following features were pointed out by the technical committee.

- (1) Slide occurred in the fill.
- (2) In geographical feature this site is catchment.
- (3) Water level was high during the earthquake.
- (4) Two kind of banking materials were filled at the damaged site. Crushed mudstone which is easy to weathering and terrace gravel were deposited in lower and upper zones, respectively.
- (5) The banking materials were filled by enough degree of compaction.

Therefore the main reason to cause the failure was the decrease of shear strength and permeability of the crushed mudstone due to long-term weathering named slaking. One more effect of the convex shape of the base mudstone on the shaking during the earthquake was also pointed out.

**Figure 4.** Estimated soil cross before failure section
