Lifeline System Earthquake Damage in Yushu, Qinghai Earthquake ($M_L=7.1$, 14th, April, 2010)

SUMMARY:

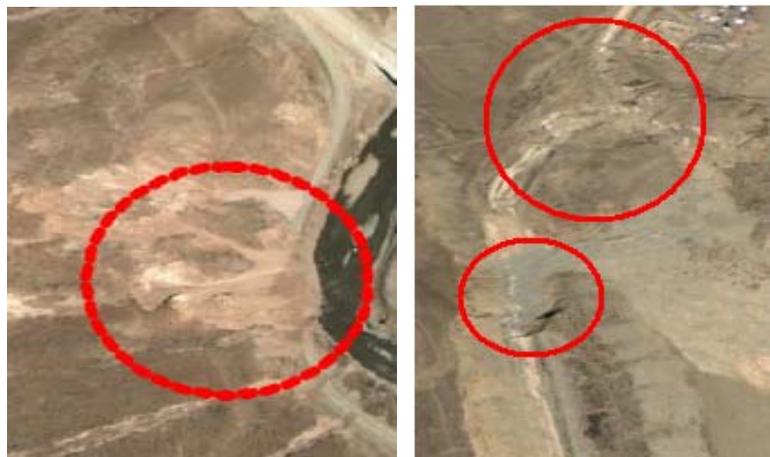
In this meizoseismal area, there are only two main highways, named G214 and S308 respectively. During this earthquake, two highways had been damage in different damage degree, the typical earthquake damage included foundation failure, bridge and culvert damaged, etc. The highway foundation split and settlement were found in the length of 875km everywhere. About 87 landslides occurred in G214 and S308 in this earthquake (Figure.2). The ground rupture due to seismic fault was an important reason to interrupt transportation (Figure.3).

Figure 2. Interrupted road by landslide and collapsing

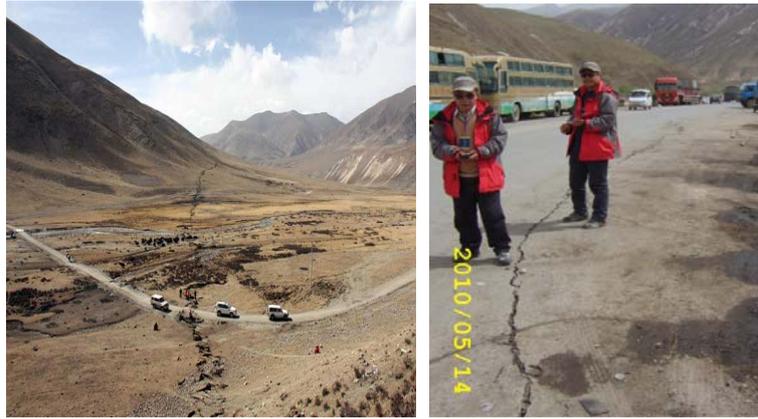
Figure 3.Damaged road by active fault

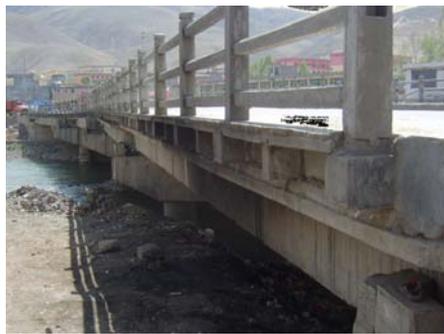
The bridges were damaged in different degrees were damaged in the affected area; most of bridges in Yushu were simply supported girder. Seven bridges in G214 and S318 were damaged from moderate to heavy damage. In Gyêgu town, the main seismic fault passed through one Girder Bridge, and made it diversely contra rotate and have snake motion in deck, separate between the deck and bridge approach (Figure.4). Damage seems to be due to a combination of ground surface rupture and strong ground shaking. Some typical bridge damage is shown in Figure 4(Figure 4).

a) Contra rotating and snake motion

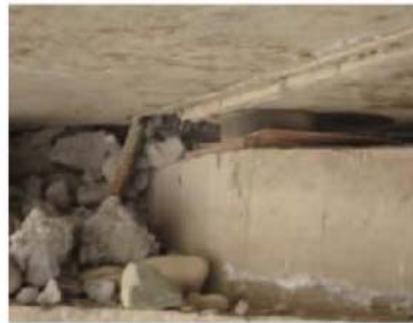
b) Bearing displacement and fractured seismic anchor

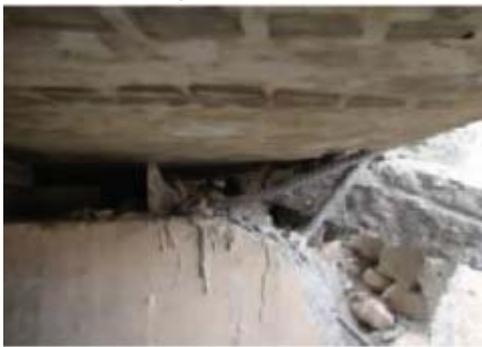
c) Fractured cap beam of abutment

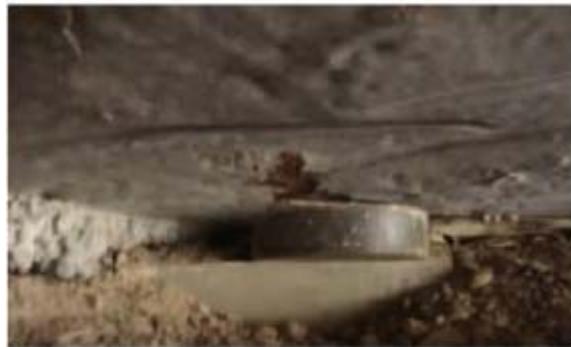
d) Baring separation

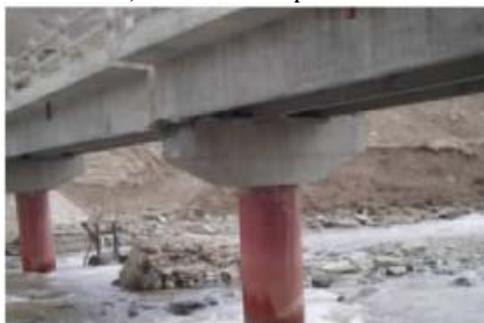
e) Beam displacement and fractured seismic anchor

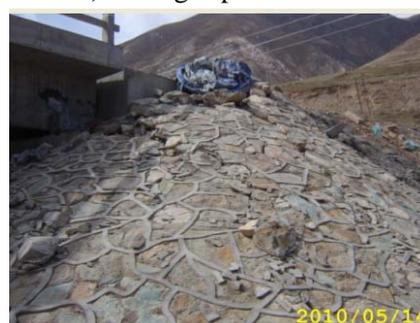
f) cone protection damaged

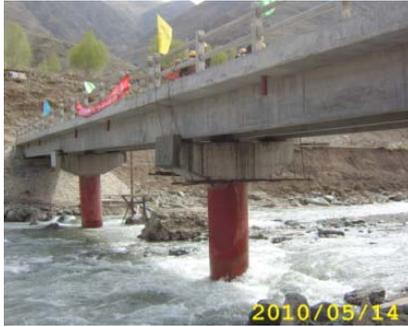
g) Bridge pier tilting

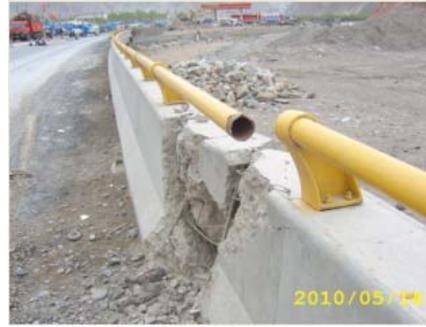
h) sinistrorse displacement of guardrail

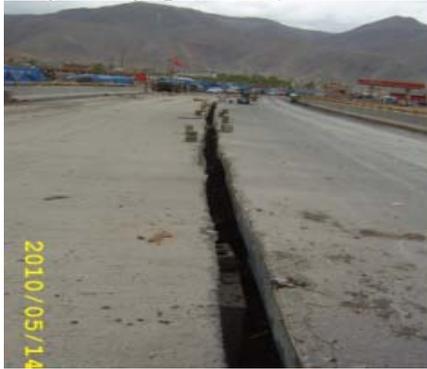
i) Deck split or crack (average displacement 40cm)

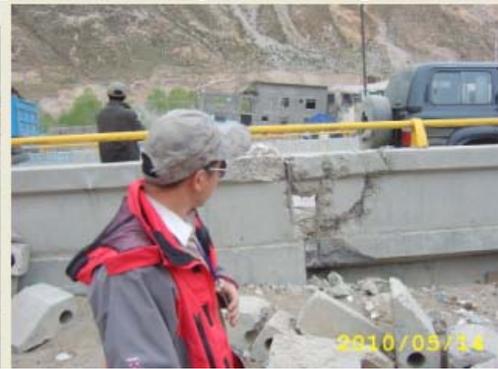
j) guardrail damage

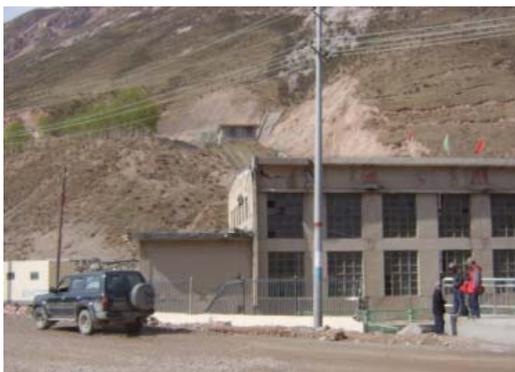
In this meizoseismal area, the electric-power system was immediately damaged after earthquake. Until 16th, April 2010, the electric-power partly recovered to use temporary generators. Because power supply was based on small waterpower factories, the electric-power lost their function due to the damage of waterpower factories (Figure.5)

a) The waterpower factory damage

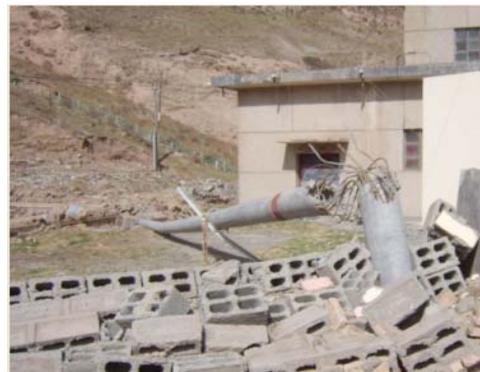
b) broken pole

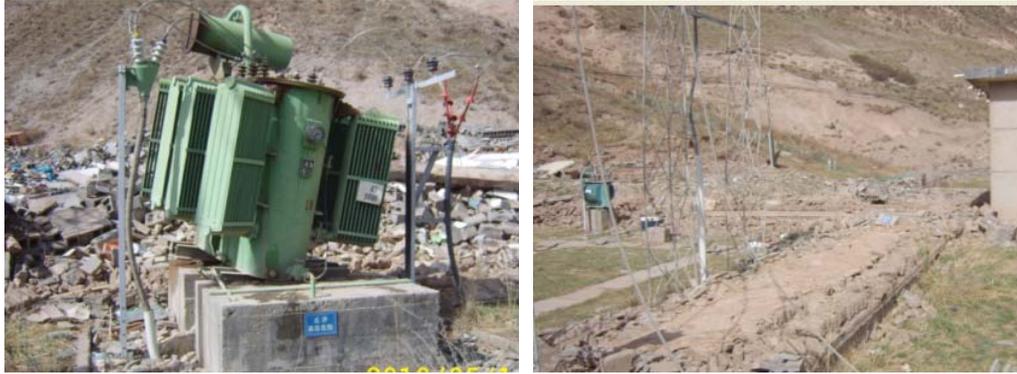
c) Transformer displacement

d) snapped electric line

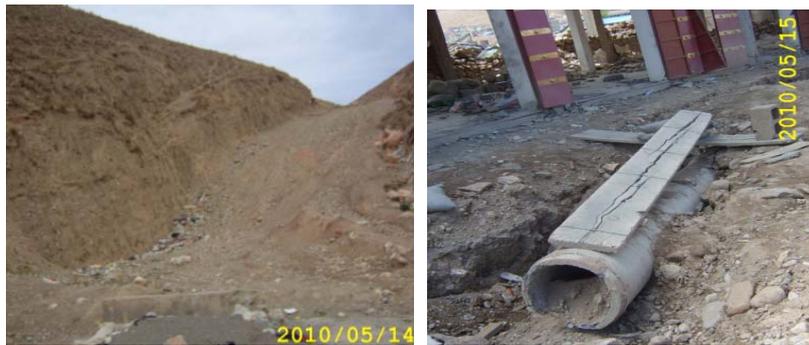
Around Gyêgu town, the water-supply system was damaged due to the strong ground motion, active fault and landslide or debris. Because the water-supply system in Gyêgu town consisted of concrete pipeline, ditch and canal on the ground, they are vulnerable to strong ground motion, landslides or debris (Figure 6). The emergency water-supply was set up by temporary wells and plastic pipeline until April 17th 2010.

a) Cannel buried by debris or landslide b) damaged pipeline near the active fault

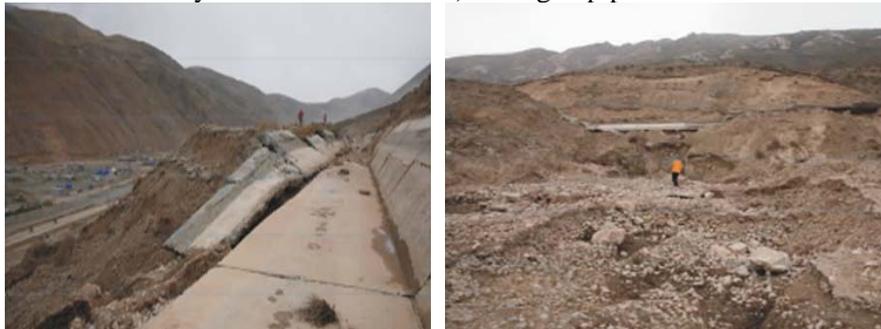
c) Foundation failure of ditch due to landslide d)

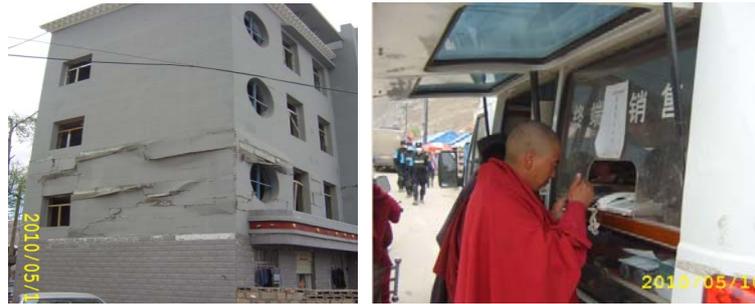
Figure 7. Damaged building and emergency telecommunication based on satellite communications

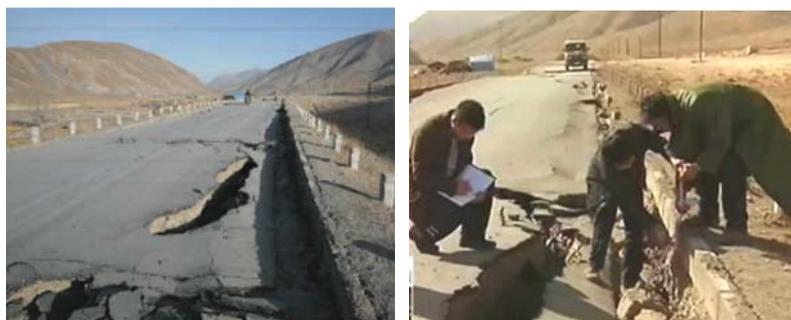
A great number of Geotechnical disasters were triggered in this earthquake. According to the report of China Earthquake Administration (CEA), there were about 295 landslides and a large number of ground fissures in this earthquake affected area. The landslide was formatted partly because of frozen soil heat-thaw. The transportation system, water-electric power and water-supply were interrupted by foundation settlement, landslide, debris and collapsed rock and soil (Figure 8).

a) Highway foundation settlement and crack

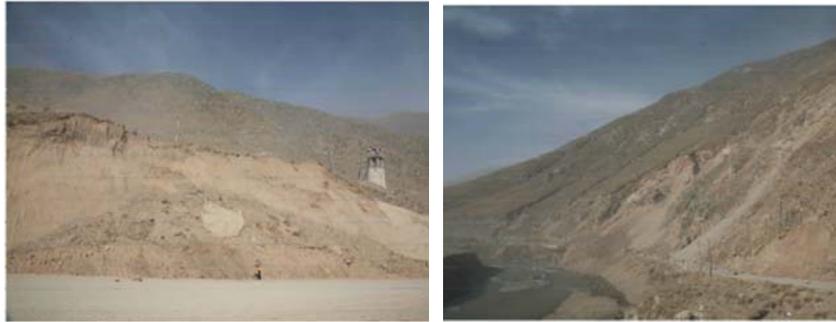
b) Covered highway by landslide
