Experimental Evaluation of the Seismic Performance of Hospital Sprinkler Systems

K.C. Kuo

National Taipei University of Technology, Taiwan

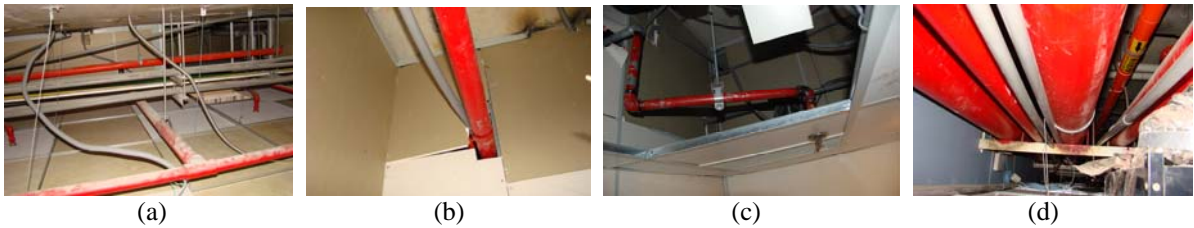
The experimental subassembly was modeled after a hospital sprinkler system that suffered damage in the March 4, 2010 (Jia-sen) earthquake, Taiwan. The recorded PGA at the nearest observation station was around 170gal. A branch pipe in the patient room on the top floor (7th floor) broke and led to severe leakage of water. Figure 2.1 is the plan of the sprinkler piping system in the patient room. Figure 2.2 shows the pictures of the investigation results.

Figure 2.2. Investigation results of the sprinkler system damaged in 2010 Jia-sen earthquake: (a) bed area (b) from shower room to bed area, (c) entrance, and (d) corridor

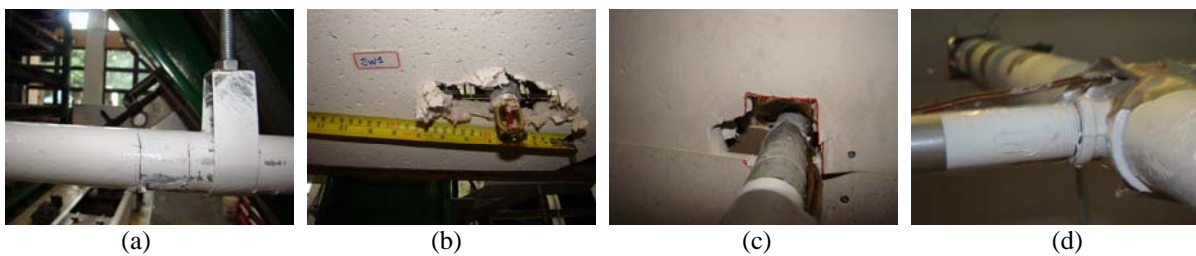
This section presents the damage of the specimen observed by eyeball inspection. The damage of the sprinkler subassembly is the main concern of the test. The observed damage patterns include slippage of hanger, scrapping off on piping surface (whitewash), and rupture of pipe threads (leading to leakage of water). In addition, for ceilings and partitions, the damage patterns include cracking or crushing of ceiling/partition boards, and out-of-plane deformation of partition boards. Figure 3.6 shows the pictures of various damage patterns of the specimen.

Table 3.1 displays the damage observed after each run. In the table, PFA adopts the recorded testing data in X-direction; the number in parentheses designates the largest range in cm for the corresponding damage. Before leakage of water occurred under the input of 0304 earthquake, cracking or visible bending deformation of the pipes was not observed. In previous research (Taghavi, S. and Miranda, E. 2003), three damage states were defined for sprinkler system: breaking the hangers, damage to pipe, and damage to sprinkler heads. In this test, hangers did not break as their lateral deformation was limited by the partitions. As for sprinkler head, the collision between sprinkler head and ceiling was observed. However, the mineral-fiber ceiling board was comparatively soft and did not break the sprinkler head. Subjected to 0304 earthquake, the crushing range of the ceiling board was as large as 7.0cm (see Figure 3.6(b)).

Figure 3.6. Damage patterns: (a) slippage of hanger, (b) crushing of ceiling, (c) crushing and out-of-plane deformation of partitions board, and (d) rupture of threads

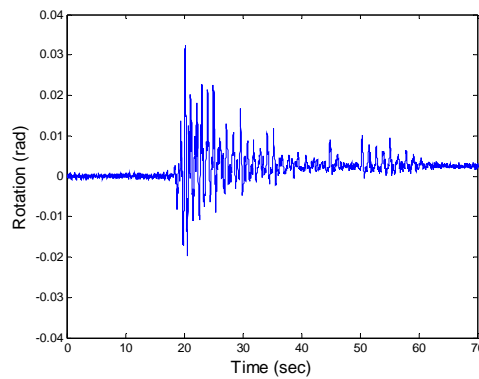
The rotation at the T-joint where the rupture of threads occurred is of concern. The time history of rotation at the T-joint was calculated using the data recorded by the displacement transducers. For each run, the experienced maximum rotation of the T-joint was indicated in Table 3.1. During the input of 0304 earthquake, the testing was interrupted when water bursting from the ruptured T-joint was observed. Subjected to the spectrum-compatible time history of acceleration with PFA of 408gal, the maximum rotation was 0.032radian (Figure 3.7) and no rupture of threads occurred.

Figure 3.7. Time history of rotation of the T-joint subjected to the spectrum-compatible time history of acceleration with PFA of 408gal
