An Investigation on the Pre- and Post- Repair Vibrational Characteristics of Two Gymnasiums Damaged by the 2011 Great East Japan Earthquake

M.Wakui, K.Araki & J.Iyama

15 WCEE
LISBOA 2012

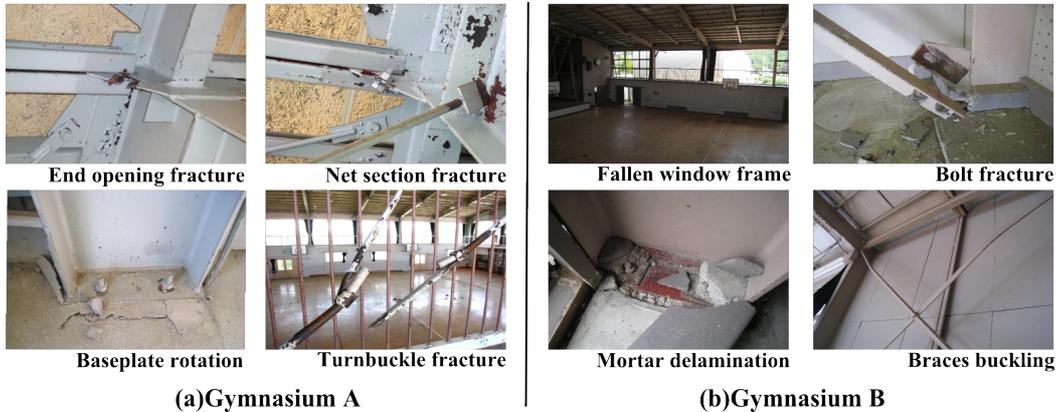
Figure 2. Observed failure modes

Figure 2 shows the modes of failure observed in gymnasium A and B after the 2011 Great East Japan Earthquake. The braces of both gymnasiums were severely damaged. For gymnasium A, the turnbuckle fractured in 2 bays and the bolted brace-to-gusset connection suffered net section failure in

1 bay, end opening fracture in 1 bay, and bolt fracture in 2 bays. For gymnasium B, the bolt fractured in all 4 of its bays. The base plate of several columns to which the braces were fixed had slightly rotated for both gymnasiums. Damage such as yielding could not be observed in the roof bracing by simple visual inspection. As for non-structural damage, only the windows broke in gymnasium A while the window frame completely fell off in gymnasium B.

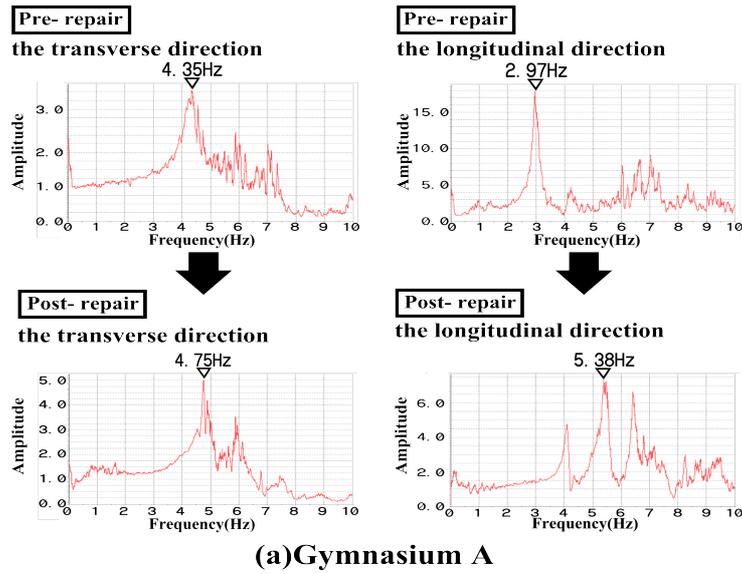
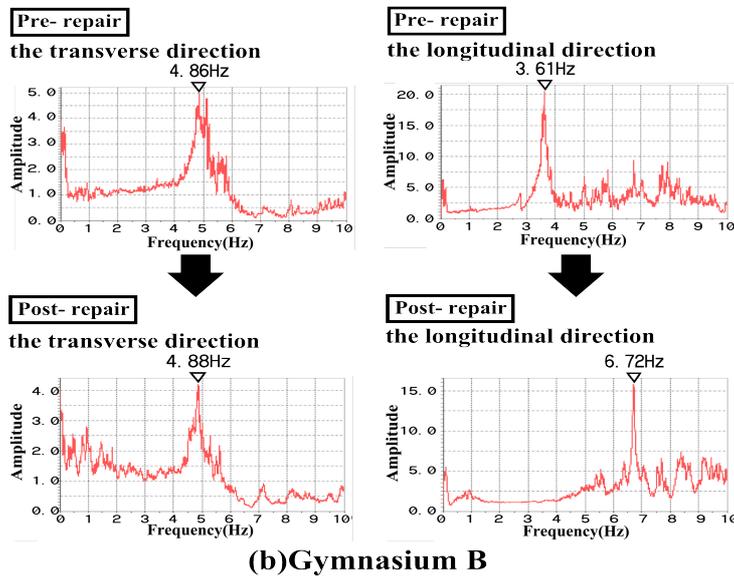
Figure 4. Response spectra from microtremor measurements

Fast-Fourier Transforms (FFT) were conducted to obtain the Fourier amplitude spectra from the measured microtremor response velocity time histories. The spectra were smoothed with a Hanning window of 0.1Hz, and used to obtain the transfer function between the column base and the column top. These are shown in Figure 4.

In the transverse direction, the pre-repair predominant frequency of gymnasium A is 4.35Hz, and the post-repair 4.75Hz. This small increase in frequency is assumed to be from the rise in stiffness caused by the enlargement of the base plate and increase in the number of anchor bolts. The pre-repair predominant frequency of gymnasium B is 4.86Hz and the post-repair 4.88Hz. In spite of having repaired the column base, the pre- and post- frequency has hardly changed. An increase in the weight of the gymnasium due to the installation of new window frames maybe a cause of this.

On the other hand, in the longitudinal (braced) direction the pre-repair predominant frequency of gymnasium A is 2.97Hz and the post-repair 5.38Hz. Those of gymnasium B are 3.61Hz and 6.72Hz, respectively. For both gymnasiums, the large increase in frequency is due to the repair of the vertical braces.

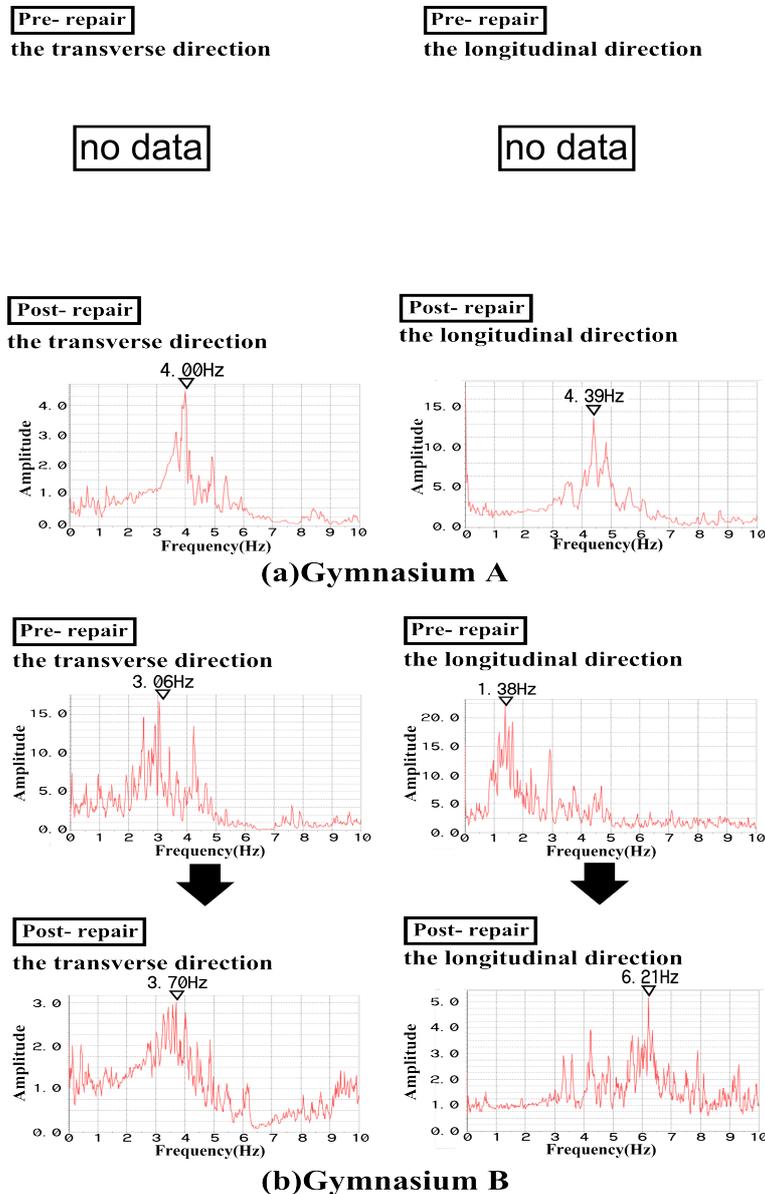
Figure 5. Response spectra from earthquake response measurements

Figure 5(a) shows a post-repair response record of gymnasium A measured around 17:00 on October 10, 2011 (the seismic intensity is 3). The predominant frequency is 4.00 Hz in the transverse direction and 4.39 Hz in the longitudinal direction. These values are smaller than the corresponding values obtained from the microtremor measurement results.

Figure 5(b) shows a pre-repair response record of gymnasium B measured around 11:45 on September 10, 2011 (the seismic intensity is 2) and a post-repair response record measured around 20:00 on March 27, 2012 (the seismic intensity is 2). These two records have been selected for comparison since they have a similar maximum acceleration at the column base. The predominant frequency in the transverse direction has increased slightly from 3.06 Hz to 3.70 Hz due to the repair. This trend was not observed in the microtremor measurement results. On the other hand, the predominant frequency in the longitudinal direction has increased considerably from 1.38 Hz to 6.21 Hz as in the microtremor measurement results.

One should note that the differences between the predominant frequencies of the microtremor and earthquake response results in each direction are smaller after the repair. Additionally, like gymnasium A, the frequencies are smaller than the corresponding microtremor measurement results.
