Seismic Performance of a Six Storey Reinforced Masonry Building during the Christchurch Earthquake

J. Centeno & C. E. Ventura
University of British Columbia, Canada

J. Ingham
University of Auckland, New Zealand

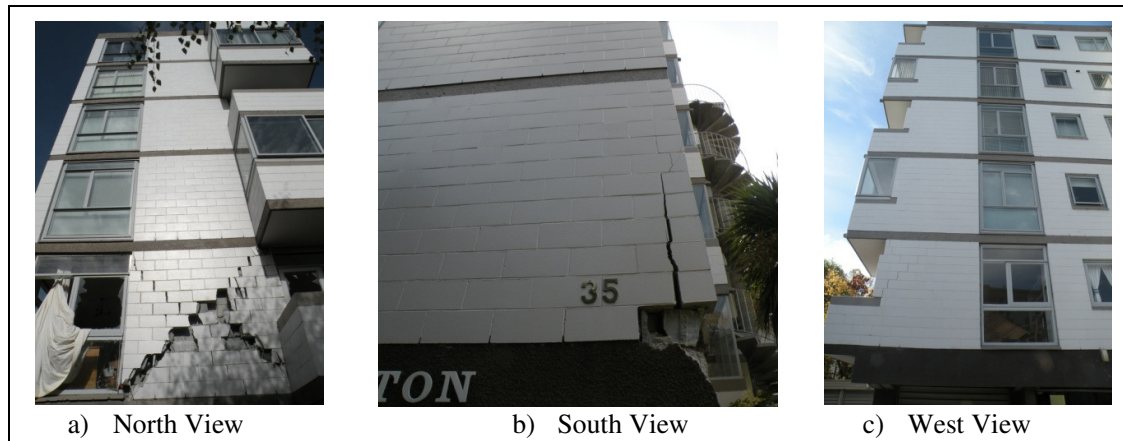
Figure 4. Damage to Veneer

structural damage. At the second floor, the veneer side of the cavity wall at the north end showed large diagonal cracks (Fig 4a); and the wall at the south end presented a toe crushing failure (Fig 4b). The east and west views showed some light mortar cracks on the face and base of the walls (Fig 4c).

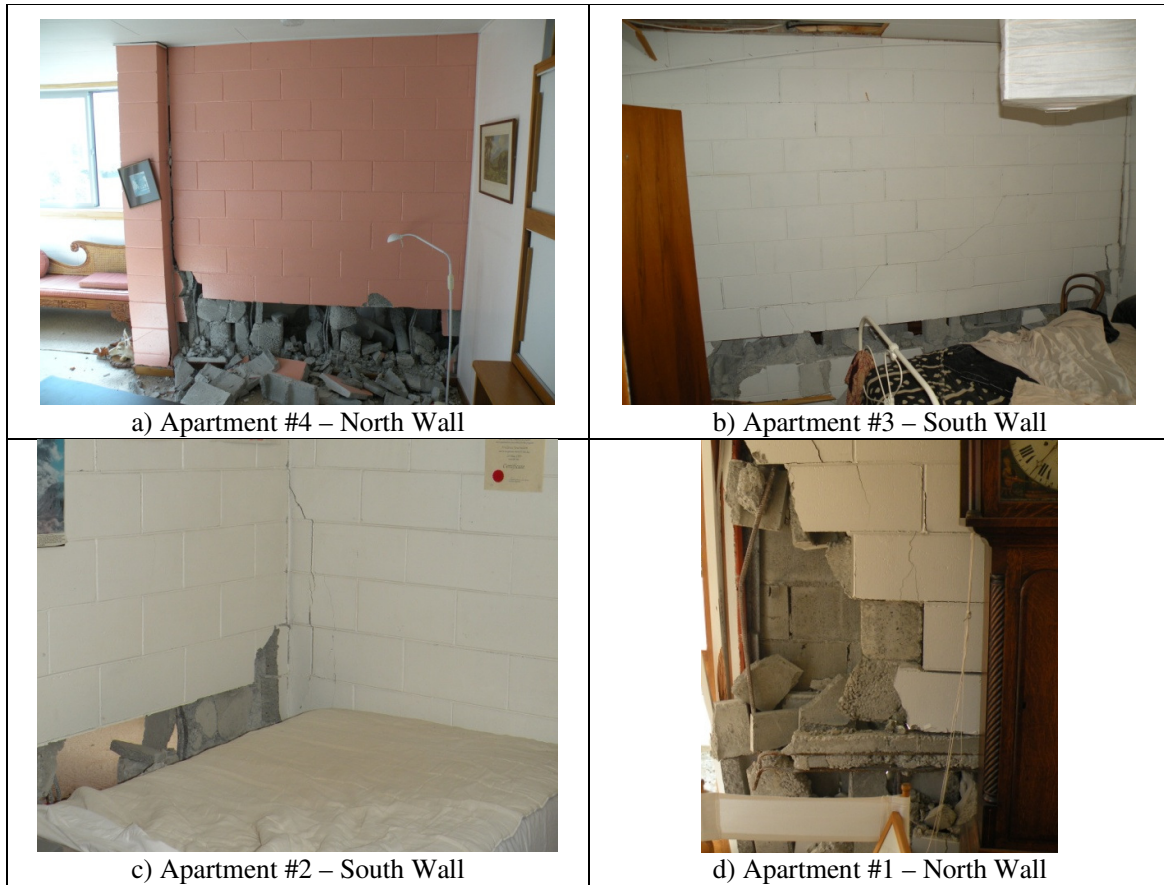
Figure 5. Damage to Interior Walls – West End

The interior masonry walls on the second floor, spanning in the east to west direction, had suffered toe crushing failure and were the primary sign of failure of the building. It was estimated, based on the observed level of damage, that these walls' lateral and vertical resistance had been significantly degraded.

The damage was found to be more severe towards the west end of walls in comparison to the east end. Shown in Fig 5 is the damage found on the west end which consisted of spalling of all face shells and crushing of the grout columns. This side also presented one vertical splitting crack at the contact surface with its neighbouring wall, (Fig 5a and Fig 5c). Although damage was also considerable in the east end, there were less cases of face shell spalling, as shown in Fig 6.

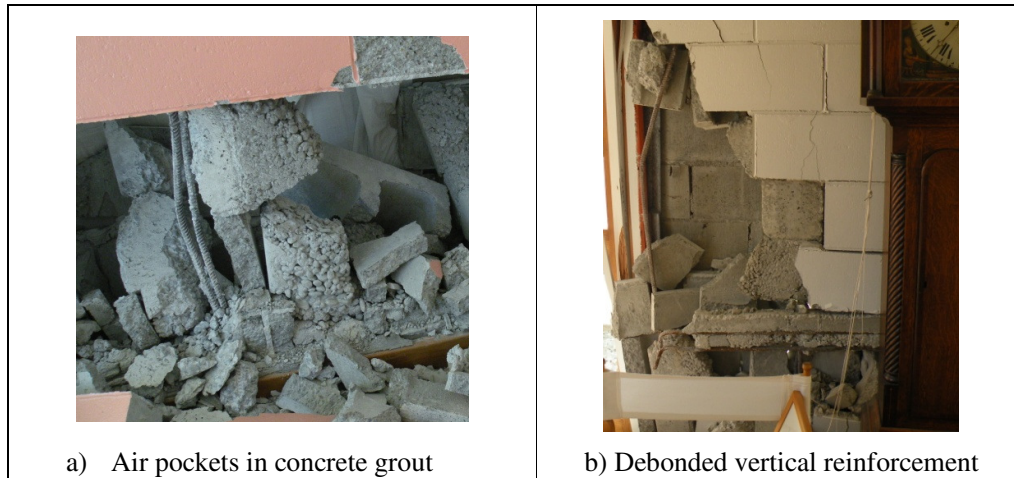
Figure 7. Damage to masonry grouted cells

Many of the failed walls showed poor quality concrete grout. On some occasions, grout presented a honeycomb shape indicating formation of air pockets due to poor compaction (Fig 7a). In other cases, in portions of a wall with toe crushing failure, the vertical reinforcement was found debonded from the surrounding grout and often buckled (Fig 7b).
