# GI 199 and 2011 Mineral, VA Earthquake Impact to North Anna Nuclear Power Plant

**Yong Li & Kamal Manoly**  
*US Nuclear Regulatory Commission*

### 2011 Mineral, VA earthquake's impact to the North Anna nuclear power plant

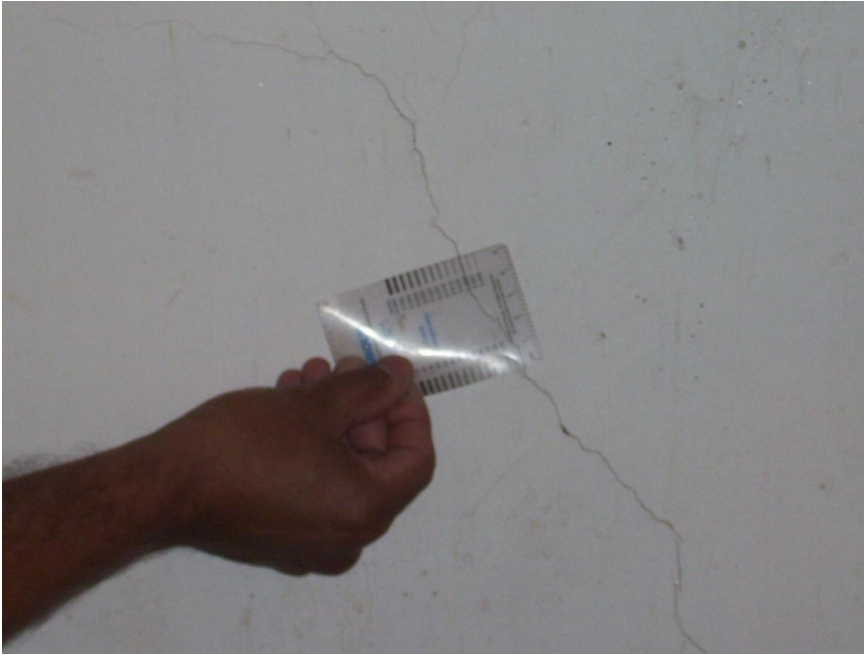
Common damages observed were cracks on interior walls and those cracks occurred mostly inside non safety-related structures. There are generally two types of cracks in terms of their orientation on the affected structural elements. One is horizontal and the other is inclined, and those cracks are generally hairline cracks (Figure 2). Most horizontal cracks were either developed from pre-existing weaker interfaces, for example, construction joints between lifts and in some cases between the ceiling and the wall. These cracks did not affect the structures' functionality.

Figure 2. Inclined crack on the internal wall of turbine building. The width of the crack is about 0.25 mm

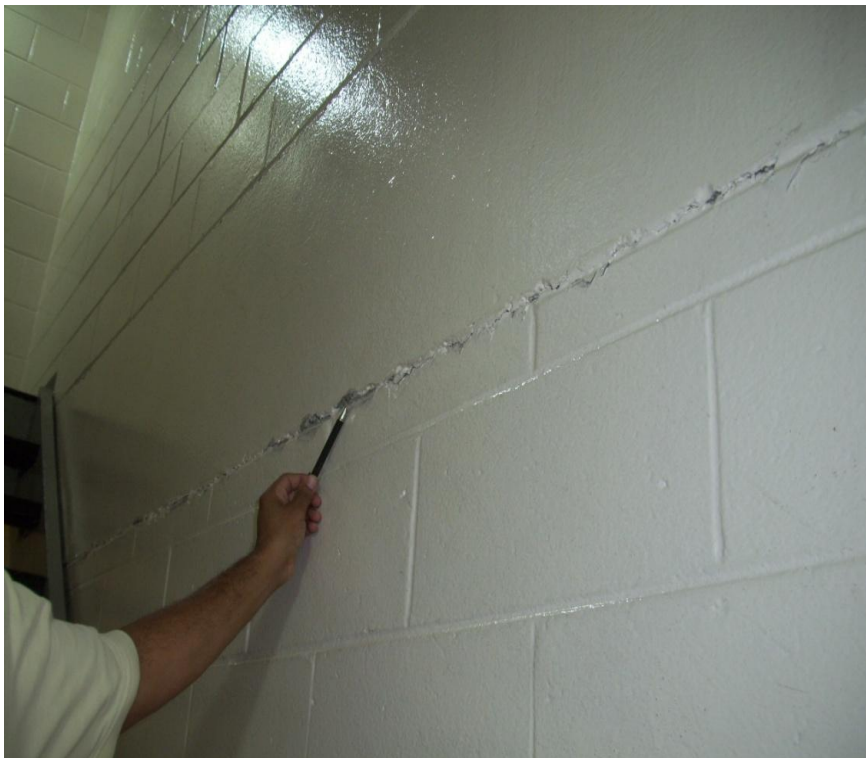
Figure 3. Horizontal cracks developed from construction joints between lifts in the Auxiliary building.

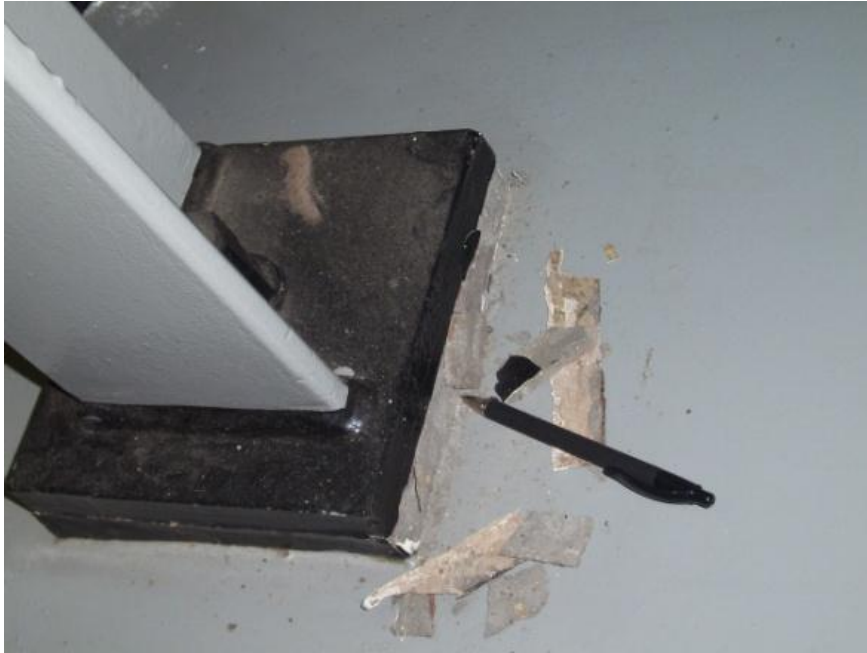
Spalling was also observed at some tank bases (Figure 4), and those base plates were anchored to the floor. However, some small displacements occurred at other support bases which were not anchored.

Figure 4. Spalling at an anchored Phase Separator tank base.

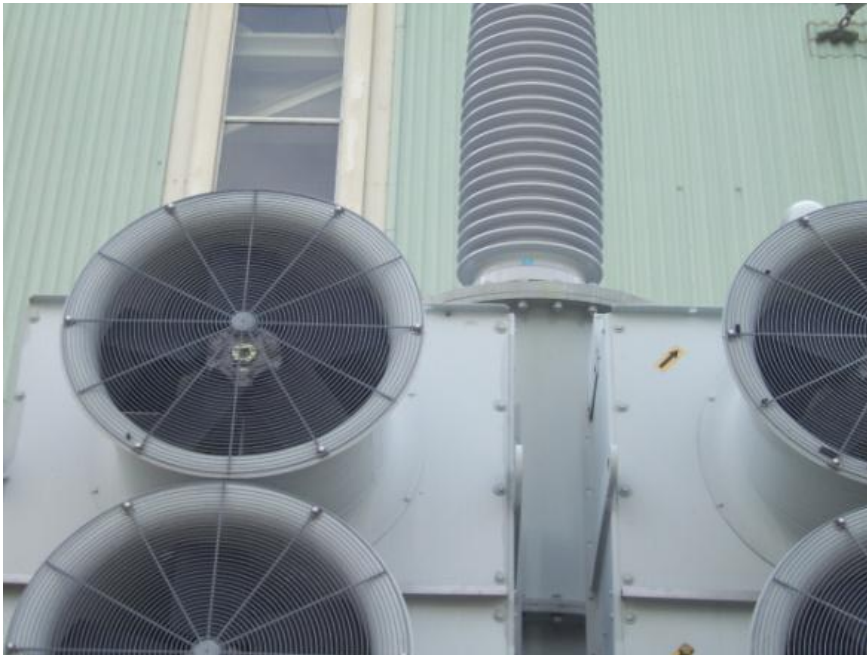
Figure 5. Transformer's bushing and the flange

Transformers (located outside of turbine building) were damaged due to the earthquake (see Figure 5). The transformer bushings are made of porcelain and they are in contact with metallic flanges. These heavy bushings projected out from the transformer with one end fixed and the opposing end free to move during vibration, which resulted in cracks of those bushings. The damage to transformer's bushings caused the loss of offsite power. However, all four emergency diesel generators automatically started to provide cooling to the plant.

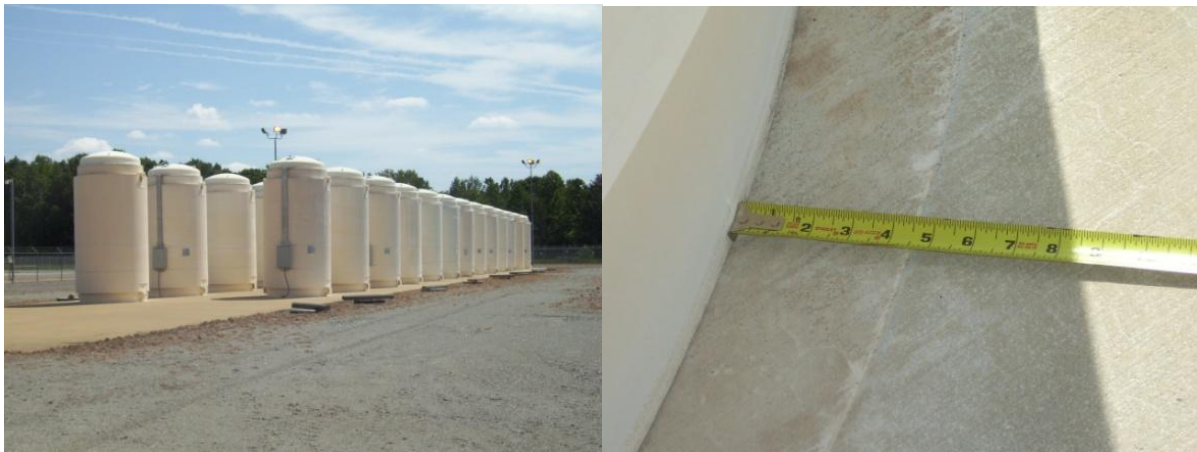
There are two types of dry casks at the NANPS site to store nuclear spent fuel: TransNuclear vertical cask and NUHOMS horizontal cask. Both types of casks were impacted by earthquake ground motion. Each TransNuclear cask weighs about 115 Tons when loaded. Twenty five (25) out of twenty seven (27) of the TransNuclear casks experienced different amounts of movements and the largest displacement is 11.4 cm (Figure 6). In addition, there are twenty six horizontal NUHOMS casks and half of those casks were empty. Gaps between some of the casks changed slightly and spalling was also observed at the roof vent of cask structures (Figure 7). Sensors installed inside the casks indicated that no change to radiological conditions occurred and these conditions remained normal.

Figure 6. TransNuclear casks at the NANPS (left) and some of the casks were moved as far as 11.4 cm (right).

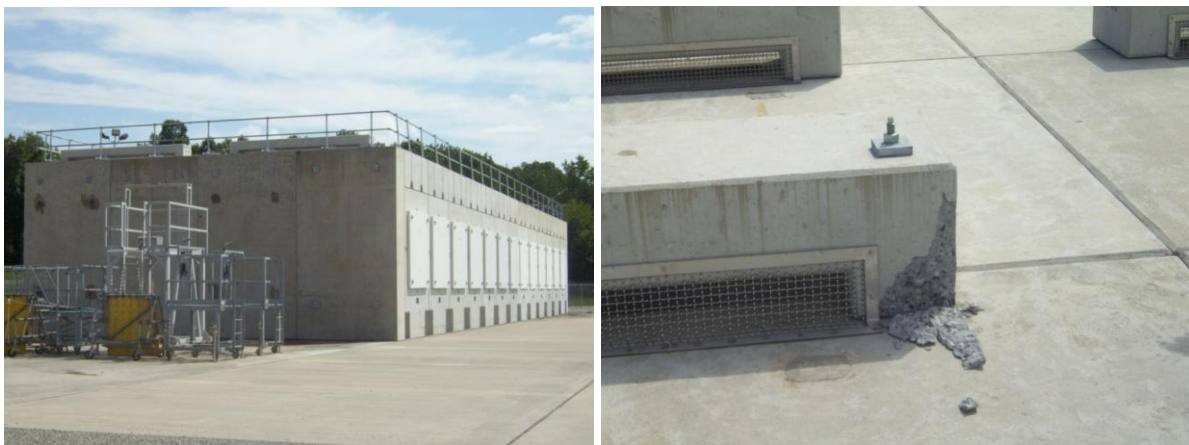
Figure 7, NUHOMS dry casks at NANPS plant (left) and the spalling damage at the top of cask (right)
