Damage to Steel Educational Facilities in the 2011 East Japan Earthquake: Part 1 Outline of the Reconnaissance and Damage to Major Structural Components

SUMMARY:

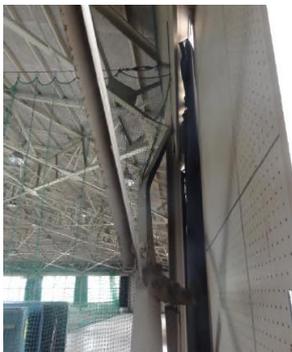
Typical damage observed in angle braces is shown in Figures 4.3, 4.4, and 4.5. Figure 4.3 shows the buckling and yielding of an angle brace, and Figures 4.3 and 4.4 show fracture at the brace connection. In the current Japanese building standard, the brace connection, including the bolt, weld, and gusset plate, is required to have a higher ultimate strength than the yield strength of the brace’s effective cross section in order to ensure ductility of the structure. The fracture of the angle brace was exclusively observed in buildings constructed before 1981 and these brace connections conceivably didn’t meet the demands of the current building standard.

Figure 4.3. Buckling and yielding

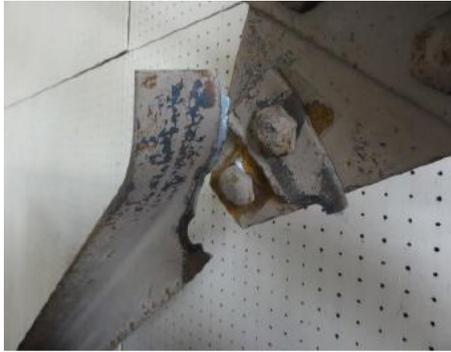
Figure 4.4. Pull out fracture at the end

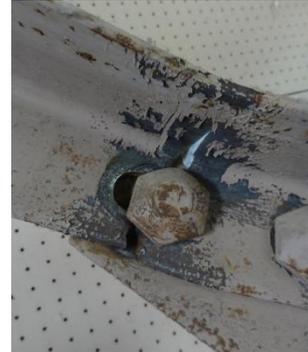
Figure 4.5. Net section fracture

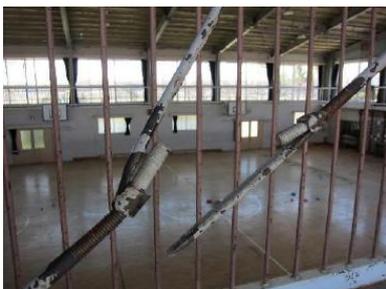
Typical damage observed in round bars with a turnbuckle is shown in Figures 4.6, 4.7, and 4.8. The brace fractured in 28 out of 44 buildings, and this ratio is higher than in the buildings with angle braces. Although fracture mainly occurred in buildings constructed before 1981, a case worthy of mentioning is the fracture of a turnbuckle in a building constructed in the 1990s, shown in Figure 4.9. At this time, the usage of Japan Industrial Standard turnbuckle braces for buildings was not common practice, and the ductility of turnbuckle braces wasn’t always ensured. One can assume that the fractured brace shown in Figure 4.9 did not have sufficient ductility. Similarly, the fracture of a tube-section brace shown in Figure 4.10, which was used in a pre 1981 building whose seismic evaluation deemed it unnecessary to retrofit, is believed to have prematurely fractured due to lack of ductility.

Figure 4.6. Fracture at the turnbuckle

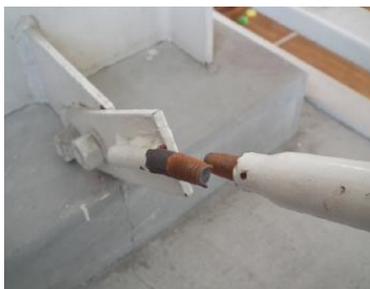
Figure 4.7. Fracture at the screw

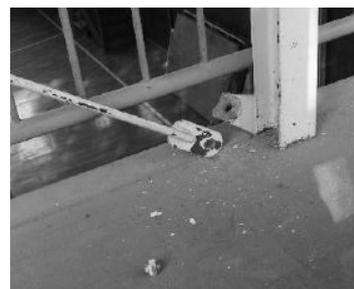
Figure 4.8. Fracture at the bolt

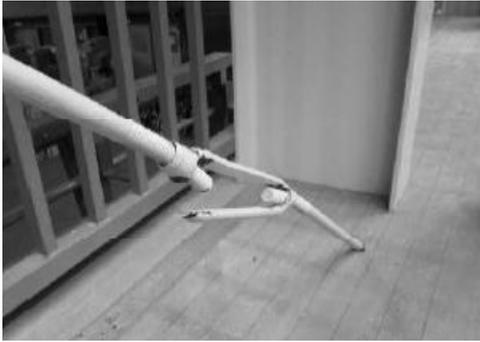
Figure 4.9. Fracture at the turnbuckle

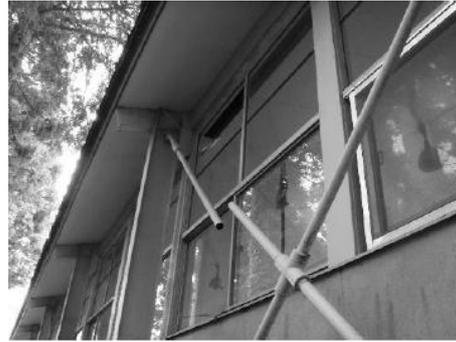
Figure 4.10. Fracture of the tube-section brace

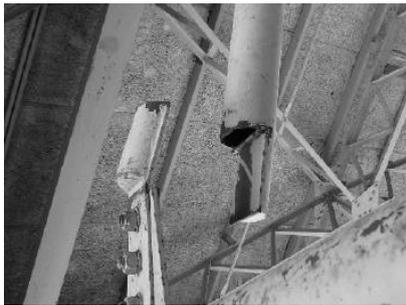
Other types of severe damage observed are the out of plane bending and fracture of the brace joint in Figure 4.11, the fracture of the gusset plate in Figure 4.12, and the fracture of the fillet weld in Figure 4.13. These were observed in buildings constructed before 1981.

Figure 4.11 Out of plane bending

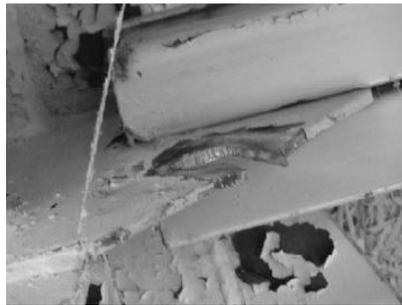
Figure 4.12 Pull out fracture at the gusset plate

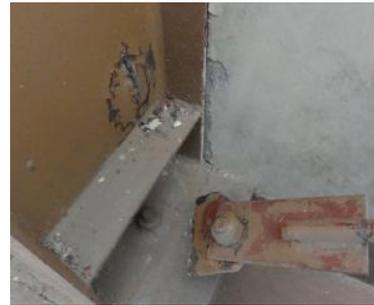
Figure 4.13 Fracture at the weld gusset plate

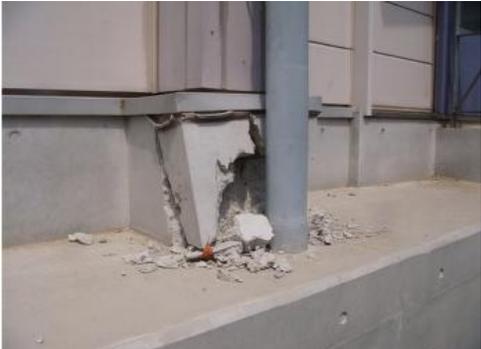
Figure 5.3. Collapse of the concrete

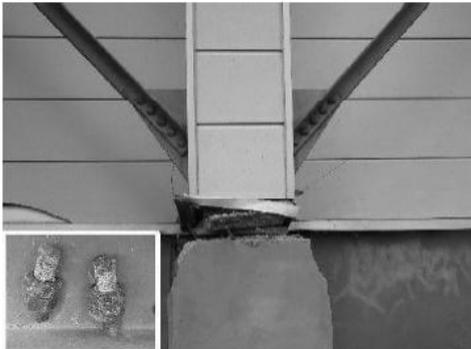
As mentioned in Section 2.2, most of the severe damage was observed at the column bases in the “Post 1981” group. Figure 5.4 shows a fractured column base from a “Post 1981” building. Both elongation and fracture of the anchor bolts were observed. Up till the 1995 Kobe earthquake, the column base had been designed as a pinned connection and elongation of the anchor bolt was not always considered in design. Due to the severe damage that occurred in exposed column bases under the earthquake, a provision to prevent premature fracture of the anchor bolts was added to the Ministry of Construction (currently part of the Ministry of Land, Infrastructure, Transport and Tourism) notification No. 1791 and it has been required to follow this provision in practice since. However, it was not till the 2000s that standards for anchor bolts with ensured ductility were decided on and then manufactured. This is why severe damage has occurred to column bases of the “Post 1981” buildings.

Figure 5.4. Pull out fracture of the anchor bolts

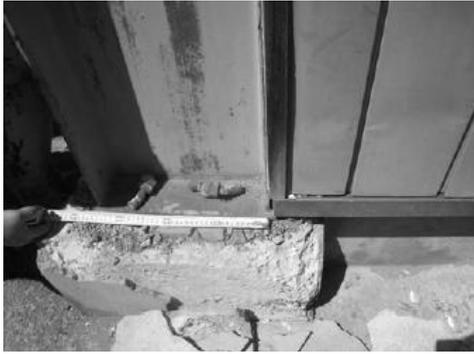
Figure 5.5 shows a fractured column base of a building which did not require retrofit by the standards for seismic evaluation. Figures 5.6 and 5.7 show elongation and fracture of the anchor bolts in “Non-retrofitted” buildings. Fracture at the column base was observed in many buildings constructed in or before 1981, as well as in the “Post 1981” group. Although most failed in tension, some failed by torsion of the column caused by an eccentrically connected brace as is shown in Figure 5.8.

Figure 5.5. Pull out fracture of the anchor bolts

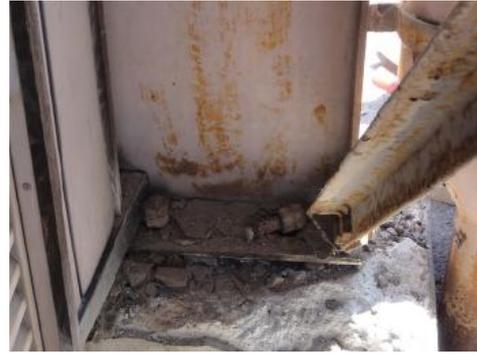
Figure 5.6. Pull out fracture of the anchor bolts

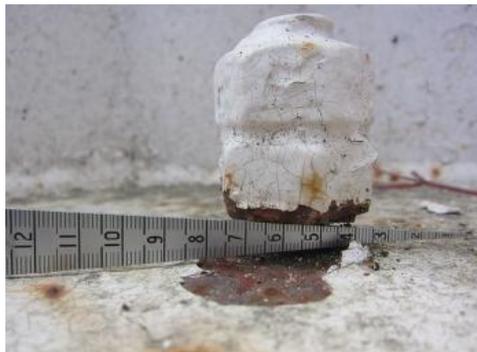
Figure 5.7. Elongation of the anchor bolt

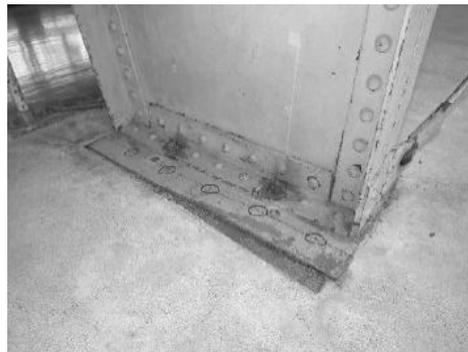
Figure 5.8. Fracture and torsion of the column base

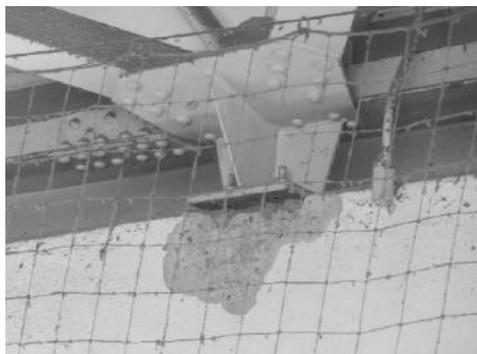
Typical damage of an R-type gymnasium was the collapse of the side concrete at the anchor, shown in

Figure 5.9. In one-third of the R-type gymnasiums, the anchor's damage was ranked as IIs, which includes concrete collapse like in this figure. Figure 5.10 shows the sway of the roof base in an R-type gymnasium. In this case, the anchor bolt was bent and fractured because the amount of sway exceeded the clearance between the bolt and base plate.

Figure 5.9. Collapse of the concrete (R-type gym)

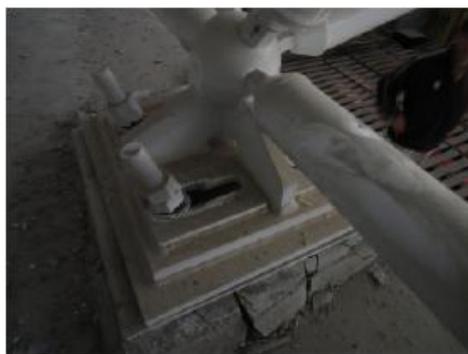
Figure 5.10. Sway of the roof base(R-type gym)
