# Earthquake Damage Assessment of Reinforced Concrete Hotel Buildings in Hawaii

C.C. Simsir, C. Ekwueme, G.C. Hart & A. Dumortier  
Weidlinger Associates Inc., Marina del Rey, CA, USA

This paper presents an evaluation of damage to mid-rise reinforced concrete hotel buildings from the 2006 earthquakes on the island of Hawaii. Designed in the 1960s and 1970s with limited consideration for ductile detailing, the structural system of the hotels consisted of reinforced concrete shear walls, some of which transition to tall columns at the first two stories, providing a large open area for the lobby and the promenade. On-site damage investigation revealed that the buildings had sustained, among other structural damage, substantial cracking of the reinforced concrete shear walls and tall columns during the 2006 Hawaii earthquakes. Visual observations and concrete coring through epoxy injected cracks in the walls revealed the extent and the size of the cracks. Finite element analyses of the buildings revealed the amount and the nature of the cracking damage directly attributable to the earthquakes and differentiated it from cracking due to shrinkage. Numerically predicted regions of overs

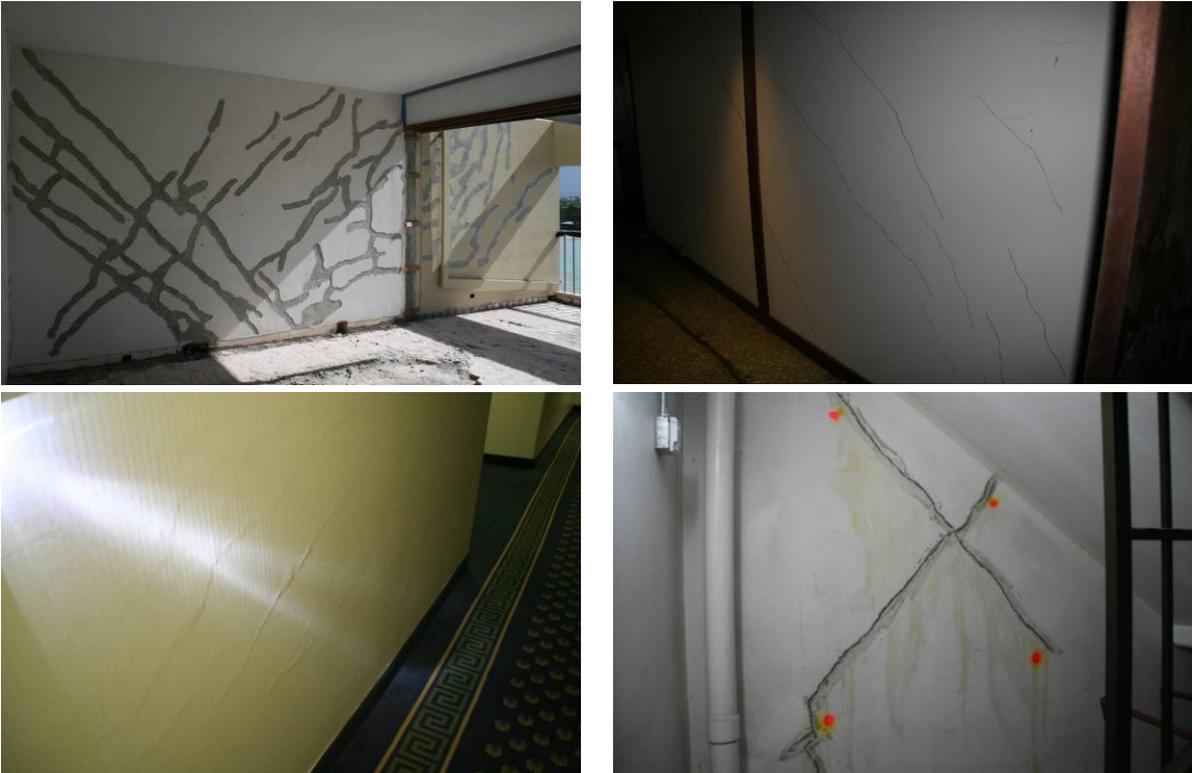
In many of the buildings that were investigated, cracks were observed in the shear walls on all the floors of the building. The wall cracks at the lower floors were primarily diagonal with a few vertical cracks (Figure 4). The wall cracks at the upper floors were fewer and primarily vertical with some diagonal cracks (Figure 5). The cracks in the tall cruciform columns were primarily diagonal (Figures 6 and 7a). Cracking and spalling was observed in other columns (Figure 7b). Buildings in which coupling beams were used between adjacent shear walls sustained damage in the form of crushing of concrete and de-bonding of the reinforcing steel bars from the concrete in the coupling beams (Figure 8); the adjacent shear walls also sustained diagonal cracks.

**Figure 4.** Typical cracking on lower floor shear walls.

Repair recommendations for the shear walls and columns included epoxy injection of cracks, and use of fiber reinforced polymer (FRP) sheets on the reinforced concrete walls in some of the buildings in addition to epoxy injection. Repairs are necessary to recover the strength and the stiffness of the shear walls and columns that was lost due to cracking during the earthquakes and to prevent the long term maintenance issue of cracks re-appearing through the wall finishes over time or during future seismic events. Recommendations were also made to replace the coupling beams and repair other reinforced concrete components and connections that were damaged.

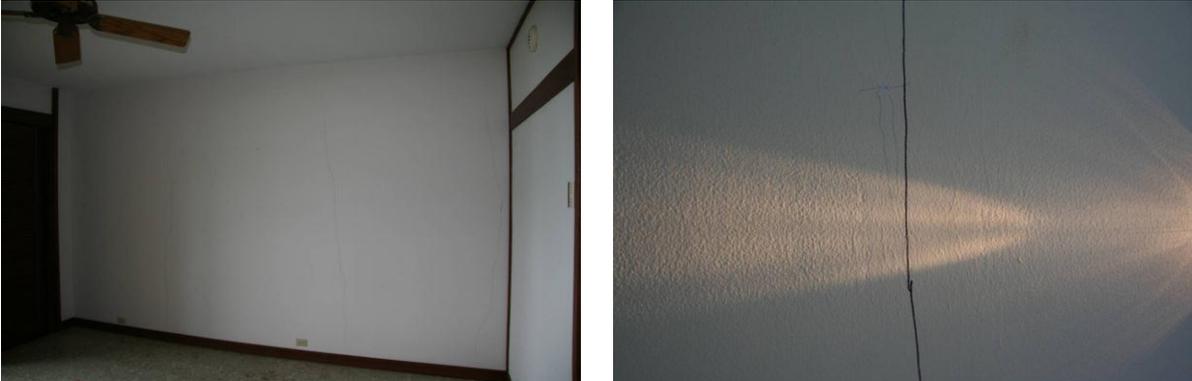
**Figure 5.** Typical cracking on upper floor shear walls.

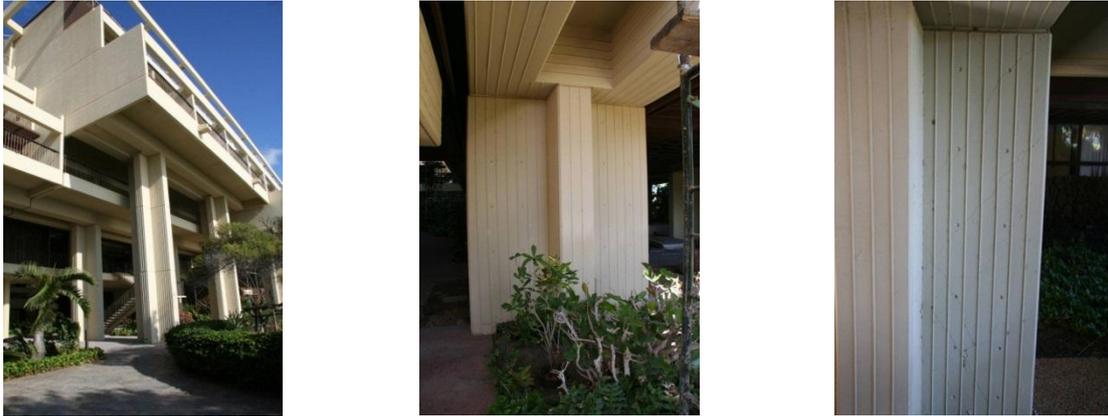
**Figure 6.** Typical cracking in cruciform columns.

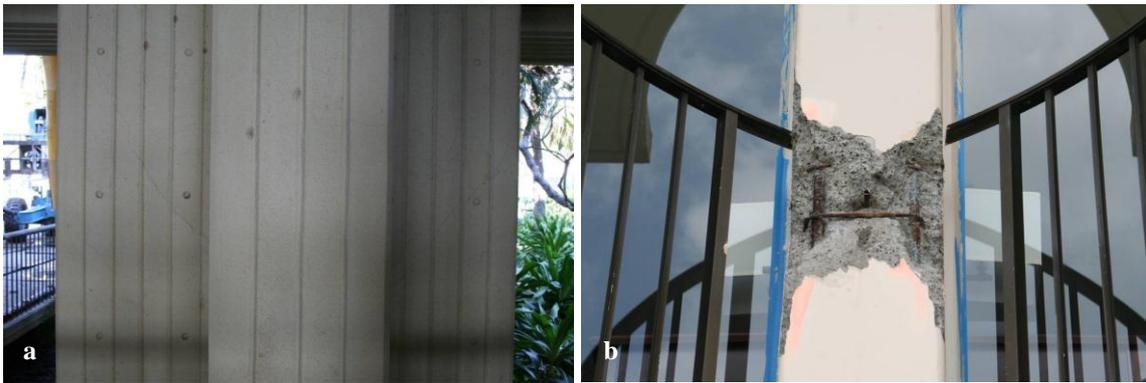
**Figure 7.** a) Typical cracking in cruciform column; b) Concrete column spalling.

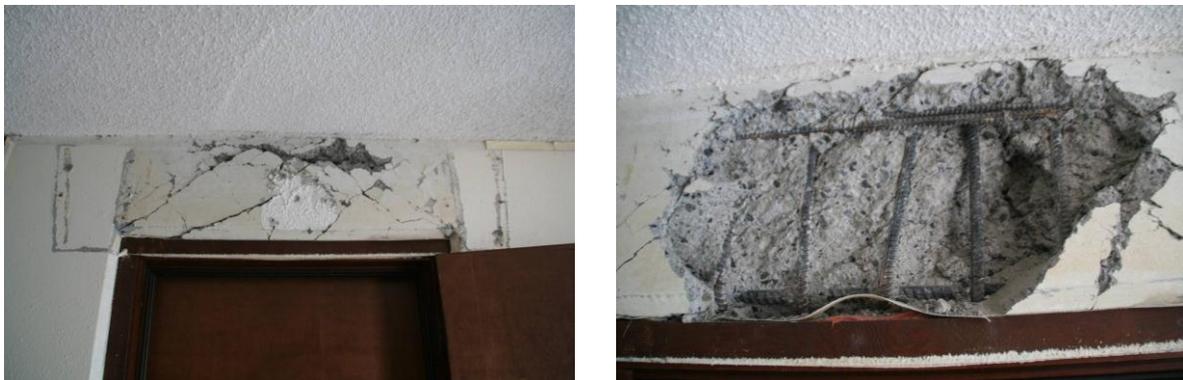
**Figure 8.** Coupling beam damage.

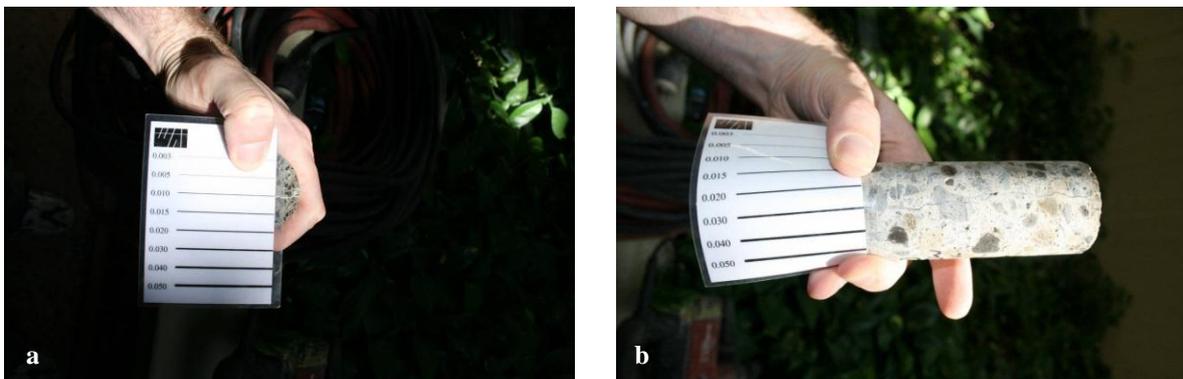
Therefore, the best way to measure the size of the cracks in the walls was to epoxy inject the cracks first and core through the cracks that had been epoxied. The epoxy penetrates the cracks, fills all the voids, and bonds the concrete together. Once the core is removed from the wall, the size of the crack is determined by measuring the width of the epoxy filling the crack. All core samples indicated that the cracks penetrate the entire thickness of the walls and the cracks are wider inside the walls than observed on the surface of the walls through the wall finish. Measurements of the cracks through the wall finishes underestimate the actual size of the cracks. This is illustrated in Figures 9a and 9b in which the crack width was measured as 0.25 mm (10 mils) on the wall finished surface and 0.76 mm (30 mils) along the concrete core, respectively. Figure 10 shows that a wall crack measured to be 0.08 mm (3 mils) on the finished surface was measured as 0.25 mm (10 mils) on the bare concrete surface without the painted finish.

**Figure 9.** Crack width on wall surface (10 mils) versus inside the wall along concrete core (30 mils).

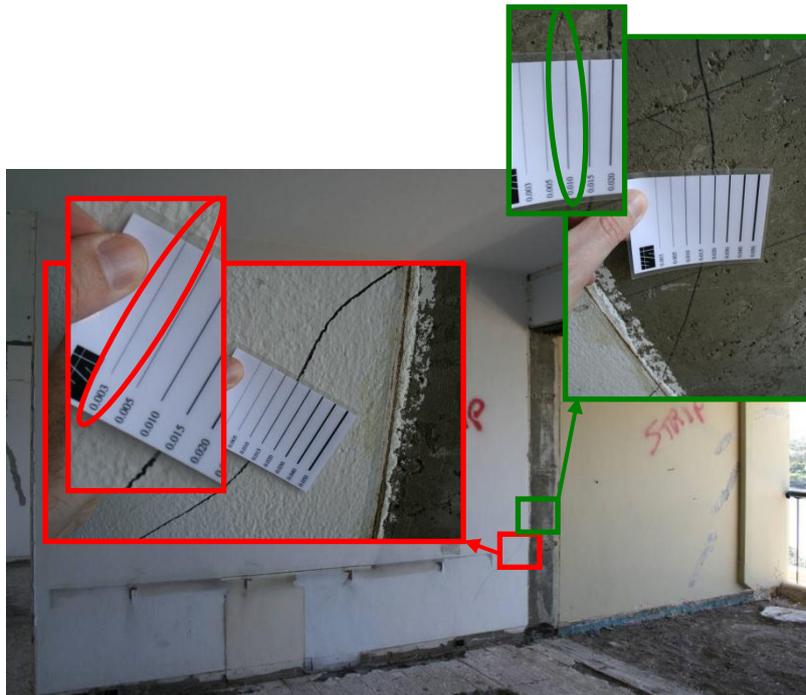
**Figure 10.** Crack width on finished wall surface versus bare concrete surface.

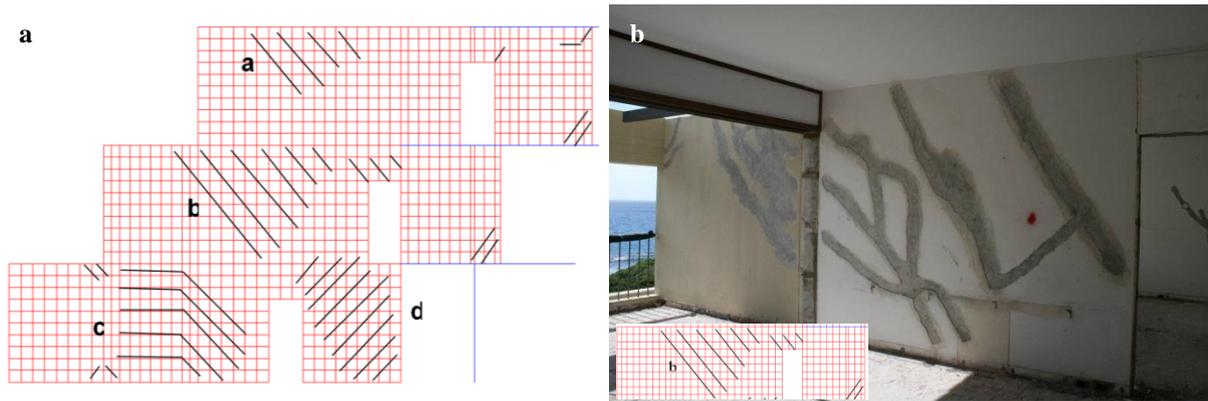
Figure 14a shows the location and direction of the expected cracks in the shear walls based on stress contours and arrows such as those shown in Figure 13. Cracking is typically along the direction perpendicular to the principal tensile stress direction. Figures 13 and 14a show that the stresses are greater and more widespread and the cracks are more severe in the lower floor walls than the upper floors. Stresses in the shear walls were sufficiently large to cause yielding of the reinforcing steel bars on the lower floors in some of the buildings. Figure 14b compares the pattern and direction of the observed cracks in a shear wall with the results of the computer analysis, indicating that most of the cracking is attributable to the earthquakes.

**Figure 14.** a) Location and direction of expected cracks; b) Comparison of analysis results to observed damage.

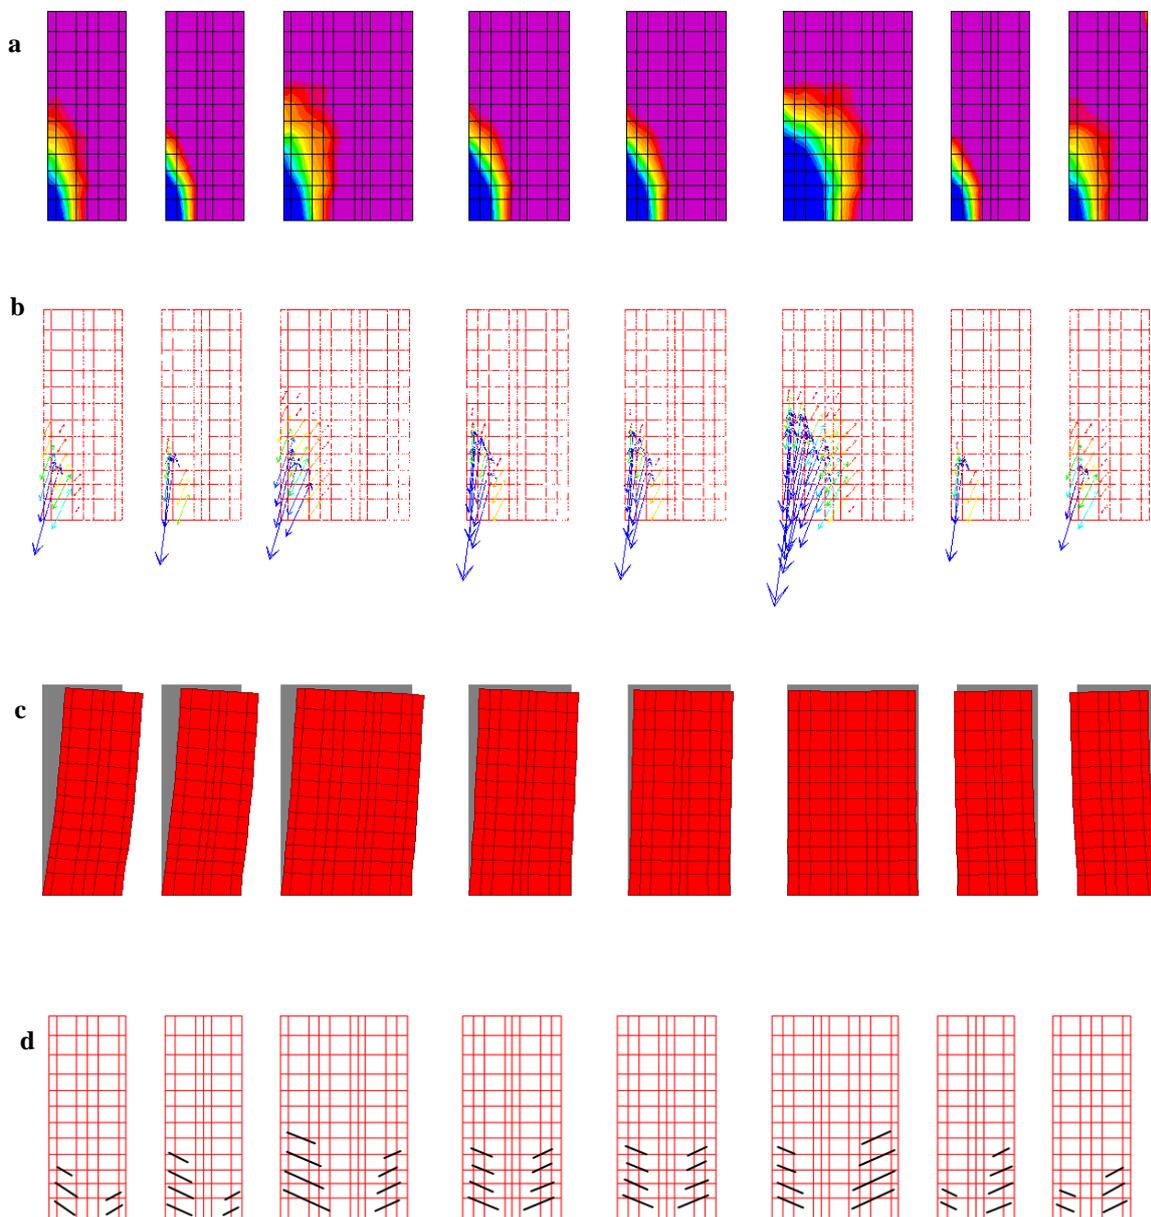
Figures 15a and 15b show stress contours and stress directions, respectively, for a series of wall piers along the building's longitudinal direction subjected to gravity and earthquake loads. Figure 15c shows the deformation of the same walls due to shrinkage effects such that the exterior sides of individual wall piers have tensile deformations while their interior sides undergo compression. Figure 15d shows the location and direction of the expected cracks in the walls under the combined effects of seismic and shrinkage. The cracks are longer and more numerous at the exterior sides of individual wall piers because the shrinkage effects intensify them, and they are less pronounced at the interior sides of the piers due to opposite shrinkage effects.

**Figure 15.** a) Stress contours; b) Stress directions; c) Shrinkage deformations; d) Expected cracks.
