# Damage Pattern during Sikkim, India Earthquake of September 18, 2011

**M.L. Sharma, B.K. Maheshwari, Y. Singh & A. Sinvhal**

*Indian Institute of Technology Roorkee, Uttarakhand, India*

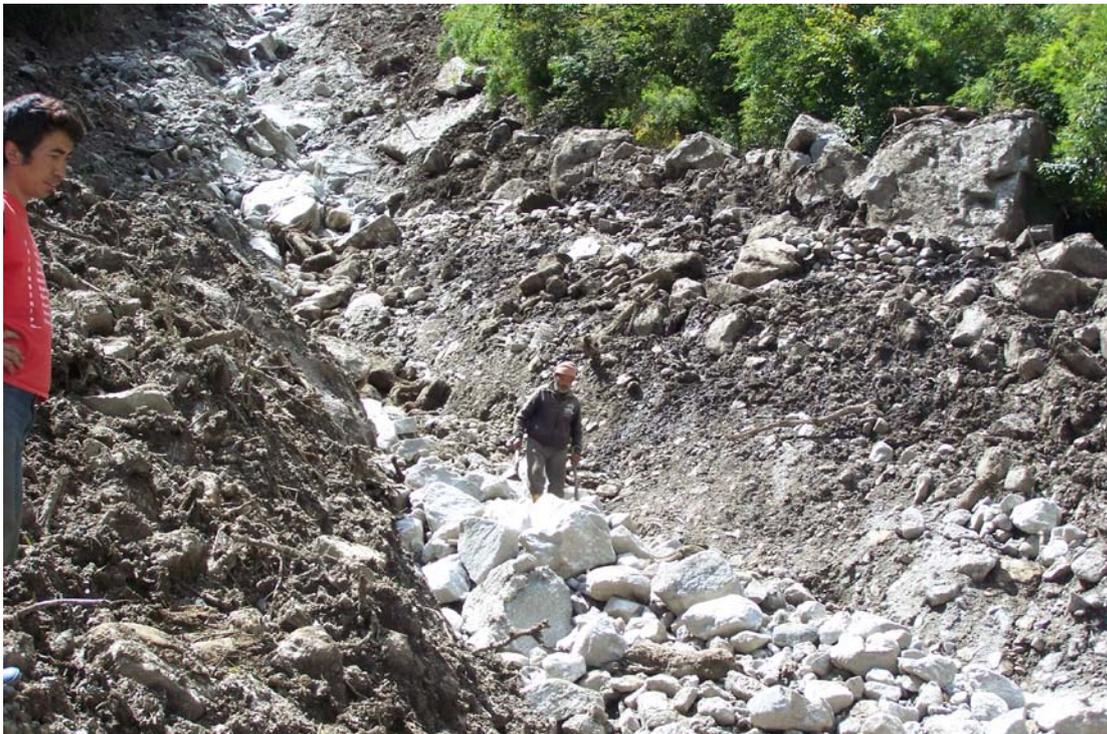
**Figure 4.1.** Massive mudslide in Singring, Lachung (North Sikkim)

Fig. 4.1 shows a mudslide in Singring, Lachung (North Sikkim, shaking intensity VIII+). Due to incessant rain followed by earthquake, a water stream changed its path and created a new stream. This phenomena is known as Landslide Lake Outburst Flood (LLOF). In this stream, water flown at such a high velocity that debris of rock also flown with it and created mud mountains at both sides of this stream. This may be attributed to reduction in strength of rock material due to saturation (Kramer 1996) and then it slid due to earthquake force carrying huge boulders and rock pieces with it. The locals were trying to divert the path of this new stream as it poses threat to the buildings at downstream. There were massive landslides in other parts of the Sikkim too.

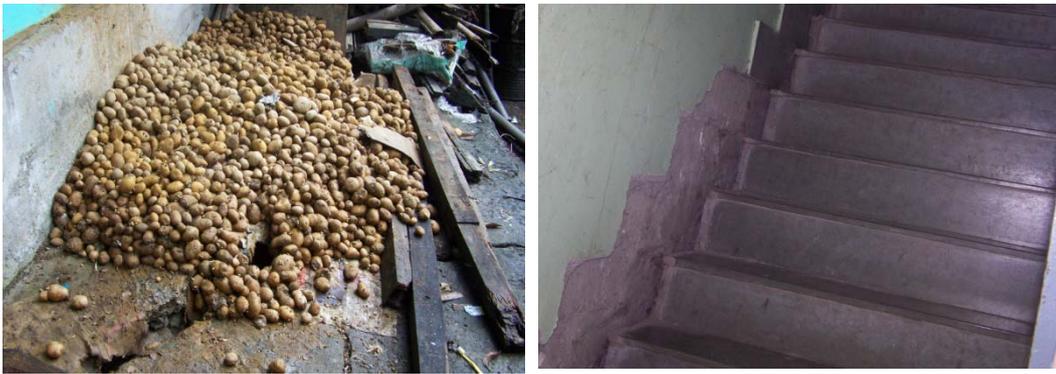
In hilly areas, normally toe line of multi-storey buildings are founded on loose soil which is supported by a flexible retaining wall. Due to earthquake, many of these retaining walls damaged which led to failure of supporting foundations. Fig. 4.2 indicates collapse of retaining wall in Ranipol, Gangtok, (intensity VII) where this failure damaged a building. It was observed that the retaining wall on the backside of the building has wide cracks with a gap of more than 15 cm. The cracked portion of retaining wall has moved away from the building, creating a wide gap. Due to earthquake, the stair case separated from the wall of the building by about 15 cm. It was observed that this failure of retaining wall was up to a considerable distance on both sides of the building.

**Figure 4.2.** Failure of a retaining wall in Ranipol, Gangtok (East Sikkim)

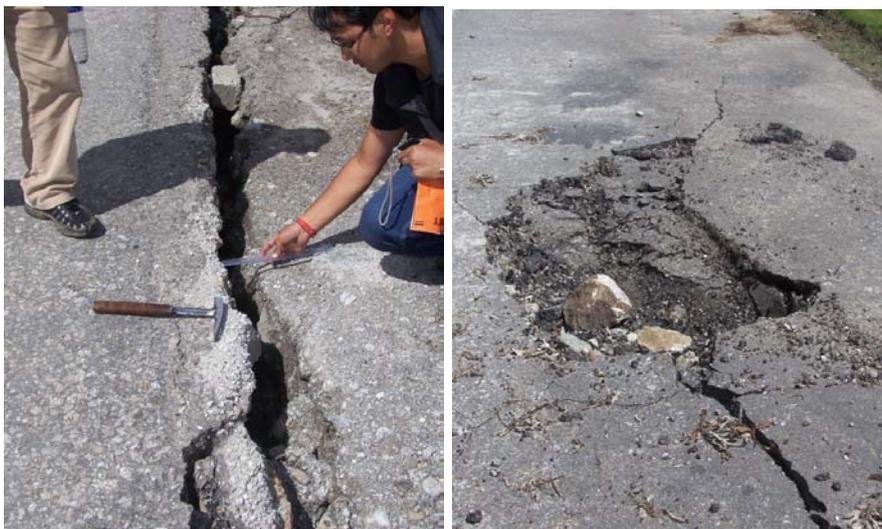
**Figure 4.3.** Ground failure and damage to roads in Lachung (North Sikkim)

In Lachung, wide cracks with a gap of about 20 cm were observed on the road (Fig. 4.3a) which can be attributed to the failure of backfill on riverside. Also the road was damaged due to falling of heavy rock pieces (Fig. 4.3b). This ground failure in Lachung indicated high intensity of shaking (VIII+).

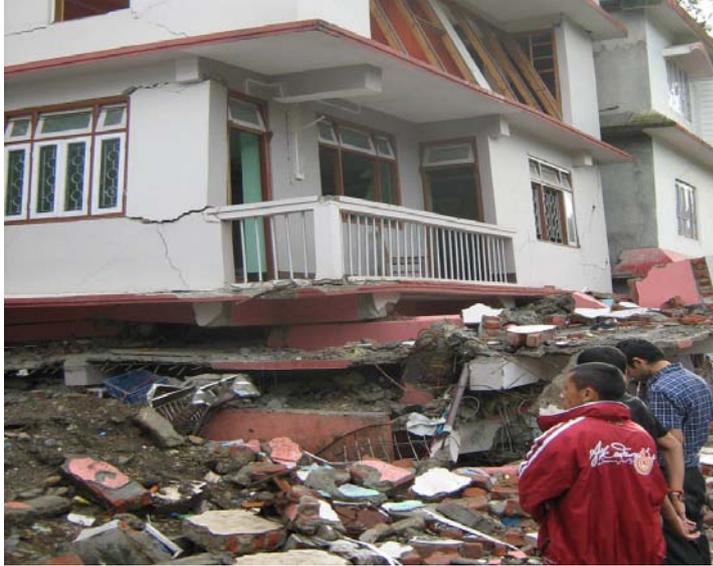
**Figure 4.4.** Collapse of ground and first floor of a building in Jorhang (West Sikkim)

The damage survey was carried out in Jorhang (West Sikkim) which is located on the terrace of Rangit River. Jorhang has epicentral distance about 66 km and intensity assigned is VIII. One of the buildings in Jorhang was totally damaged (Fig. 4.4) in which 2 of the floors (G+1) were collapsed. As the ground floor of the building is completely collapsed, perhaps this is due to foundation failure which may be due to excessive settlement caused by shaking. However, the foundation of the building could not be inspected.

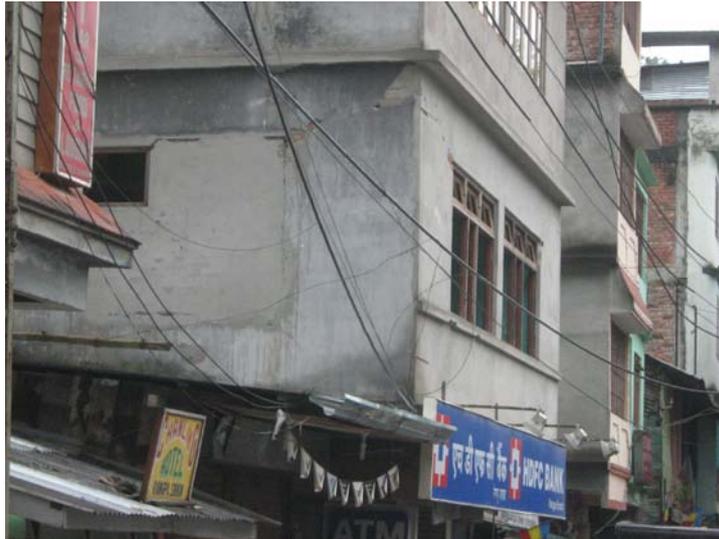
During the survey, several buildings were visited in Rangpo (intensity V-). This is the place where the permit is issued to the visitors for visiting Sikkim. Two of the buildings which were constructed on the slope of the mountain down side of the road towards the Teesta River were inspected for the reported damage. One of the buildings was the Godown used to store the waste material. These buildings were found to have minor cracks as shown in Fig. 5.1

**Figure 5.1.** Minor cracks in the building in Rangpo (East Sikkim)

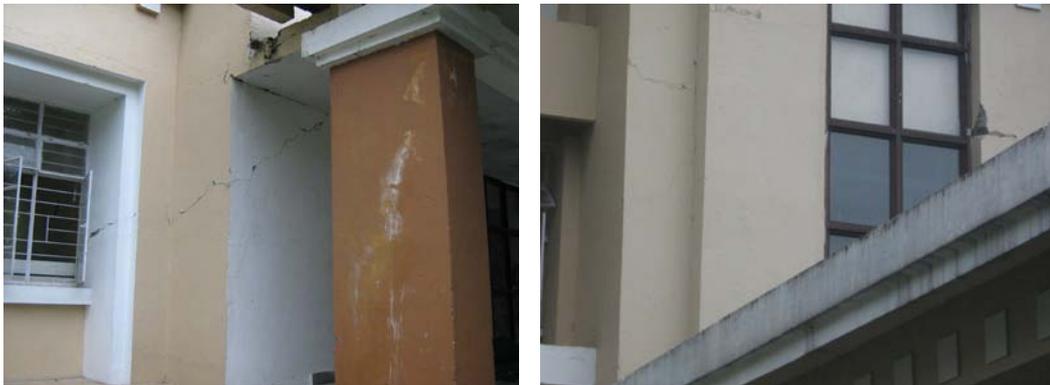
Sikkim Manipal University at Majitar (intensity VII) was visited. Some of the cracks were developed on the main entrance as shown in Fig. 5.2.

**Figure 5.2.** Cracks developed at the main entrance of the Sikkim Manipal University, Gangtok

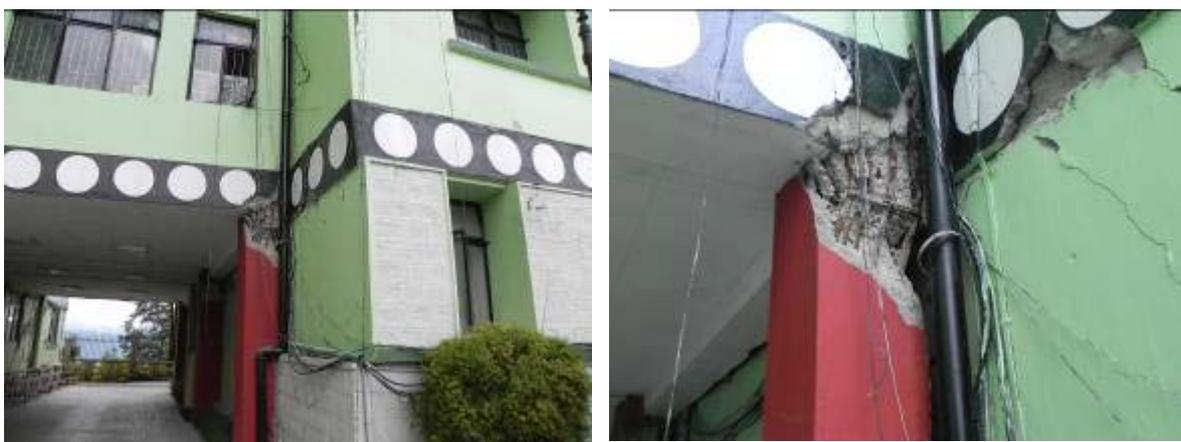
**Figure 5.3.** Column failures at the gap between 2 blocks of the secretariat building, Gangtok

earthquake, also. The building has undergone major damage particularly to the columns at the interface of the two blocks, apparently due to pounding (Fig. 5.3). The infills have been badly damaged particularly at the corners of the building. In Sikkim, it is a practice to provide the infills outside the columns. This makes the corners very vulnerable and the infills fail in wedge type corner failure combined with out-of-plane action.

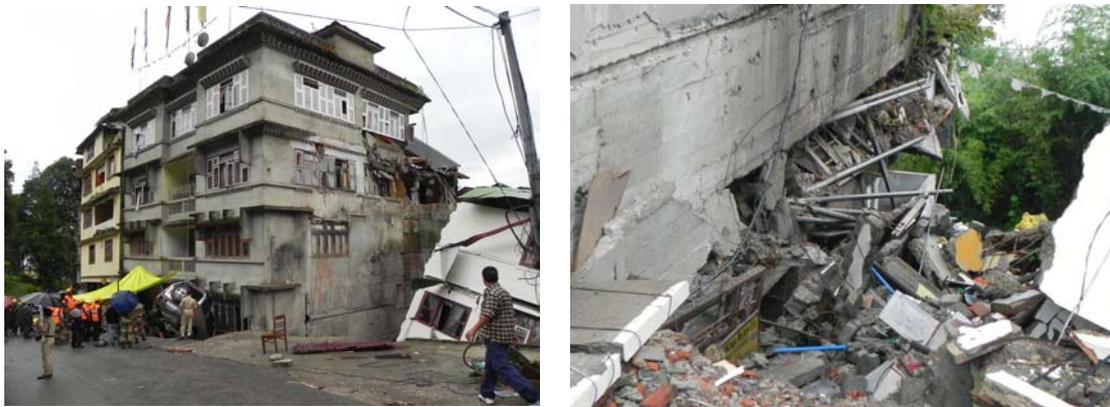
A collapse of a 9 storey building after 3-4 days of the earthquake has occurred in the balokhani area of Gangtok. The RC building has 9 storeys on the downhill side and 4 storeys on the uphill side (above the road). The building survived the earthquake with severe damage to columns of 5<sup>th</sup> storey, which was apparently used for storage and hence kept partition free and acted like a soft storey (Fig. 5.4). It was reported that the building was vacated after the damage due to earthquake but the heavy loads of stored goods from some other buildings on the storey with damaged columns led to collapse after few days of earthquake. A smaller 3 storey RC building, existing adjacent to this building was also pushed and collapsed due to this building. Based on the damage an Intensity VII+ has been assigned to Gangtok.

**Figure 5.4.** Collapse of 5<sup>th</sup> storey of the 9-storeied building and the adjacent smaller building, Gangtok
