Seismic Vulnerability and Retrofitting of Municipal Theatre of Lima, Peru

SUMMARY:

The building of Municipal Theatre of Lima started in 1920. Since then, the structure has experienced at least four major earthquakes and a fire in 1998 had damaged roof of the building. Since 2008 a restoration project that includes a structural retrofitting had been carried out. The Lima's municipal theatre has a plan area of 1190m². It is a concrete structure constructed with a theatre purposes. It has a Hall and Reception salon in front and a Pit area and stage. This five story building has a 17m high. The roof structure was made of steel in area of 396m². The most vulnerable components of the structure were front wall in the upper part and the lateral concrete frames with infill blocks of plaster masonry existing in the second and third floor. Some parts of the concrete frames structure show damage in steel bars due to humidity and poor maintenance.

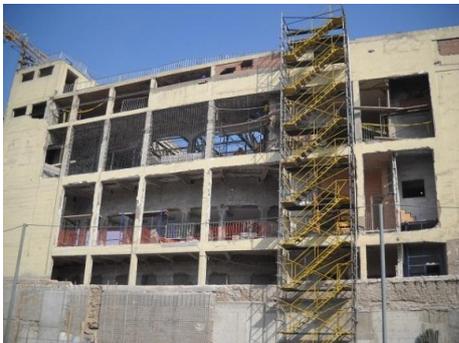
Figure 9. Lateral view

The frames of the axes A and F of the second, third & fourth floor have 10cm infill walls made of brick units of plaster. Some of the beams and columns of these frames have exposed reinforcing steel and an advanced grade of corrosion. (see Figure 9 and 10).

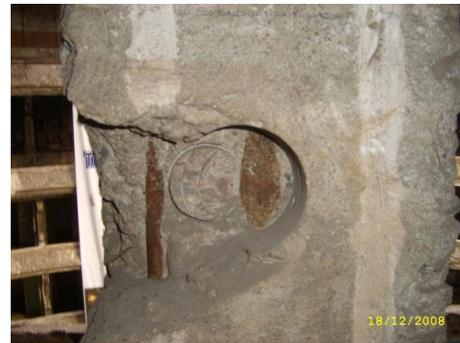
Figure 11. Third floor column

Some columns located at the third and fourth floor of the auditorium area presents shear reinforcement distribution (stirrups) does not reach the standards for concrete in seismic regions (see Figure 11).

The flexural and shear capacity of the third floor columns in the area of audience no reach the seismic demand because of the less shear reinforced and poor concrete quality.

- a) External retrofitting of concrete existing columns: to enhance the capacity of the columns it has been added external steel plates.

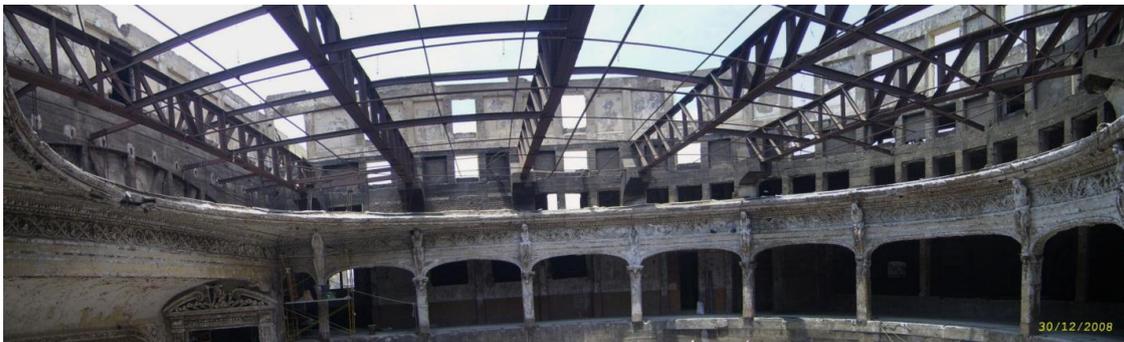
Figure 12. Old steel roof structure of the building.

The roof structure of the theatre were composed by five steel truss that were severe badly damage due to the fire. Above this structure were two wood stories that had been removed. Numerical simulations on the old building show irregularities that affect its seismic response. The retrofitting carried out on the building pretend to correct these irregularities trying to enhance its seismic behavior.

The structure of the theater shows structural damage in specific areas of it. The steel structure of the roof of the auditorium has obvious structural damage by fire (see Figure 12).

The strengthening over the building tries to introduce some capacity to supply its earthquake deficiencies. The concrete walls of the first and second floors have more steel ratio. The columns of the third and fourth floor have been reinforced by external steel plates. Also, there have been some concrete walls between the frames fill perimeter in the third and fourth floors. It has also reinforced the front wall by a steel structure attached to it. The old steel roof has been replaced by a new one.

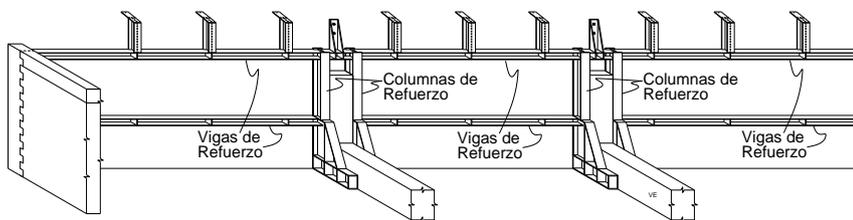
Figure 30. Isometric Draw of the Retrofitting project for the upper part of the front wall of the building.

The front area of the building is better preserved and the one with less damage, however, the 4m height no confined front masonry wall above the upper story presents little horizontal cracks at the bottom showing its seismic vulnerability

The front non confined masonry wall in the upper part of the building have a displacement that reach 4.5cm out of the plane and have no capacity to resist out of plane excitations.

e) Reinforcement of front wall of the building
