Influence of Ageing and Deterioration of Masonry on Load Bearing Capacity of Historical Building

SUMMARY:

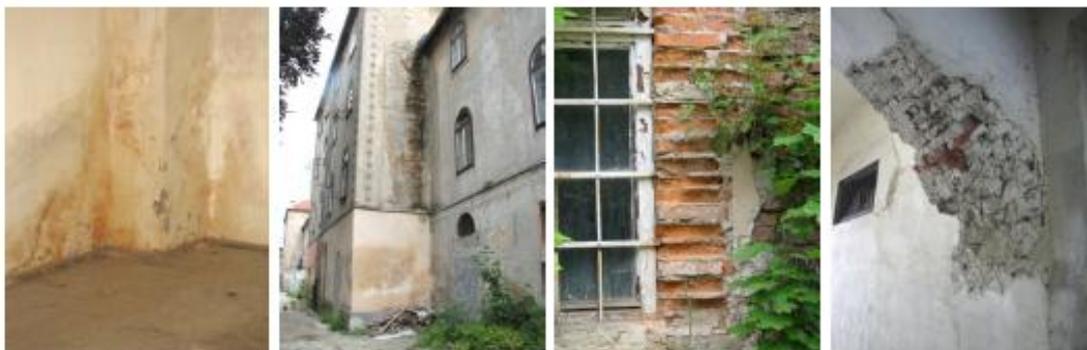
In-situ inspections in 2008 (Bosiljkov et al., 2008) revealed that the load bearing walls and columns were in some parts in very bad condition. Consequences of moisture due to capillary rise, unsuitable introduction of hydro isolation, damaged downpipes and damage due to overloading were obvious (Fig.2). Deterioration due to moisture was extensive throughout the basement and partially in the ground floor, while in the upper floors along drainage at some positions on outer walls. The building was abandoned for at least a decade; therefore neither structural repairs nor proper maintenance have been done recently.

Figure 2. Deterioration due to capillary rise, inadequate drainage, freezing-thawing and overloading

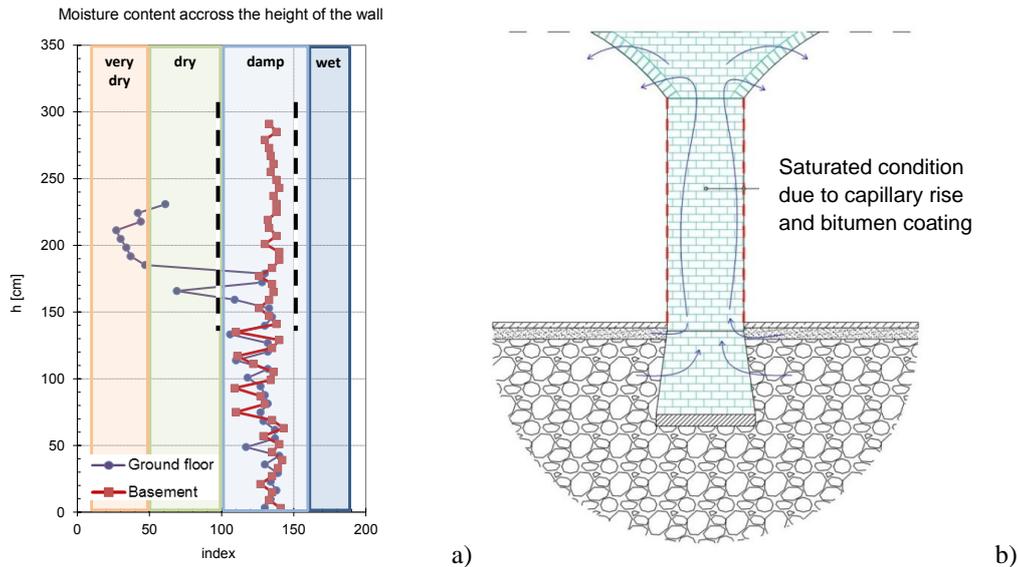
Moisture content of bricks was determined on the basis of drilled brick powder and brick specimens taken from the walls and drying them till constant mass. Moisture content of powder from the basement was 18.9 - 29.6% for exterior walls, and 1.4 - 14.3% for interior columns. In the upper floors the moisture was noticeable lower; 1.3 - 3.3%. Comparison of moisture and water absorption for

On site damp investigation was also done with surface electronic moisture meter. Moisture content was measured in the basement, ground level and the 1st floor. Along the height of the building where in-situ shear tests were done, across the entire basement floor wall and approximately half of the height of the ground floor the masonry was damp, but then in relatively short transition it became very dry as seen in Fig. 4-a. The reason for high level of moisture in the ground level was due to improper introduction of bitumen coating for almost all elements of the basement level (Fig.4-b).

Figure 4. Cross-section of basement column and moisture content measurements across the height of the walls

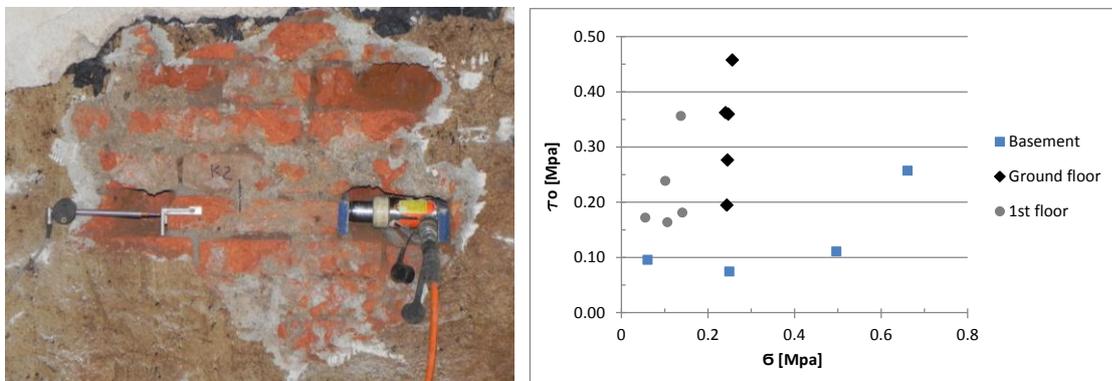
Figure 5. In-situ test setup for shove test and calculated initial shear strengths

Shove tests confirm the presumptions of strength decrease in the basement due to amplified

deterioration because of moisture. Ground and the 1st floor had substantially higher initial shear strength τ_0 . Average values were 0.33 MPa with corresponding average moisture content of 9.7% in ground floor and 0.22 MPa and 5.7% in the 1st floor, while the basement average initial shear strength reached only 0.16 MPa. Initial shear strength τ_0 was lower in the 1st floor probably due to lower vertical load and the change of coefficient of friction in dependence of vertical load and moisture content. The moisture content (measured at testing positions) was not significantly higher in the basement in comparison to other floors, which may imply that not moisture content itself but the long term exposure to moisture with freezing and thawing cycles contributes to amplified deterioration of the bond and mortar.

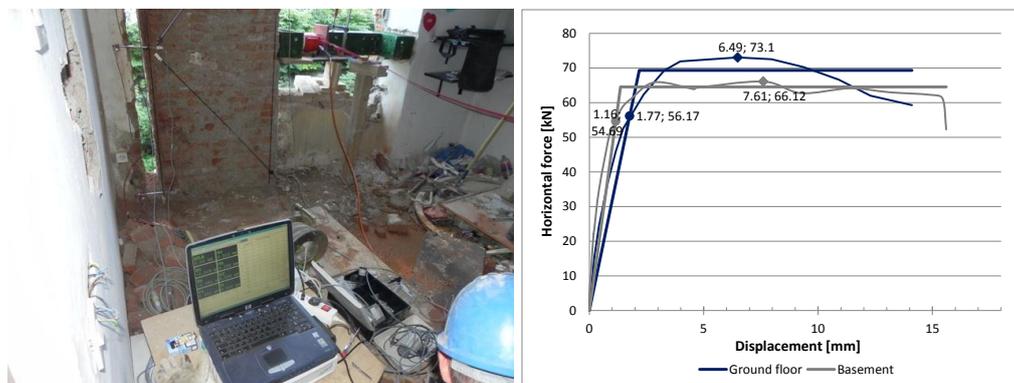
Figure 6. Shear test setup and hysteretic envelopes and idealized bilinear curves for both floors

Reference tensile strength f_t of both walls, calculated considering bilinear idealized curve, clearly shows better state of masonry in normal condition. For the ground level wall f_t was in average 0,072 MPa, while for more deteriorated wall in the basement it was 0.046 MPa, which is 36% less. Ductility and maximum displacements were higher for the specimens in the basement level.

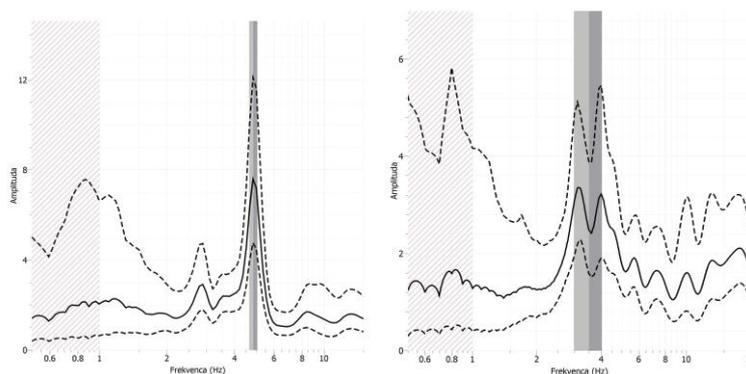
Figure 7. Microtremor measurements (FSR - 1st floor to basement) a) N-S direction, b) E-W direction

Soil frequency measured nearby in previous free-field measurements was 3.3 Hz. Compared with the building's fundamental frequencies; the soil-structure resonance in transversal direction is not excluded.

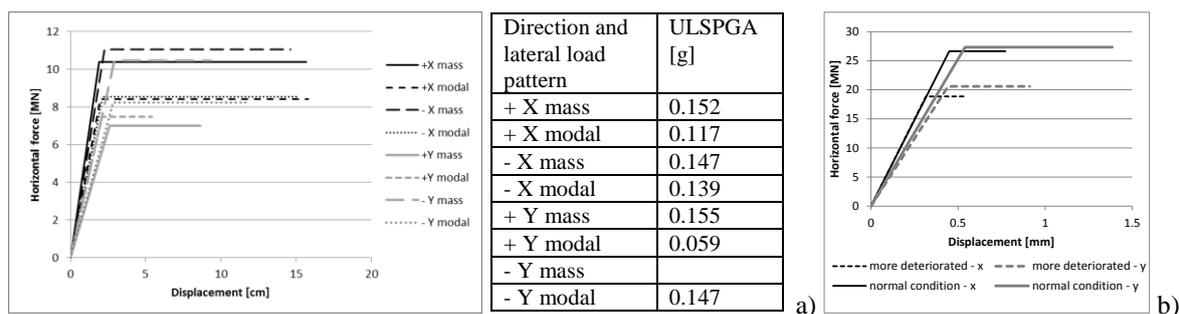
Results with 3Muri show, that in any of the supposed combination of parameters, the Kolizej does not withstand the code demands. Seismic resistance capacity curves for Kolizej with experimentally determined material characteristics for various direction and lateral load pattern combinations are presented in Fig. 9-a. Longitudinal direction is referred as X direction and transversal as Y. As it can be seen from Fig.9-a, the resistance is the lowest in Y direction of the building, furthermore critical is combination with modal lateral load pattern. Hence in all directions modal load pattern is more critical than mass. This indicates that in case of Kolizej the critical storey mechanism model is not the best solution for the assessment of the seismic resistance.

Figure 9. Pushover curves for transversal and longitudinal direction from 3Muri – a) and capacity curves resistance obtained considering normal condition and more deteriorated material with SREMB – b)
