Evaluation of Reinforced Concrete Bridge Columns Repaired with Fiber Reinforced Polymer Laminates Using Shaking Table Experiments

K.M. Mosalam, P. Kumar, H. Lee, M.S. Güney

University of California, Berkeley

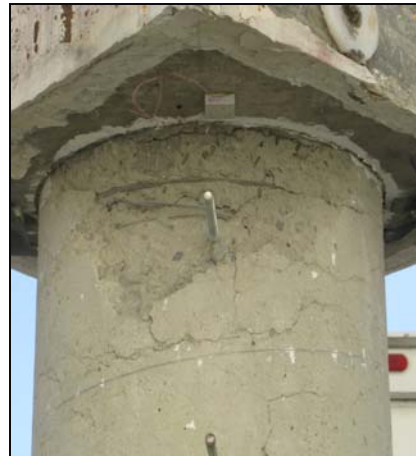
Both as-built test specimens were subjected to the same set of horizontal and vertical ground motions and they developed shear and flexure cracks, with more damage in as-built specimen SP2 compared to SP1, Fig. 2.4(a) and (b). Both damaged columns were repaired by the same standard procedure.

(a) Damage state of as-built specimen SP1

Using the sounding hammer test, loose and unsound concrete was mechanically removed from the columns surface, Fig. 2.4(c). Using wire brushes the exposed parts of the reinforcing bars were cleaned of any rust. Injection ports were installed in all cracks at adequate spacing. Bonding and protection system were applied on cleaned concrete and reinforcement surfaces, Fig. 2.4(d). Voids wider than $\frac{3}{4}$ in. were patched using structural mortar and those smaller than $\frac{3}{4}$ in. were cap sealed using gel/paste epoxy system, Fig. 2.5(a). After the cap seal and patch material were cured, structural epoxy system was injected in all cracks. Multi-port injection system was used with relatively low pressure to prevent expansion and further damage to cracked concrete, Fig. 2.5(b). When injection resin was cured, specimen surfaces were grinded to remove cap seal material and injection ports. Surface was then cleaned of any dust debris and one coat of prime was applied. Four layers of unidirectional GFRP composite system impregnated with structural epoxy system were installed on damaged specimen SP1, Fig. 2.5(c). On the other hand, two layers of unidirectional CFRP composite system impregnated with structural epoxy system were installed on damaged specimen SP2, Fig. 2.5(d). Temporary polyvinyl compression/curing tapes were wrapped on the installed FRP.

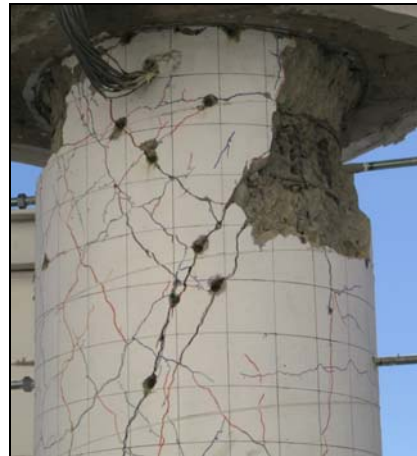
(b) Damage state of as-built specimen SP2

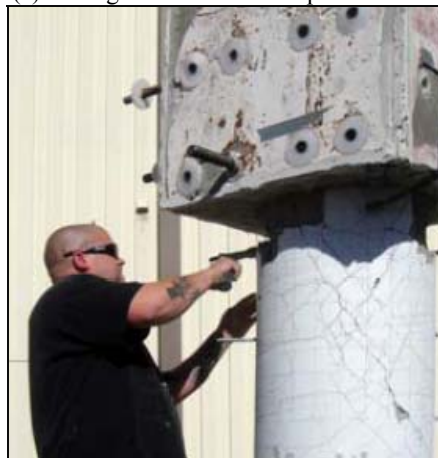
(c) Hammer test to remove loose material

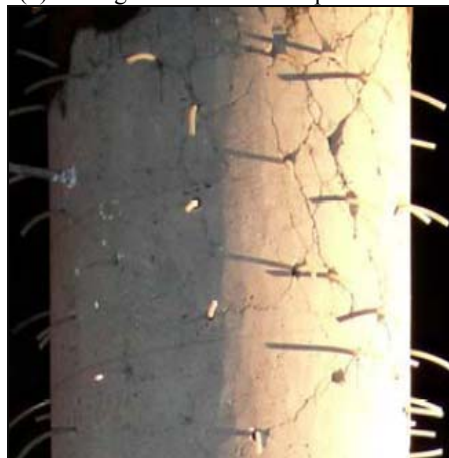
(d) Injection ports in damaged regions

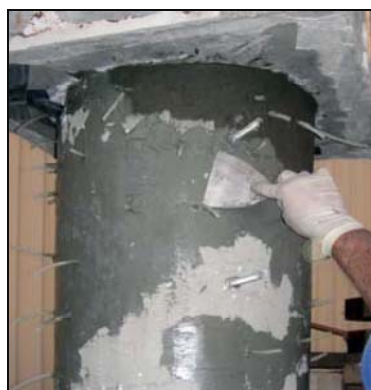
(a) Cap sealing and surface repair

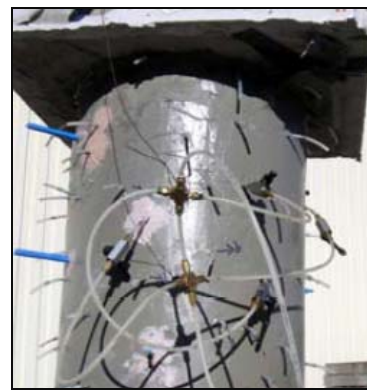
(b) Multiport injection system

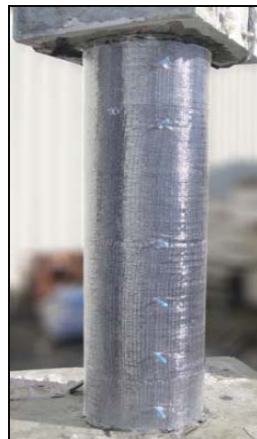
(c)) GFRP repaired SP1

Among the various possible ways of retrofitting with jackets, simple technique of wrapping was chosen. The repair was oriented towards ductility improvement. After testing of the as-built columns, both columns experienced moderate to severe damage. The shear-critical column SP2 had more damage than SP1. Therefore, CFRP with higher tensile strength than GFRP was used for SP2 and GFRP was used for SP1.

To achieve a target drift ratio of at least that of the as-built specimens, i.e. 2% for SP1 and SP2, section design was carried out, requiring jacket thickness for SP1 and SP2 of 0.140" and 0.065", respectively. Since the thickness of each layer of the CFRP and GFRP was 0.04", four layers of GFRP were used for SP1 and two layers of CFRP were used for SP2.

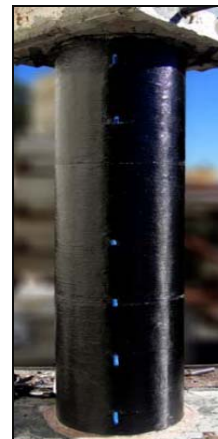
(d) CFRP repaired SP2
