Evaluation on the Structural Safety of Reconstructed Houses in Padang

Krishna S. Pribadi, Dyah Kusumastuti, E. Lim & A. Utami
Research Center for Disaster Mitigation, Bandung Institute of Technology, Indonesia

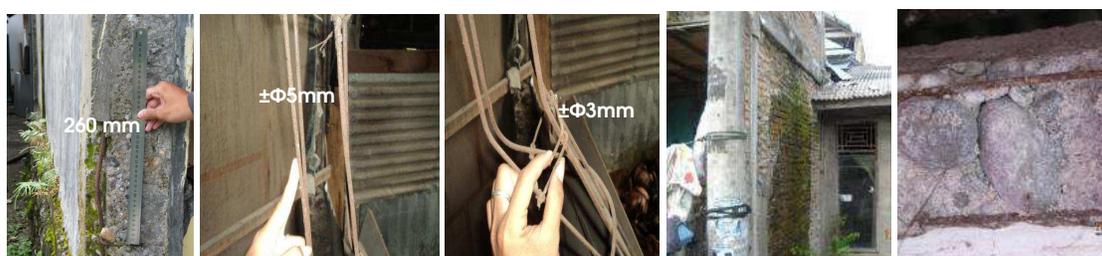
The detailing on non-engineered structures revealed that most buildings used Φ-8 mm reinforcement bar for main rebar and Φ-6 mm reinforcement bar for stirrups. These dimensions do not fulfill the requirements specified in guideline (Φ-10 mm for main bar and Φ-8 mm for stirrups). Moreover the spacing provided in structural elements was too large (200 – 250 mm), compared to the distance stated on the guideline (150 mm) (see Figure 1).

Figure 1: Spacing of stirrups, diameter of stirrups, diameter of main rebar, lichen on bricks & aggregate of damaged concrete (left to right)

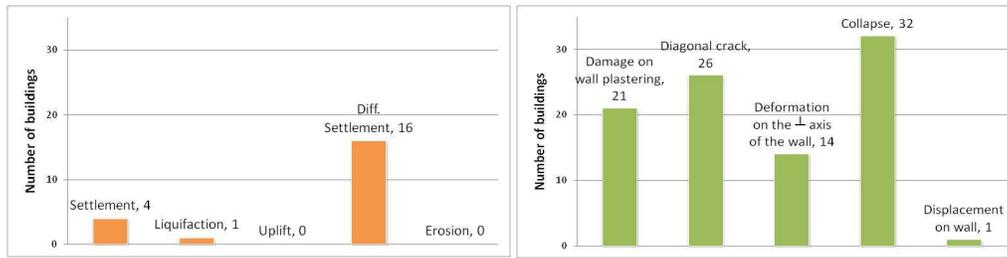
Damage on foundation system was dominated by differential settlement. One of the main reasons for this damage was the adoption of round-shaped stones used as foundation materials, which will have poorer bonding interaction than sharp-edged stone. Poor quality mortar, poor workmanship, unavailability of tie beam, soil condition may also contributed to the damage severity.

**Figure 2:** Types of damage in foundation system (left) and wall construction (right)

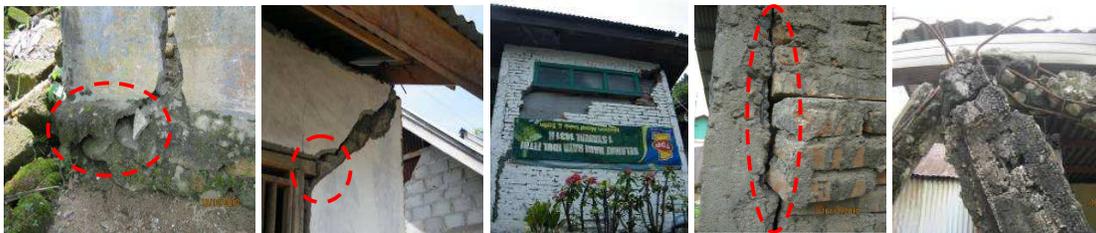
**Figure 3:** Damage on foundation, corner crack, damage on wall, damage on orthogonal wall & damage on beam column connection (left to right)

Wall was found to be the weakest part of the construction since most damage occurred in this load bearing element. Various types of damages, such as damage on wall plastering, crack, deformation/displacement and collapse were observed to be occurred on this element. There are many factors that contribute to damage on wall, such as the poor quality of material, structural configuration, structural confinement from the frame, workmanship, etc. The damages on beam and column were mostly characterized by concrete spalling. The intensity of damage varied from spalling on the outer

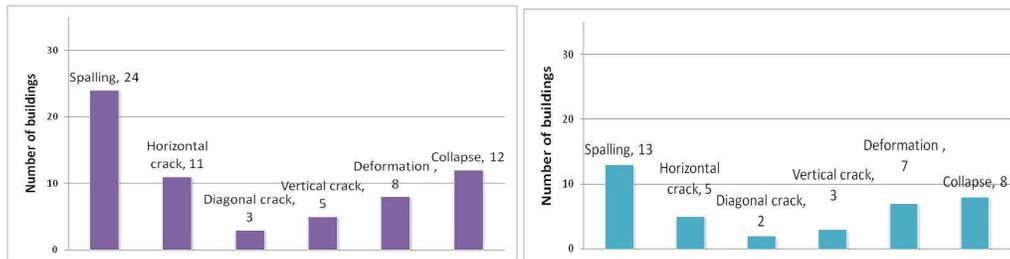
surface to total loss of concrete in the core of elements. Other types of damages, such as crack, deformation and collapse, were observed as well during the survey. The charts in Figure 4 show the number of buildings subjected to those damage. For columns, horizontal and diagonal cracks indicate lateral force caused damage and vertical cracks indicate axial force caused damage. Meanwhile for beams, vertical and diagonal cracks indicate the contribution of gravitational force and horizontal cracks indicate the contribution of axial force. As the principal damage on columns and beams was spalling, the poor quality of concrete and confinement may be the main causing factors. The use of round-shape aggregate and small diameter size and greater spacing of stirrups may be the most possible factors that cause this damage. Similar factors may be the most possible reason of collapse on columns and beams.

Figure 4: Types of damage on column (left) and beam element (right)

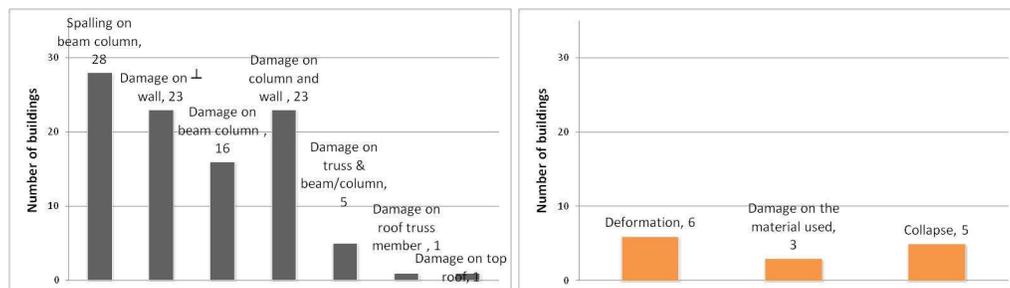
Figure 5: Types of damage on connection (left) and roof (right)

Similar types of damage on column and beam were also found in the damage on the connection between those elements. A significant number of buildings were also subjected to damage between orthogonal wall connection and connection of column and wall. No anchorage with reinforcement bar between the connection of column and wall is the main reason for this type of damage (Figure 3 – second from the right). However, only a small number of damage on roof truss connection and connection of roof truss and beam/column were observed. For roof structure, only a few numbers of samples were subjected to damage. The typical damages on roof were deformation along the span of the roof, damage on roof material and collapse of roof structure.

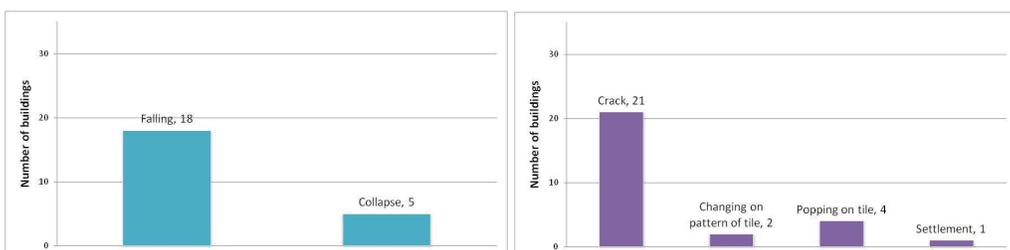
Observation on non structural elements was limited to ceilings, floor and stairs. Many ceilings fell during earthquake, yet only a few of them completely collapsed. Crack was the main damage observed in floors. Popping up and changing pattern on tiles were also observed in some samples as well. Settlement of floor system was uncommon, as shown by the data (Figure 6 and 7)

Figure 6: Types of damage on ceiling (left) and floor (right)

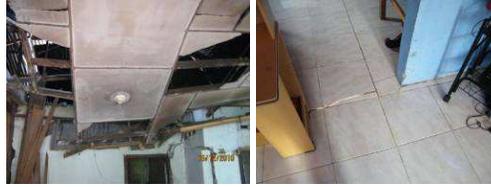
Figure 7: Damage on ceilings and floor

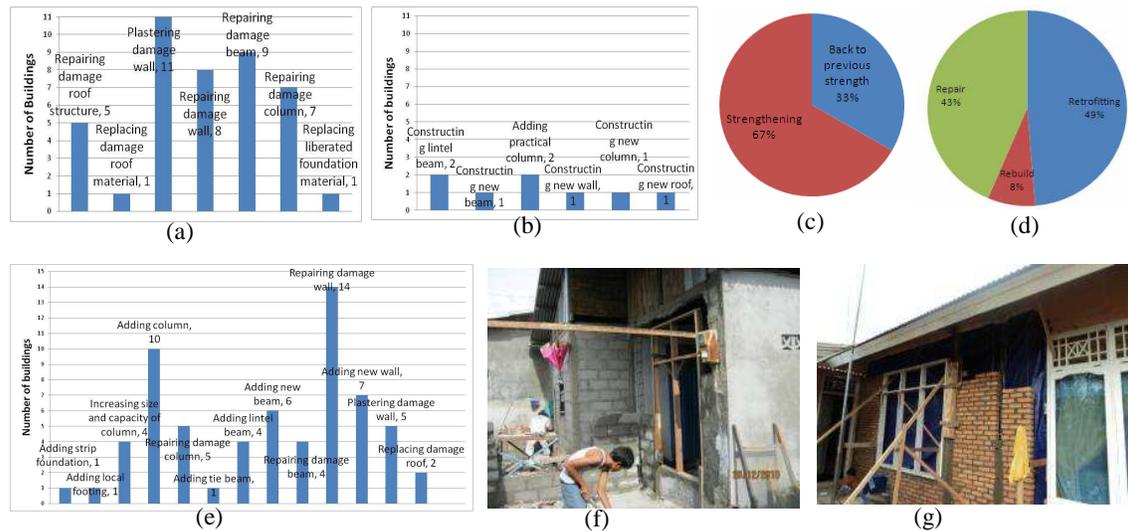
Rebuilding the structure with totally new elements was conducted when the house is totally unusable. In some cases, it was found that the design is strengthened with the use of practical column and lintel beams, which were not available in the original design. According to the information collected during survey, most of the damaged buildings were subjected to repairing and retrofitting. Only a small percentage of samples were rebuilt and most of them were intended to be strengthened (Figure 9d). Although the survey shows that most buildings (67 %) were intended to be strengthened (Figure 9c), further observation reveals that most of the strengthening practices were still questionable. This might be due to the fact that most selected samples had limited or no access to the information on proper construction and detailing of seismic resistant structures.

Figure 9: a) Repair, b) rebuild, c) intension in rebuilding, d) portion in reconstruction, e) retrofitting, f) expanding the structural layout & g) installing new practical column

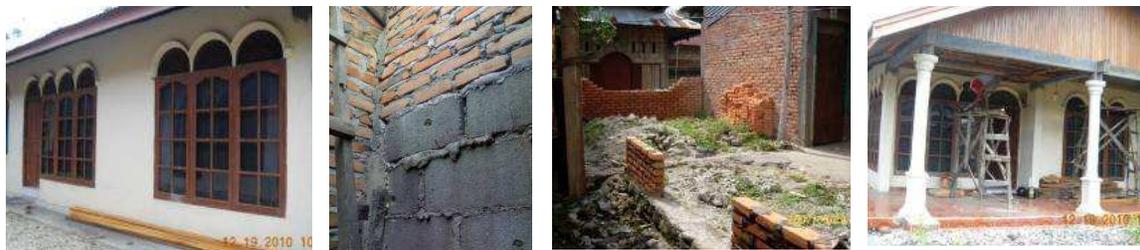
In most samples, no building drawings and specification neither building permits were found. In some sites, the reconstructed houses were even more vulnerable than the previous condition, layout became more irregular due to additional space, with a lot of wall openings. New columns were found installed without ring beams, therefore compromising the structural integrity. Some structures were observed using reinforcement bar of inadequate size and different types of bricks in one panel of wall. In some samples, the utilization of used reinforcement bar (yielded)- (Figure 11 left) in newly constructed structural elements were also found. Pre-cast architectural columns utilized in some structures are considered to be improper because of the questionable strength of the concrete and the way they are connected to the other parts of the building.

Figure 10: Large opening, different wall materials, no tie beam & pre-cast column (left to right)

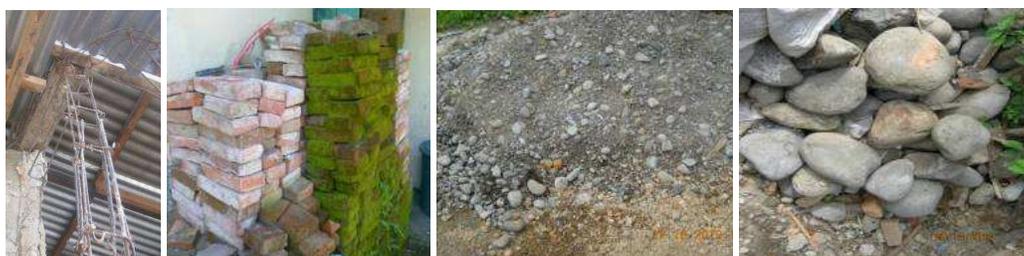
The laboratory test on samples of brick-mortar specimens shows that the average compressive strength was 20.91 kg/cm². This value was below the minimum requirement of 30 kg/cm² based on guideline 2006. In addition, the average yield stress of Φ -8 mm rebar was 369 MPa and the yield stress of Φ -6 mm rebar was 415.93 MPa. In addition, non-destructive test conducted on RC elements during the survey revealed that the average compressive strength of concrete was 182.17 kg/cm², which was below the minimum requirement (243.9 kg/cm²/20 MPa). The use of round-shaped aggregate/pebble and poorly graded aggregate was observed in the sites. In addition, many bricks were observed in poor condition, such as having cracks along the edge and lichens (Figure 11).

Figure 11: Yielded rebar, lichens in brick, poor aggregate & round-shaped pebble (left to right)

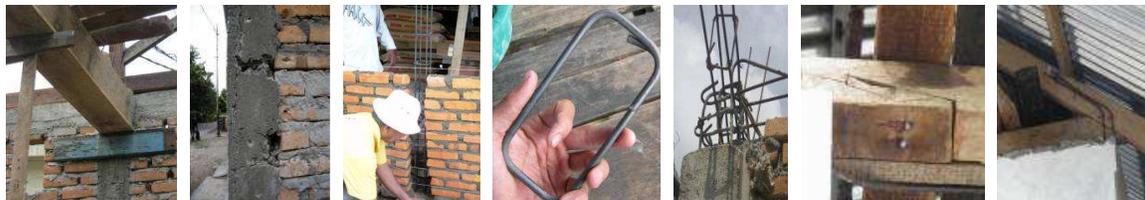
Most of the construction did not provide adequate development length in beam-column connection. Approximately one third of the samples did not provide anchorage between column and wall. In addition, about half of the samples did not provide seismic hook in the stirrups as required by the guideline. Only one third of the samples provided anchorage between roof structure and column/beam/wall, and many of them were still not properly installed, most of them just nailed the sides of roof truss members without using reinforcement bar as anchorage to tie up the roof structure. Most of the main truss connection on roof trusses used nails instead of bolts and gusset plates. The same deficiency as the other connection/detailing was also found on the implementation of anchorage between foundation and tie beam. Many samples still did not provide such anchorage as specified in the guideline (Figure12).

Figure 12: Detailing and connection observed during reconstruction

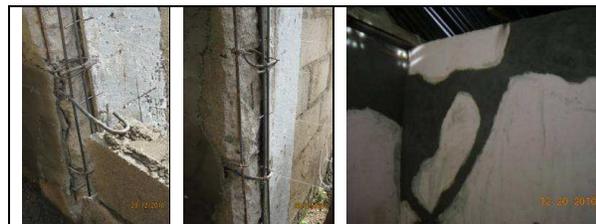
Most of the samples utilized inappropriate methods in repairing the wide and depth crack in wall construction. Steel wire mesh for strengthening the walls specified in the guideline was not widely used. Inappropriate methods in strengthening the column were observed. Figure 13 shows that the workers inappropriately tried to put “jacketing” on the columns.

Figure 13: Improper methods: jacketing (left and middle) & crack repairing (right) procurement and supervision
