CONSTRUCTION PRACTICES FOR MULTISTORY BUILDINGS
SUBJECTED TO EARTHQUAKES

Adolfo Zeevaert*

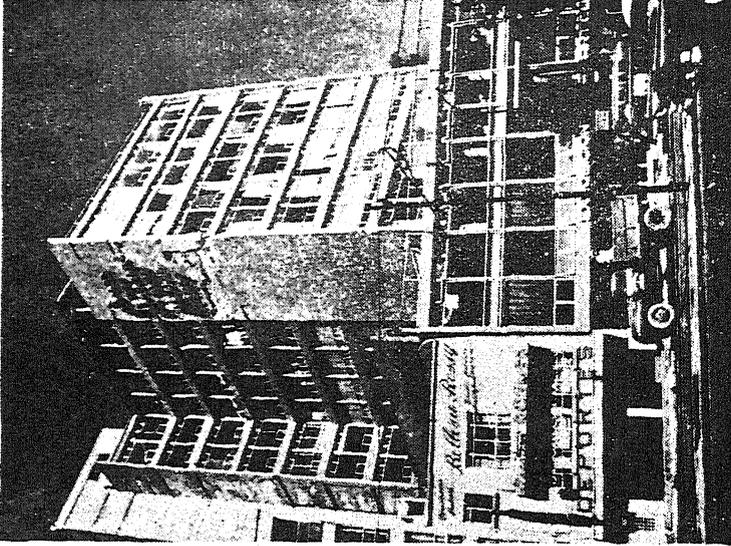
FIG. 9a A BUILDING WITH SERIOUS DAMAGES. SUCCEEDED TO CEINFORCE THE STRUCTURE, AT PRESENT IT IS IN SERVICE AGAIN.

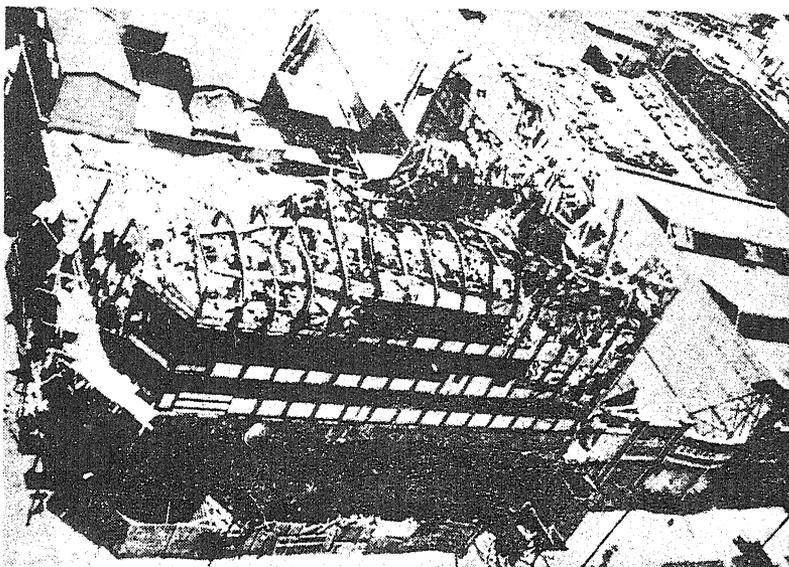
FIG. 9b A 8 STORY BUILDING UNDER CONSTRUCTION WHICH FAILED.

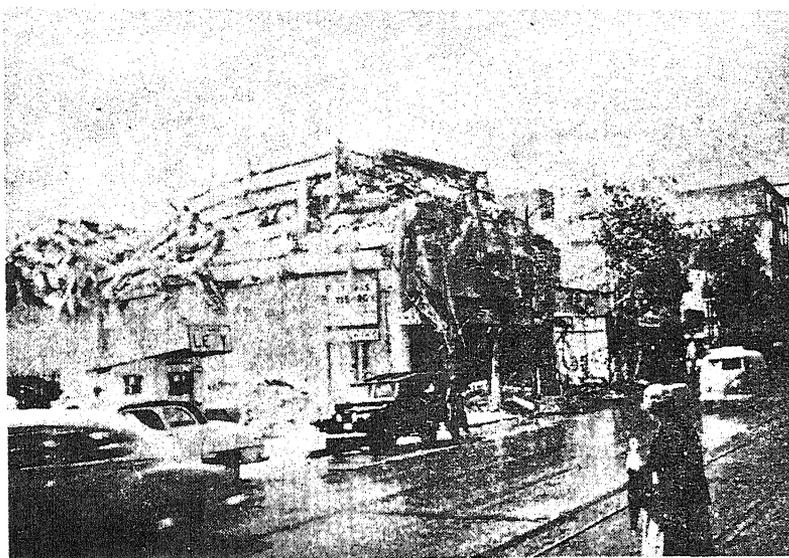
FIG. 9c A 7 STORY BUILDING WHICH COLLAPSED.

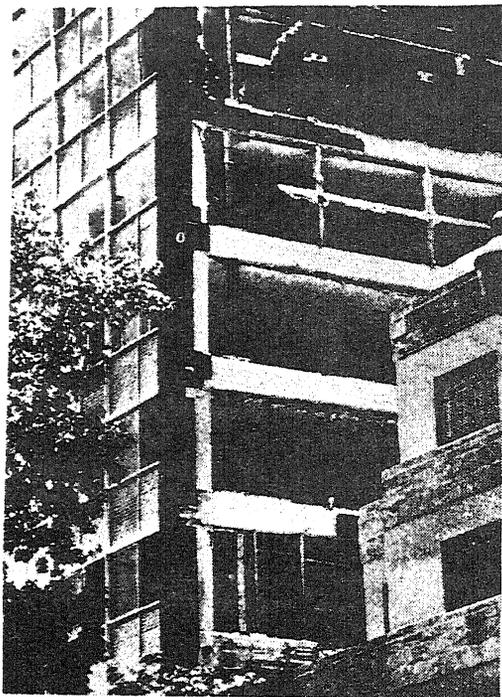
FIG. 10a A BUILDING SERIOUSLY DAMAGED ON THE CONCRETE STRUCTURE. IT SUCCEEDED IN THE REINFORCEMENT IT IS IN SERVICE NOW.

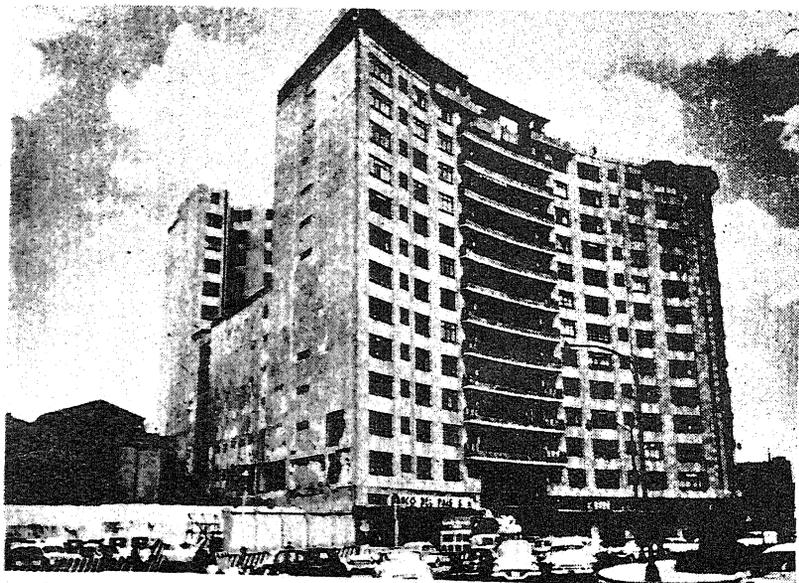
FIG. 10b A BUILDING WITH STEEL STRUCTURE SERIOUSLY DAMAGED; 12 COLUMN BUCKLE. THIS BUILDING IS NO LONGER IN SERVICE.

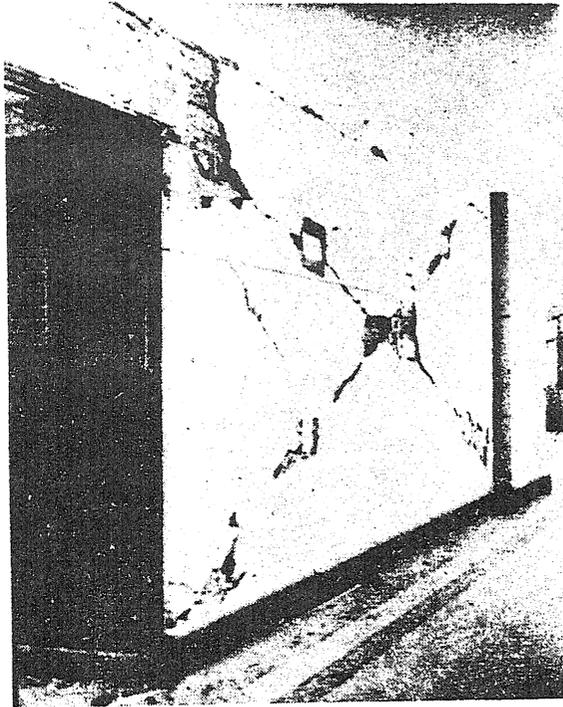
FIG. 10c TYPICAL FAILURE OF A PARTITION WALL TIED TO THE STRUCTURE.

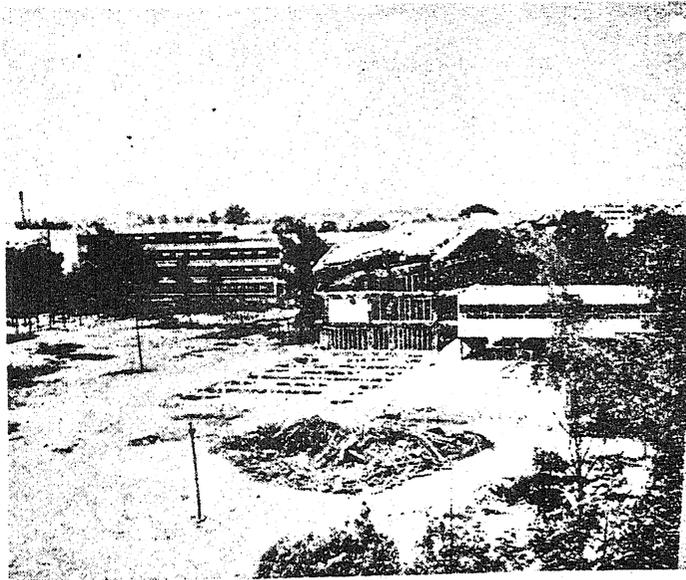
FIG. 10d THE POLYTECHNIC UNIVERSITY FAILED ON THE CONCRETE STRUCTURE.

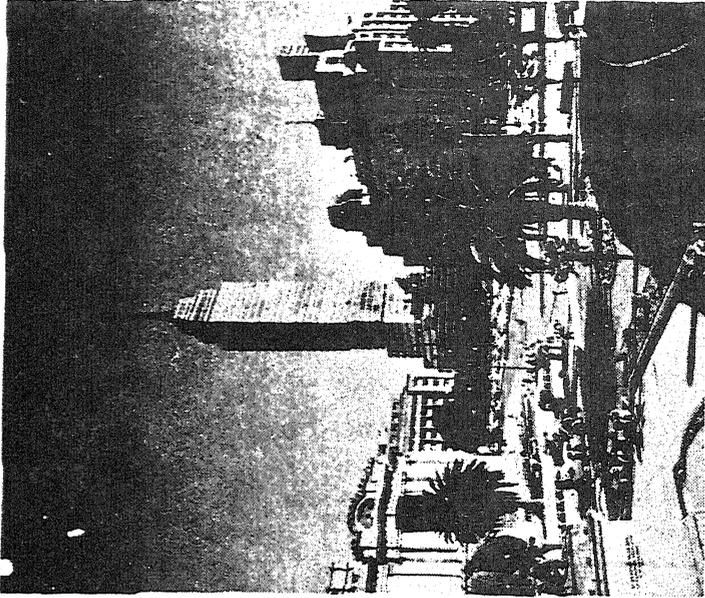
One of the buildings, where this idea of paying attention in connection with the aseismic design engineer was taken in consideration, is the Tower Latino Americana, Fig. 12. This building suffered no monetary loss, by the owner during this earthquake. On a thorough inspection, two points were brought out to be considered in the future.

FIG. 12 TOWER LATINO AMERICANA, 43 STORIES,
192.00 METER (600 FEET). AWARD OF
MERIT A. I. SC AFTER THE EARTHQUAKE
28 JULY 1957 (7 DEGREE MERCALLI SCALE)

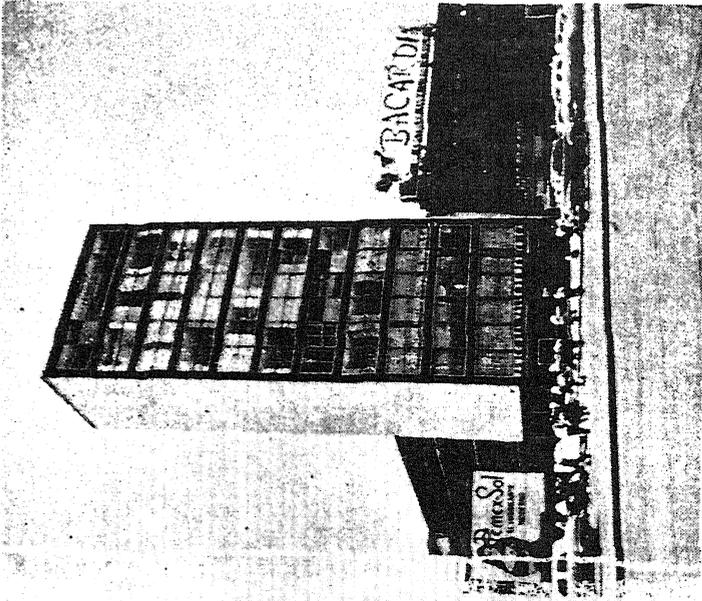
FIG. 11 A BUILDING WITH STEEL STRUCTURE,
UNDAMAGED. ARCHITECT. AGUSTO H.
ALVAREZ CONSULTING ENGINEER: CARLOS
EACALANTE M. S.
