BEHAVIOR AND DESIGN OF WOODEN BUILDINGS SUBJECTED TO EARTHQUAKE

Kenzaburo TAKEYAMA*, Toshihiko HISADA* and Yorihiro OHSAKI*

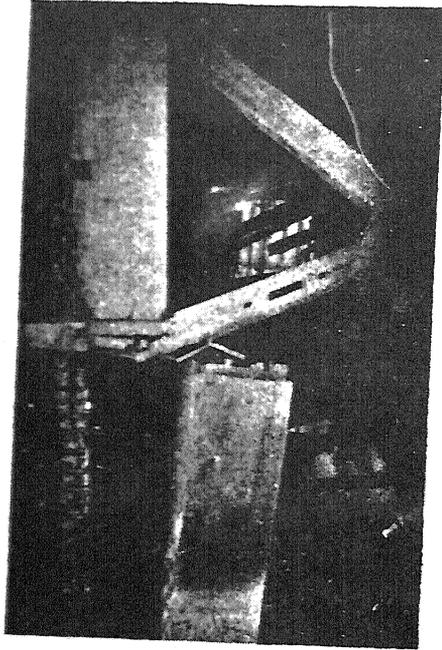
1) At the joint connecting the column and girder, the failure usually occurs as shown in Figs. 1** and 2, accompanying the falling of finishings as shown in Fig. 3. As the inclination of the structure increases, its restoring force against distortion decreases due to the structural deterioration and roof weight and finally becomes negative, which results in the complete collapse of the building as shown in Fig. 4.

FIG. 2
TYPICAL FEATURE OF DAMAGE TO FRAME JOINT

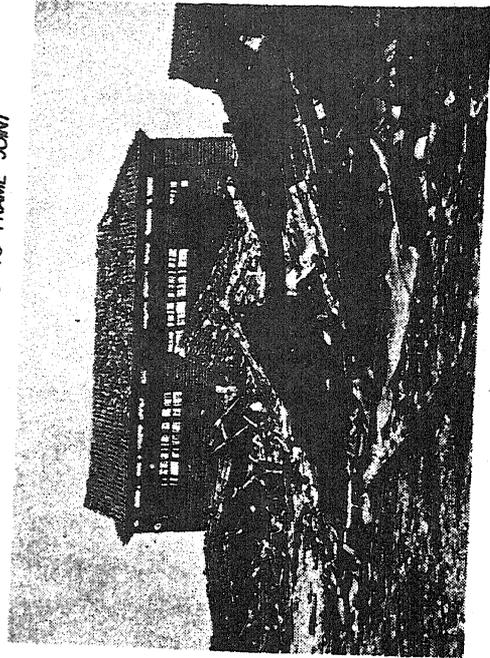
FIG. 4
TYPICAL FEATURE OF DAMAGE TO WOODEN BUILDING

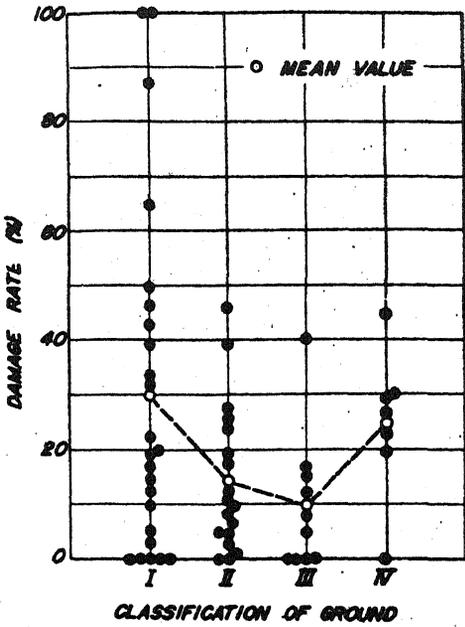
The exact distribution of the depth of the Alluvium in the Fukui Plain and geotechnical properties thereof are not known. Nevertheless, Fig. 5 shows an evident tendency that, in general, the damage rate upon the Alluvium is far larger than that upon the Bed Rock, and that the damage rate in a village located on the Sand Dune is intermediate between the Alluvium and the Bed Rock.

FIG. 5
DAMAGE RATES OF WOODEN BUILDINGS
ON DIFFERENT GROUNDS

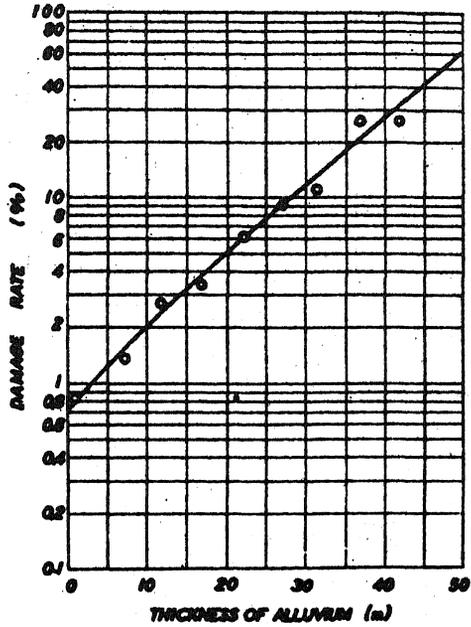
From Fig. 6 it will be seen immediately that the damage rate increases with the increase of the thickness of Alluvial deposit and, where the thickness exceeds about 30 m, the damage rate shows a tendency to increase rapidly. If we assume an equation of the type $y = ab^x + c$ for representing the relationship between the damage rate and the thickness of Alluvial deposit and determine unknown constants by the method of least square, the following equation can be obtained:

FIG. 6
RELATIONSHIP BETWEEN DAMAGE RATE
AND THICKNESS OF ALLUVIAL DEPOSIT

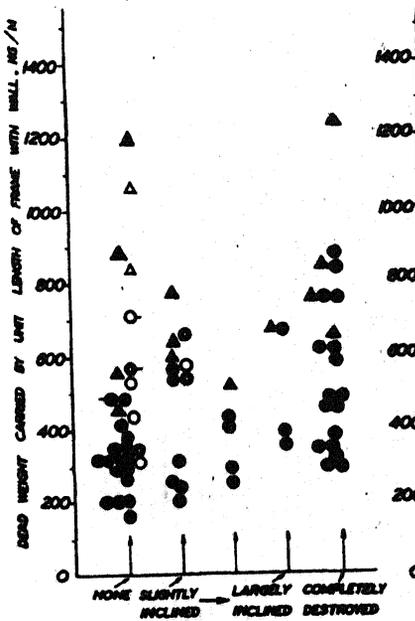
The results of investigation are shown in Figs. 7 and 8. These figures indicate the correlation between the features of damage to wooden buildings and the load carried by unit length of frame with wall therein, classified according to the kind of wall and its location in story.

In the Fukui Earthquake, it is seen, from Fig. 7, that the maximum load carried by unit length of frame which restricted the damage to slight inclination of the building would be 300 kg/m, i.e. about 30 cm/m² for a one story building with light roof and about 45 cm/m² for one with heavy roof. Based on those values and considerations indicated above, the following method of aseismic design of wooden buildings is proposed:

FIG. 7
RELATION BETWEEN DAMAGE AND DEAD
WEIGHT CARRIED BY UNIT WALL LENGTH,
IN N-S DIRECTION

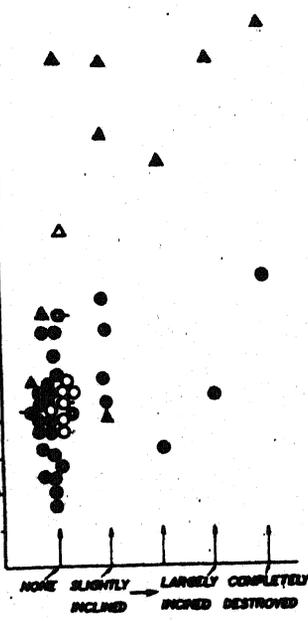
FIG. 8
RELATION BETWEEN DAMAGE AND DEAD
WEIGHT CARRIED BY UNIT WALL LENGTH,
IN E-W DIRECTION
