"ANALYSIS OF THE BEHAVIOUR OF THE PUERTO MONTT, BANCO CENTRAL
DE CHILE STRUCTURE"

"ANALYSIS OF THE DAMAGE CAUSED BY THE 1960 EARTHQUAKES IN A
BUILDING OF THE CHIPRODAL FACTORY IN LLANQUIHUE, CHILE"

THE DEPARTMENT OF SCIENTIFICAL AND TECHNOLOGICAL RESEARCH
OF THE CATHOLIC UNIVERSITY OF CHILE

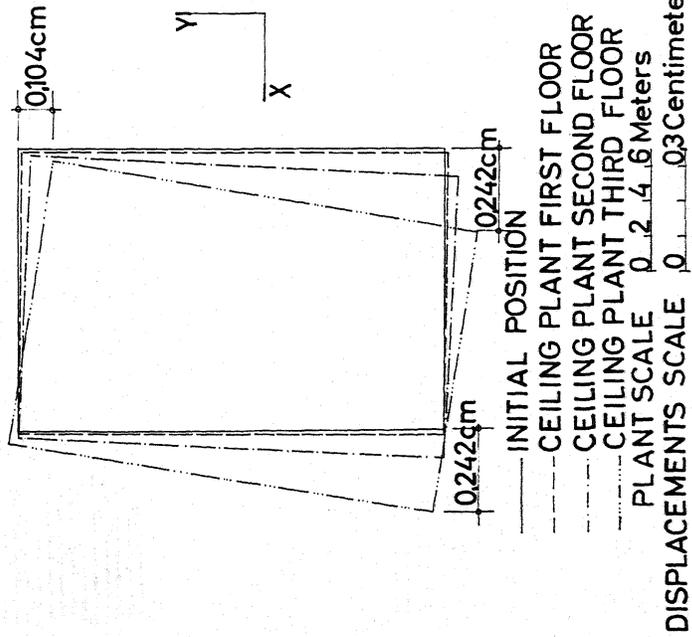
FIG. N° 1
X EARTHQUAKE DISPLACEMENTS
CHILEAN CODE

It is interesting to point out the importance of the differential displacements between the second and third floor for the earthquake in direction X, which are very acute at the end that corresponds to the intersection of axis 1 and B.

We refer to Fig. 1,2, 3 and 4 which schematically record the displacements of the three floors in the different cases. It is interesting to observe also that the torsion effect is considerably

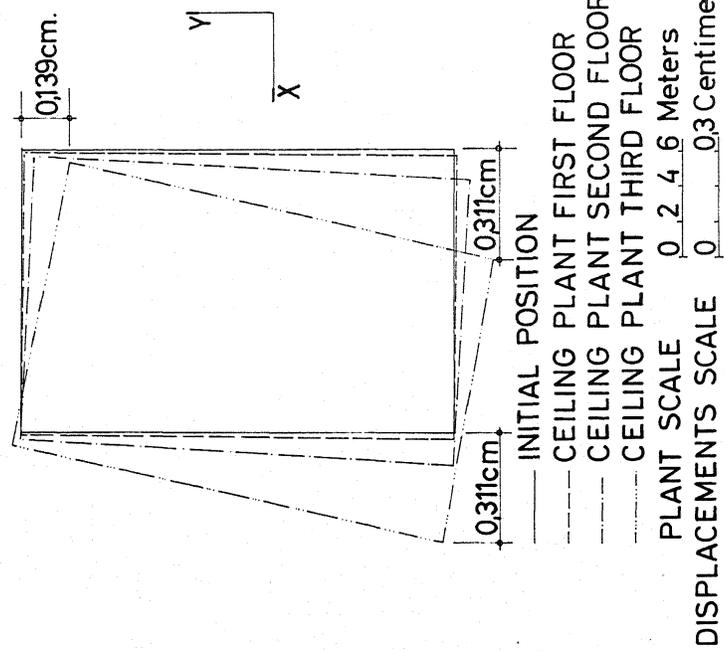
FIG. N° 3
 X EARTHQUAKE DISPLACEMENTS
 DYNAMIC ANALYSIS

This effect is notoriously greater in the case of distribution according to the Dynamic Analysis, and we will later see that it will be the fundamental cause of some of the damage observed in this building.

increased in the distribution of seismic forces if it is made according to a Dynamic Analysis. This is mainly because according to this analysis, a much larger proportion is assigned to the total shear of the upper floor. The cause of this latter fact is the small mass of the ceiling of the second floor as compared to the weight of the third floor ceiling in case 1.

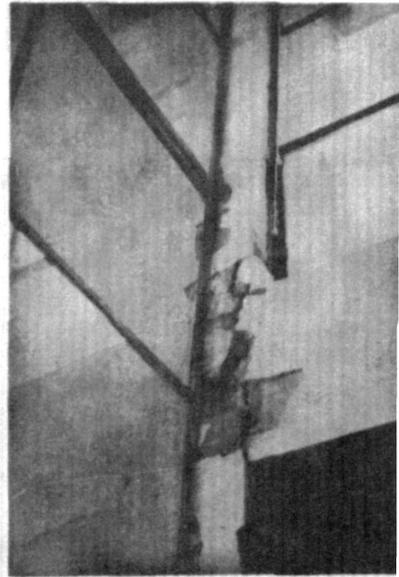
FIG. 8

e.- Element A/B-1, broken in its two plates, at the height of the second floor ceiling.

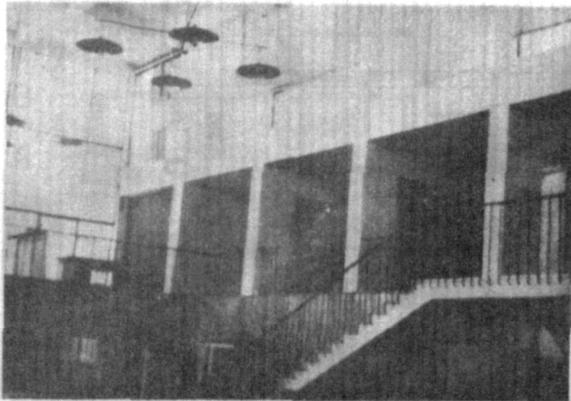
FIG. 6

- 1.- Columns C-1 and D-1 between the second and the third floor (Figs. 6 and 7).
- 2.- The lintel of the ceiling on the second floor which meets column D-1 (Fig. 6).
- 3.- The beam in the ceiling on the second floor which meets element A/B-1 according to axis B.
- 4.- The beam in the ceiling on the second floor which meets element A/B-1 according to axis B.
- 5.- Element A/B-1, broken in its paraments (inside Fig. 8 and outer Fig. 9) at the height of the ceiling on the second floor.

b.- Ceiling lintel on the second floor which meets column D-1.

This lintel is of capital interest because its failure is a clear consequence of the minor importance commonly given to this type of structural element. Normally its section could be considered sufficiently strong and its investigation unnecessary, but in this calculation its influence has been considered in spite of the complexity of the structure, and results confirm the appearance of failures. Considering the distribution of horizontal forces of Chilean Coae, it appears that it is submitted to a moment of 3.4. ton-m in the most unfavourable case, and the rupture calculation assigns to it a maximum resistance moment of 2.7 ton-m. If the distribution of horizontal forces is made according to the Dynamic Analysis, the moment in the lintel would be 4.35 ton-m, which represents an even more unfavourable situation.

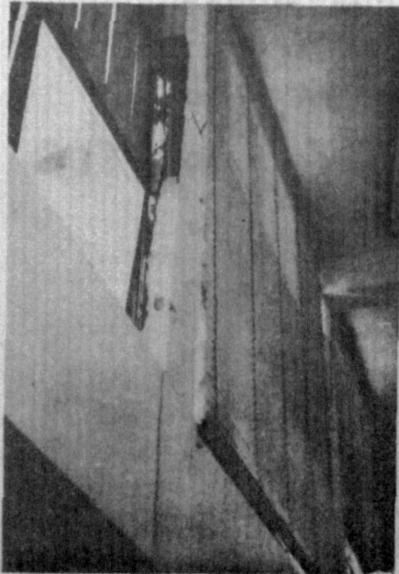
FIG. 7

a.- Columns C-1 and D-1 - between the second and third floor.

These columns which suffered destructive damage, had been overdimensioned for whatever distribution of horizontal forces considered. Due to the important reinforcing percentage of steel, this could be considered as a serious discrepancy between calculation hypothesis and reality. Nevertheless, this apparent non-coincidence, is explained by the fact that these columns were greatly weakened by the insertion of heating piping, and also in one of them, the most seriously damaged, by the insertion of a valve box that frankly weakened it.

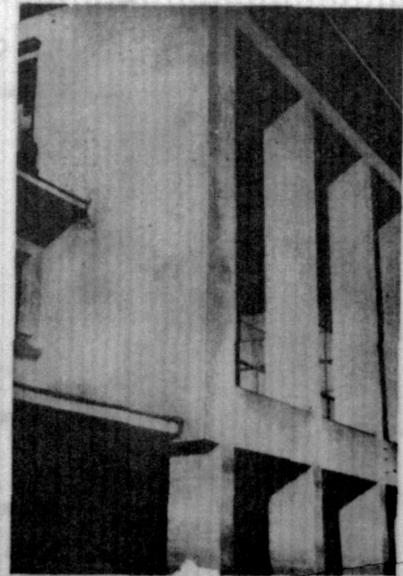
FIG. 9

The serious damage this element suffered, as can be seen from Fig. 9 is not justified immediately. Thus, if we calculate the work fatigue due to torsion, this will not be sufficient to produce the rupture. The values for the stresses are numerically unimportant 740 kg/cm² for the steel, 70 kg/cm² for the concrete and 5 kg/cm² for shear stress.

We could presume also that the failure was due to torsion effect in the element itself; nevertheless, we obtain a stress of 0.8 kg/cm², which added to the above shear stress does not reach a value that can be considered dangerous.

We can see that the displacement between the second and third floor is serious: 0.14 cm. Such displacement made each one of the walls constituting this element act as a beam of about 3 m. span. With this hypothesis we obtain in the lower end a moment of about 680 kgm, which value agrees with the rupture moment of the wall calculated for the reinforcing steel available at its section in a 1 mt. wide beam. This justified the cracking of concrete in this section and also the appearance of the horizontal crack at the second floor level. It should be noted that in the A/B-6 twin element, not being in contact with the second floor which restricts its displacement, is not submitted to a similar effect, this being in accordance with the non-appearance of cracks. Of course, in this element there is a displacement of 0.20 cm. but produced between the first and third floor, and the span of the wall acting as a beam is of more than 6 m, which makes that the moment indicated falls within acceptable limits, in accordance with the steel reinforcement provided in it. The above indicated values are obtained by applying the Chilean Code. The corresponding Dynamic Analysis gives substantially higher values, specially as to displacement between the second and third floor. This fact confirms our opinion that this displacement has been the main cause of destruction of this element.

It is likewise interesting to emphasize the importance of a differential displacement between the ends of a columns when its ends are fixed. This effect is generally not taken into account and is, as analysis shows, the cause of destruction for column A/B-1. It would therefore, be advisable, when the relative displacement between two floors is important, to take account of this effect in the design of elastic columns which stresses are small but which strains will cause the destruction or failure of the member designed basically for conditions of support of merely vertical loads.

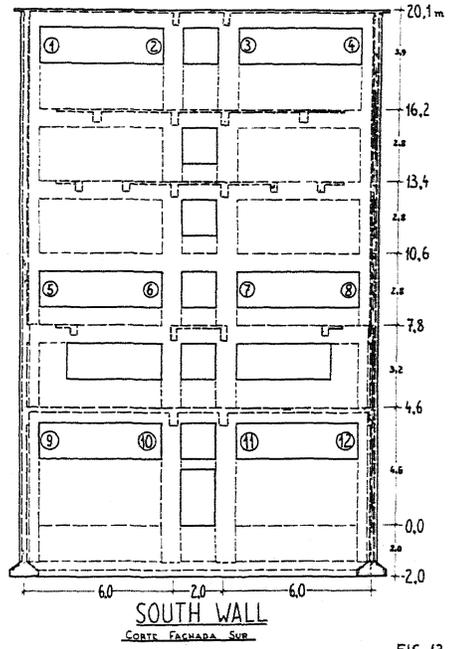
FIG. 13

The most serious damage was to the south wall. Columns 5, 6, 7 and 8 (see fig. 13) were practically destroyed. Columns 1, 2, 3 and 4 on the top floor, have cracks and in some places loosening of the concrete. Columns 10 and 11 have visible cracks.

With respect to columns 5,6,7 and 8 the calculations made have established that the outer column (5 or 8 according to the direction of the earthquake) undergoes traction forces combined with bending producing in the steel stresses that are over the elastic limit. It must be remembered, nevertheless, that a tractioned column has higher principal stresses than a similar compressed column, due to this fact, we can assume the column shifted part of its shear to the other columns at the same level when the initial failure occurred. In any event, it has been verified that the steel reached its limit of elasticity or very near to this point, leaving this column in a bad condition to support the severe compression and bending produced when the direction of the earthquake changed.

After the two outer columns were damaged, the total shear at this level had to be resisted by the two central columns. Bending moment and shear caused by these forces upon these central columns are beyond their capacity, and they produced general breaking at this level.

(b) The steel ratio in columns 5, 6, 7 and 8 is 0.8%, and in columns 1, 2, 3 and 4 is 0.25%. It does not seem satisfactory to provide such low reinforcements that could produce fragile rupture and introduce sudden redistribution of forces in a definite level that can be more disastrous than the forces developed by the earthquake itself.
