A PROGRESS REPORT

STRUCTURAL ENGINEERING ASPECTS

ALASKAN EARTHQUAKE

OF MARCH 27, 1964

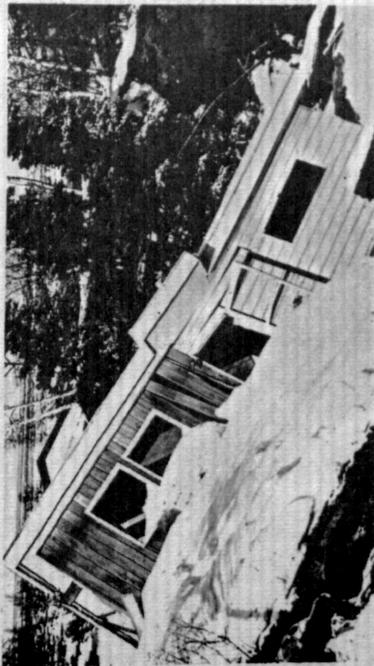
The damage due to landslide and earth movements was spectacular, and tended to overshadow the less spectacular damage. Typical dwelling damage as a result of landslide in the Turnagain residential area is shown in the accompanying figures.

Fig. 2. Typical landslide damage to a wood frame dwelling in the Turnagain section of Anchorage.

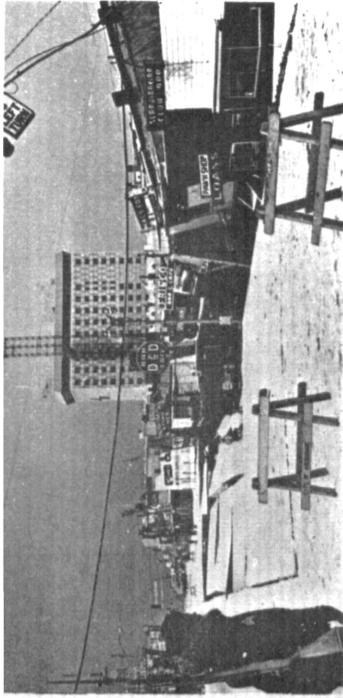
The Fourth Avenue landslide occurred in part of the business district. The buildings were total losses and have been demolished.

Fig. 3. Fourth Avenue landslide damage. Anchorage-Westward Hotel in the background.

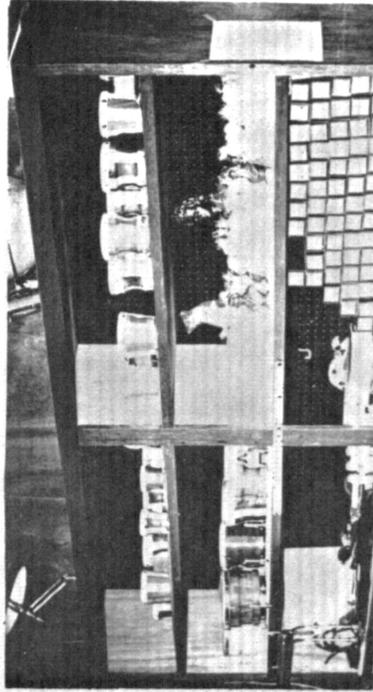
Fig. 4. Photograph taken in a store across the street from the damage shown in Fig. 3. Items on the shelves have not been rearranged since the earthquake, indicating low earthquake intensity if long period effects are neglected.

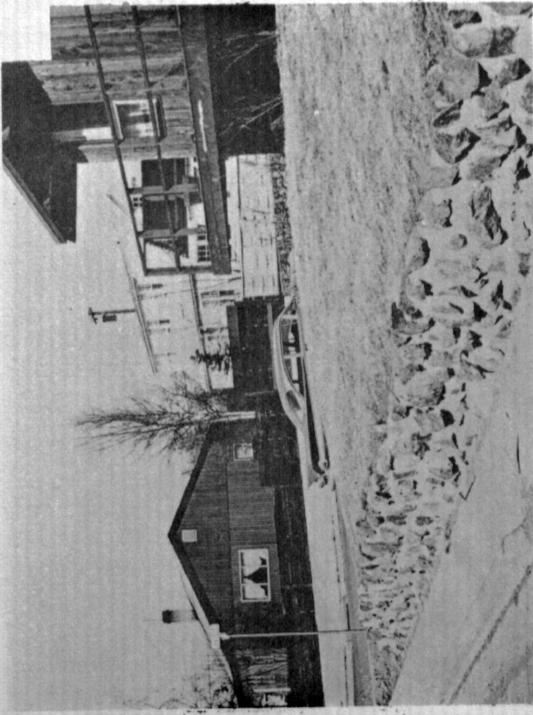
Wood frame dwellings in Anchorage performed excellently when foundation failure was not a factor. Brick or hollow concrete block chimneys, in general not reinforced, often were undamaged. Houses, although often not well anchored to their masonry foundations, rarely shifted from these foundations. In various sections of Anchorage, dishes and similar items did not fall from shelves. Elsewhere in Anchorage, most objects were thrown from shelves. The foregoing indicates that, although the earthquake's intensity as measured by this type of damage was quite variable, the performance of wood frame structures was superior when located on firm ground.

Fig. 5. Typical undamaged wood frames dwellings. This type of structure was rarely damaged except for chimneys. Landslide was also an obvious exception.

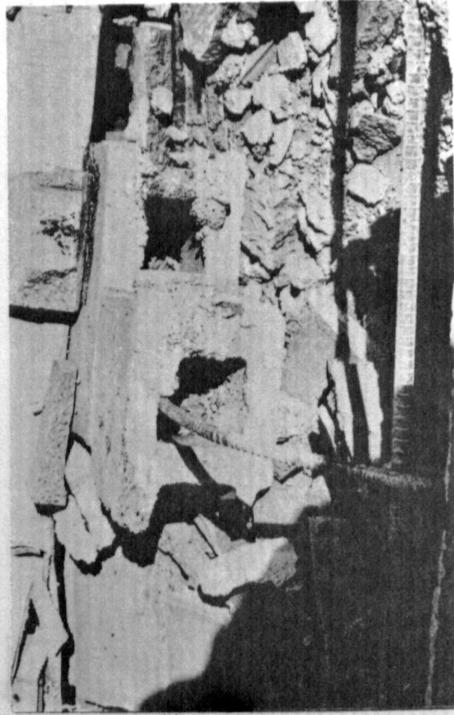
joints of the hollow concrete block. The placement of vertical steel was inconsistent. This reinforcement, in general, appeared to be of a size and amount that would not be considered to be fully adequate in other sections of United States that are considered seismically very active. Workmanship was often poor where collapsed walls were noted; the concrete grout did not fill all of the cells in many observed instances.

Fig. 6. Example of defective workmanship. The cell containing the steel had never been filled with grout, and therefore was not earthquake resistive.

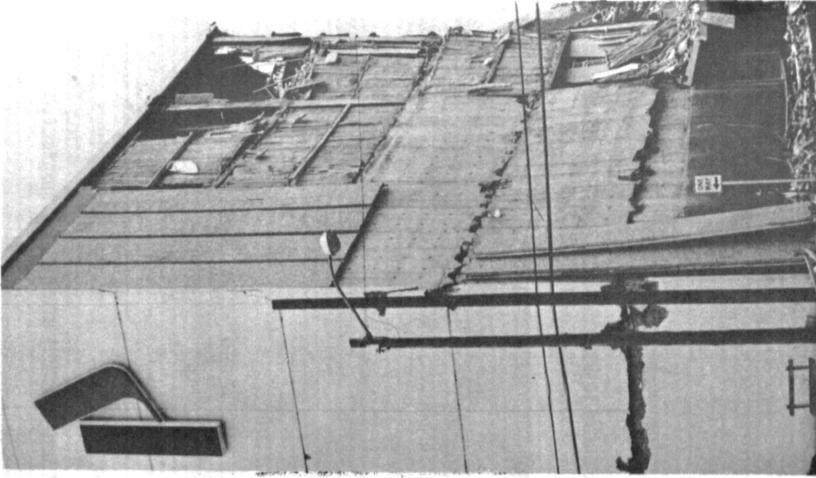
Earthquake damage was severe to the Penney Building and the building was torn down to its foundations before being rebuilt. An examination of the accompanying figures shows that the bulk of the damage occurred above the first story. Precast walls fell, shear walls collapsed, and columns were sheared. Also, major movements occurred along the construction joints, principally at the second floor level.

South wall damage was largely associated with movement along the second floor construction joint. The wall movement along the second floor construction joint followed the pattern commonly found in Anchorage. The laitenance had not been effectively removed and the concrete wall was not truly monolithic.

The mechanism causing failure can be explained by torsional forces. Torsional forces were not a significant factor in the first story since shear walls were found along all street fronts. The upper stories, however, had a structurally open north wall, and large torsional forces would arise from the U-shaped shear wall bracing system when subjected to east-west lateral forces. These torsional forces gave the highest unit stresses in the second story.

Fig. 7. Penney Store, southeast corner. Wall on the right had been faced with 5" precast concrete panels which failed during the earthquake. Note wall offset at 2nd floor level.

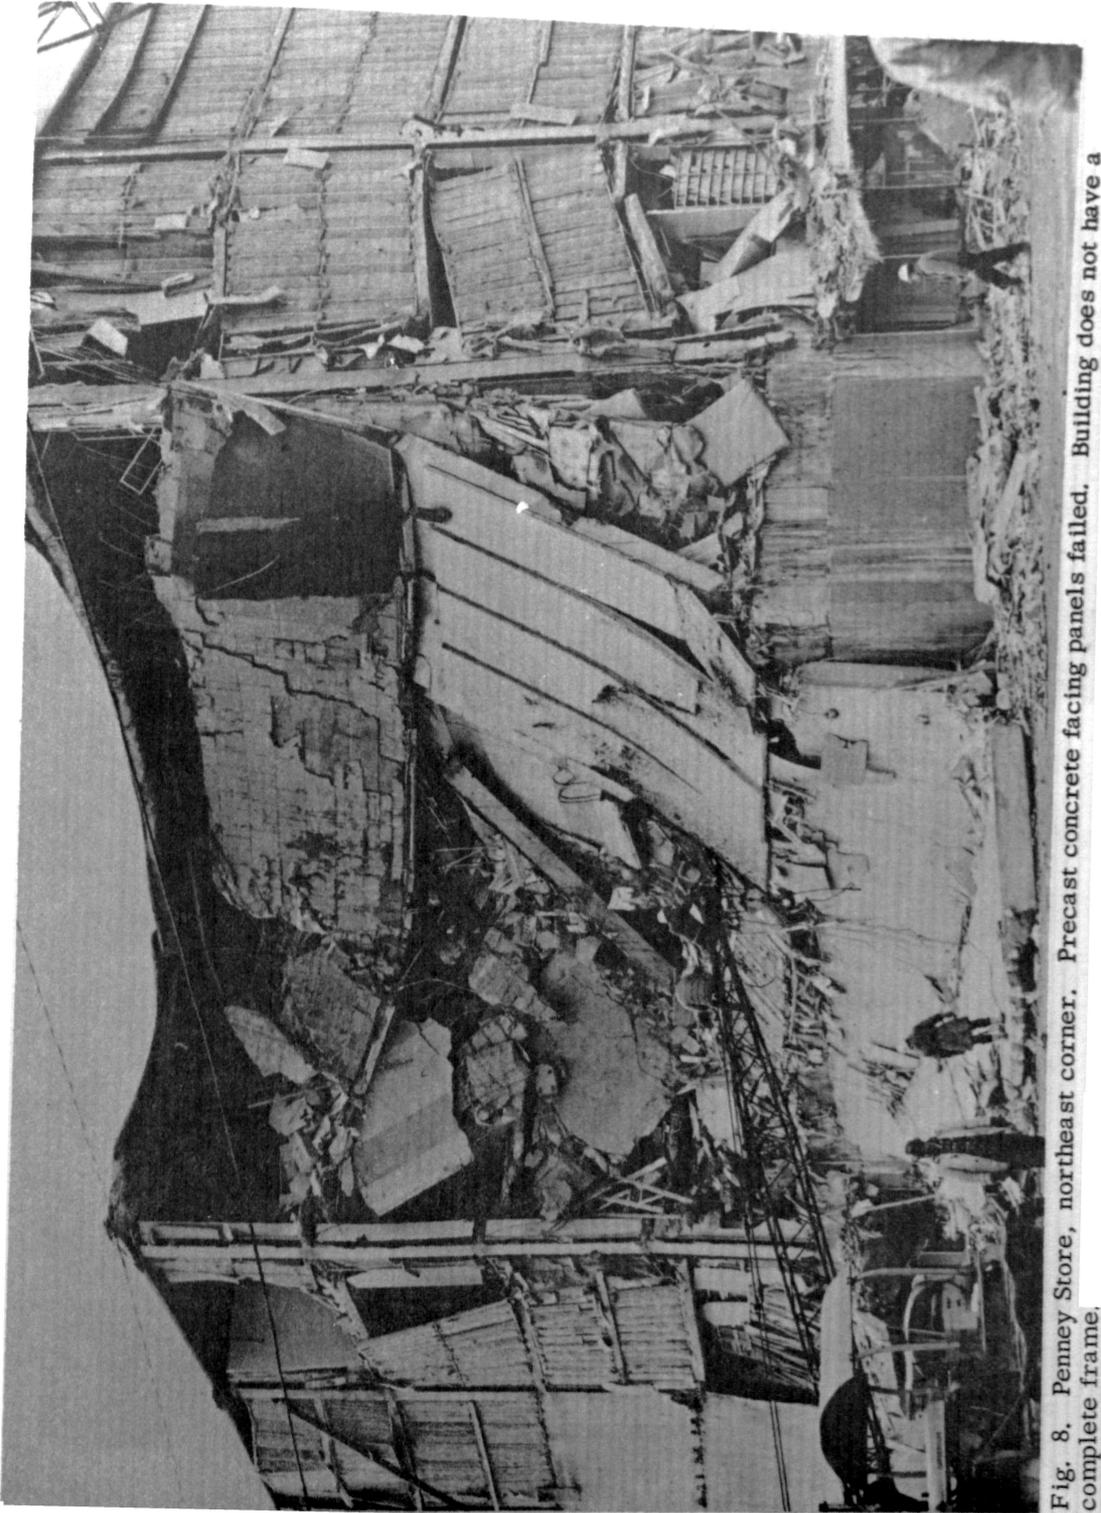
Fig. 8. Penney Store, northeast corner. Precast concrete facing panels failed. Building does not have a complete frame.

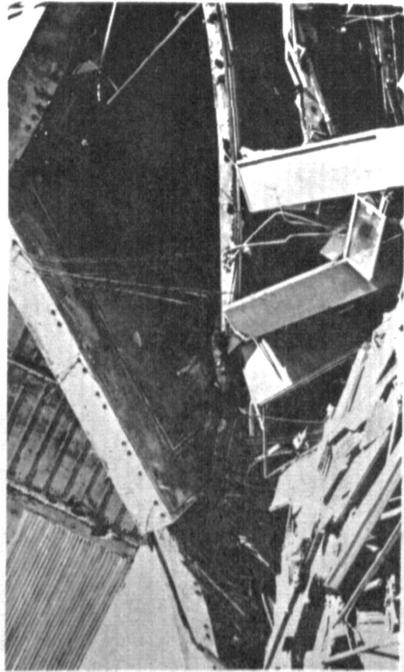
distances. There are conflicting accounts regarding the sequence of events in the failure of the prestressing cables, and no firm proof has been found to resolve this matter.

Fig. 12. Stacked floor slabs at Four Seasons Apartment Building. Note failed prestressing rods.

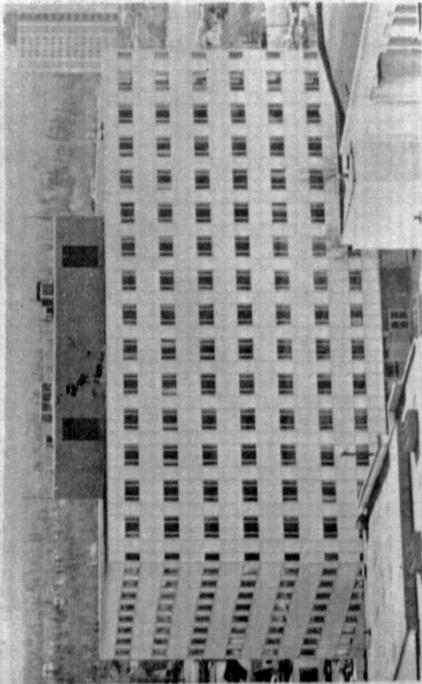
The principal structural damage was found in the central core. The reinforced concrete walls had their principal damage in the first story, with damage being progressively less in the upper stories. The damage pattern in the reinforced concrete central core may be divided into 4 distinct categories:

Fig. 9. Hill Building. Insulated metal panel "skin" not damaged. Damage occurred to the rigid reinforced concrete central core walls which are located directly below the damaged penthouse.

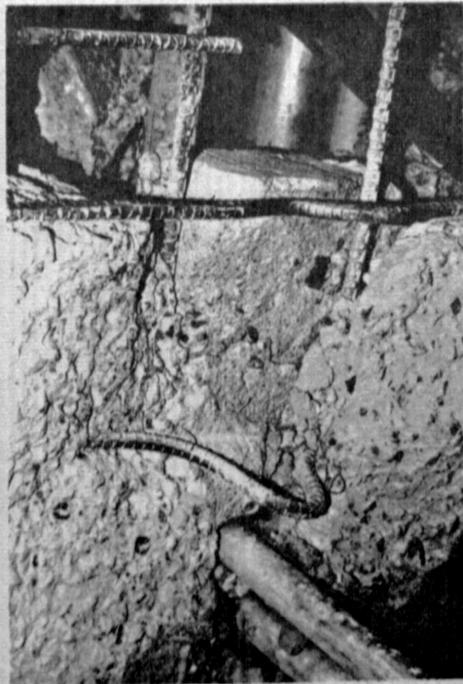
The most significant item of those listed above was the failure below the first floor slab in that it played the major role in the other damage. This failure in the west unit below the first floor slab was due to a horizontal belt of extremely poor quality concrete. This concrete did not fracture, rather it "mushed" out. The reinforcing steel acted as columns and buckled under compression loading. Laboratory analysis of this "mushed" concrete indicated excessive organic material which had resulted in extremely low strength concrete.

Fig. 10. Hill Building. Concrete in core wall below first floor failed due to its exceptionally poor quality, causing core walls to rotate and damage partitions.

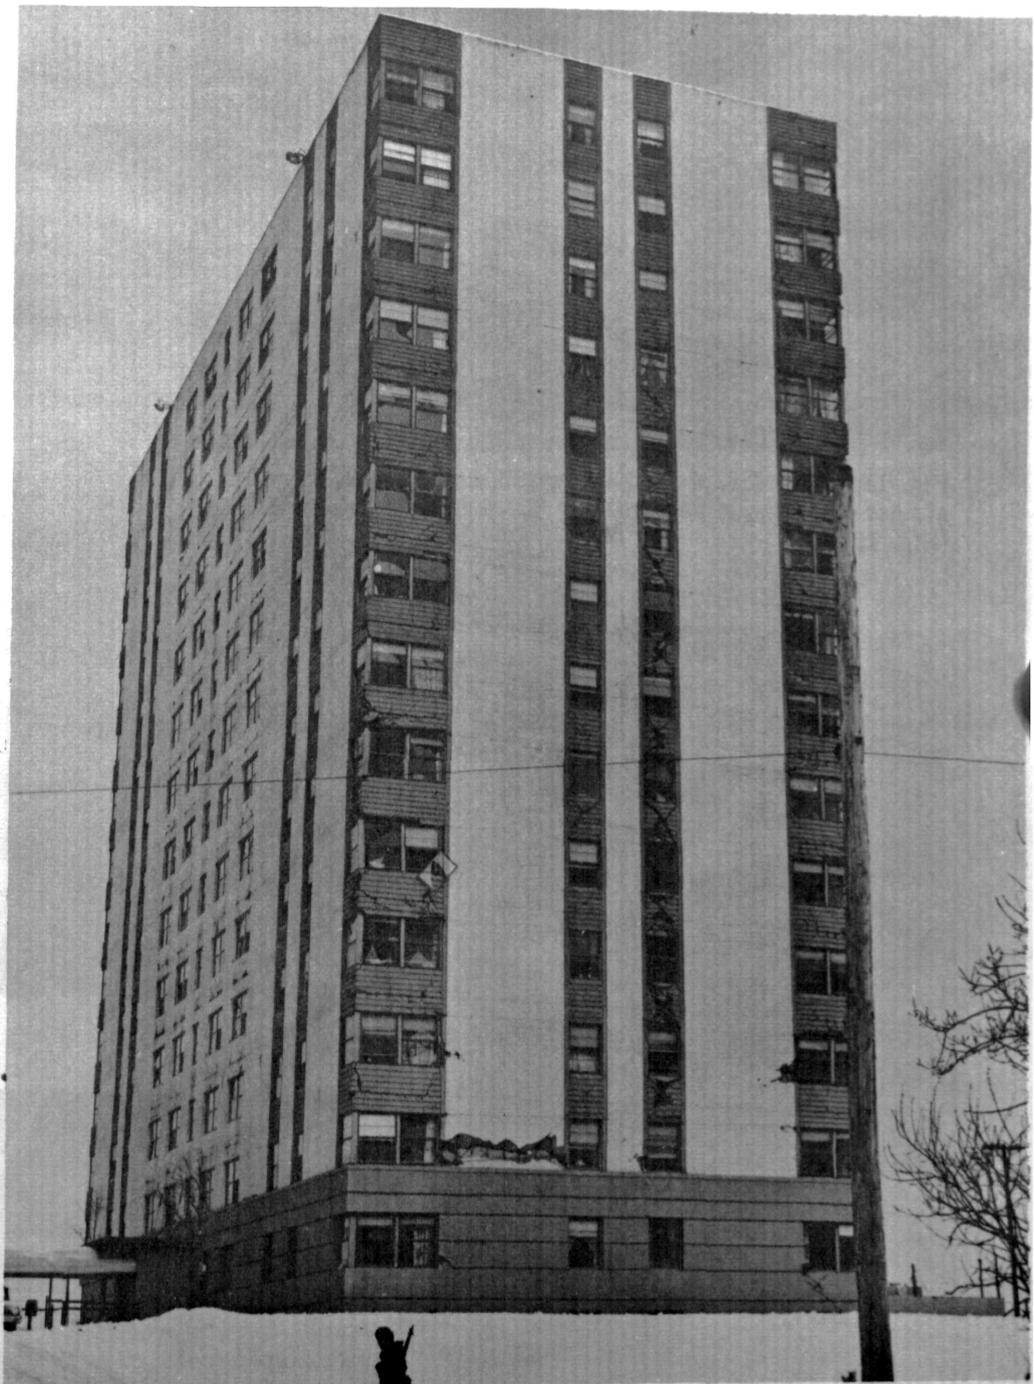
Two almost identical 14-story apartment buildings, the Mt. McKinley Apartments and the 1200 "L" Street Apartments, are interesting examples of damage. Exterior walls are reinforced concrete, and are bearing. The walls around the stairs are reinforced concrete as are interior columns. Floors are reinforced concrete and span up to about 18 feet. The earthquake resistance was provided by the exterior bearing walls and by the interior reinforced concrete walls, all acting as shear walls. Damage was usually in the form of X-cracking in the reinforced concrete spandrel walls; this is typical reinforced concrete shear failure. The vertical alignment of shear failures, termed for convenience "vertical shear," was particularly noticeable in the stories located in the middle third of each face of each exterior wall. The interior walls did not suffer as extensively as did the exterior walls. Building corners were supported by cantilever exterior walls, and these corners suffered extensive damage. Floors appeared to have suffered relatively little damage. One major bearing wall in each building completely failed in a lower story. Both buildings had a similar orientation and had very similar damage patterns although located about one mile apart. Shaking machine tests are in progress at this writing, and many additional data are to be expected in the near future.

Fig. 13. 1200 "L" Building. Note broken bearing wall and characteristic shear X-cracks in the walls. --Bureau of Land Management photo.

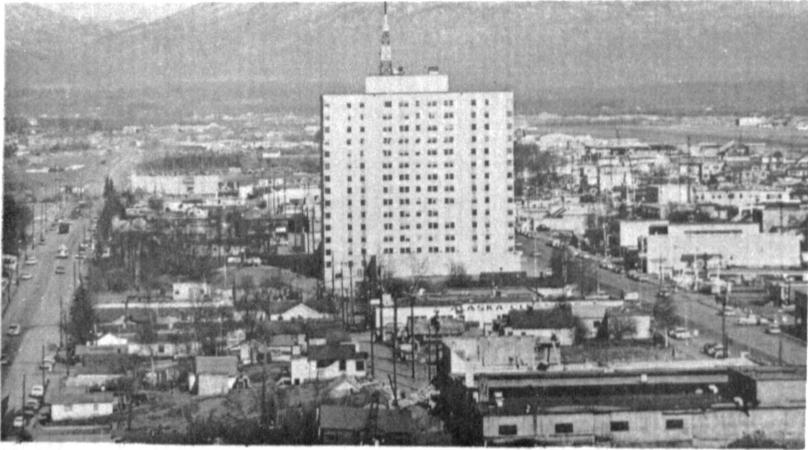
Fig. 14. Mt. McKinley Apartment Building. Structurally almost identical damage to 1200 "L" Apartment Building (Fig. 13).

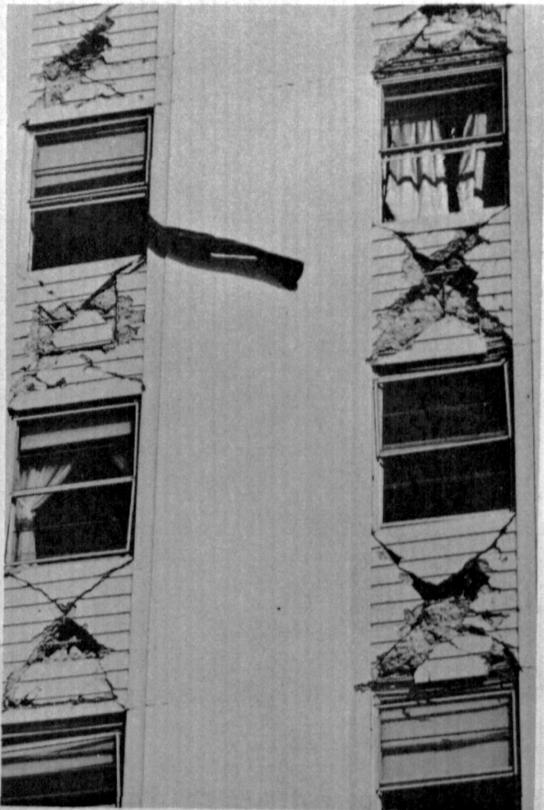
In summary, and with reference to the multistory buildings, a majority of the tall buildings had significant structural damage. The damage to reinforced concrete shear wall buildings was often found in the spandrel walls between shear walls, with this damage having a vertical alignment. It would appear obvious that this type of stress has been given too little design attention. Construction practices were usually a factor in the damage as well as design practices. Concrete construction joints often failed due to a complete lack of bond between the two concrete pours. Laitenance was rarely removed in construction joints, and as a result the concrete was not monolithic.

Fig. 15. Characteristic X-cracks in reinforced concrete spandrel walls formed a vertical alignment of damage.

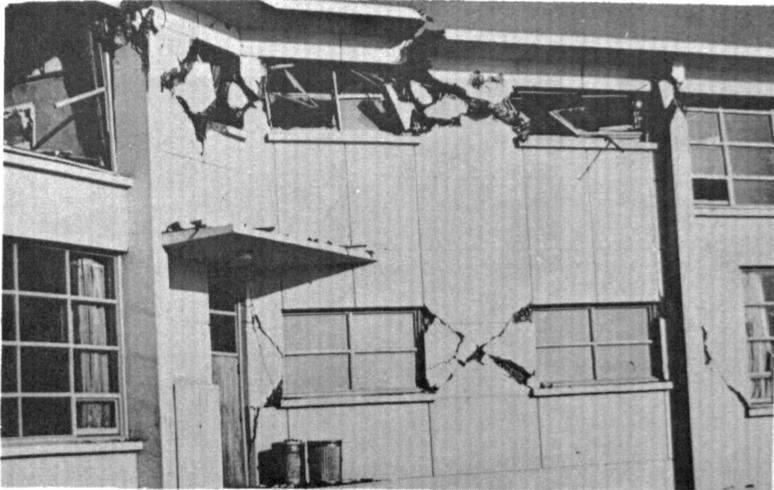
An example of a low reinforced concrete building which partially collapsed is the West Anchorage High School. Principal damage was to the 2-story classroom section which was structurally separated from the adjoining auditorium and gymnasium. Shear walls failed in the classroom wing, probably then followed by column bending failure in this wing. Extensive pounding damage occurred between structurally separated units. Eye witness accounts tell of major building oscillations before the partial collapse occurred.

Fig. 16. Portion of the severely damaged West High School, Anchorage.

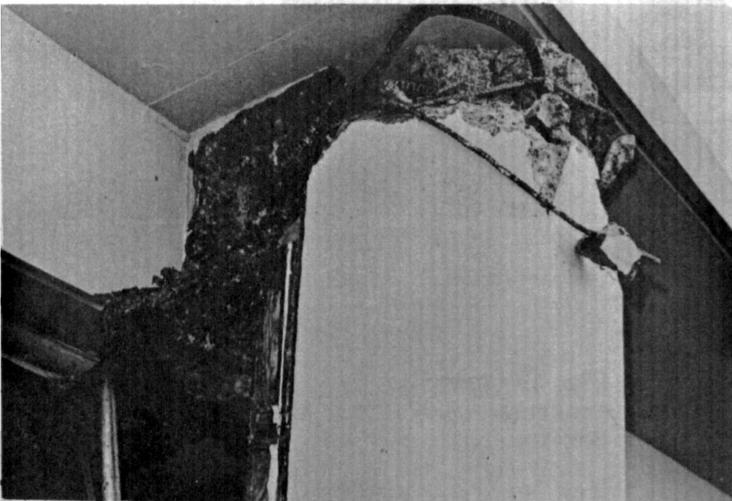
Fig. 17. Typical column damage to West High School, Anchorage.

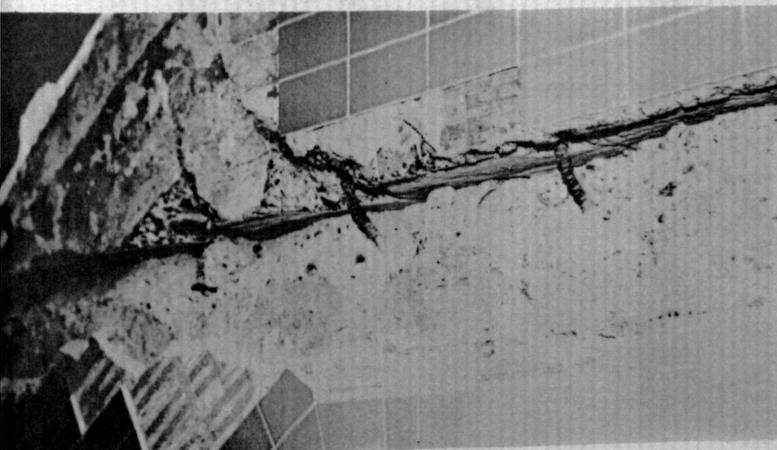
Fig. 18. Movement along a reinforced concrete construction joint, West High School. Laitance in the joint has not been removed.

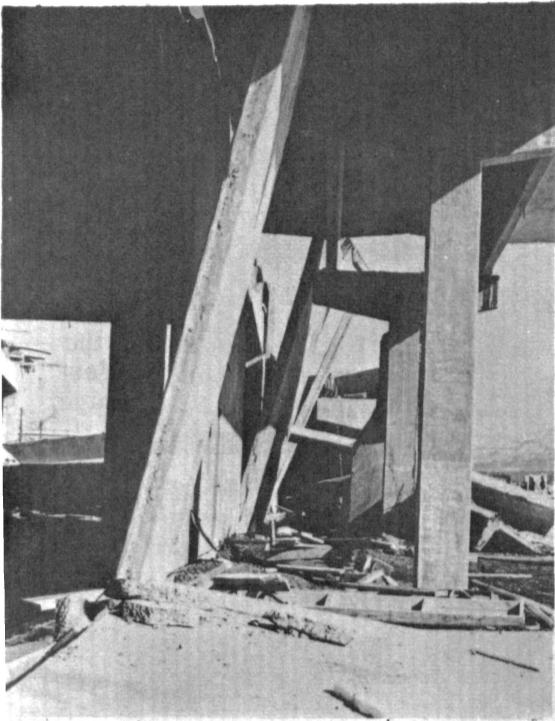
Precast reinforced concrete construction had perhaps more than its share of failures. Failures were almost invariably at the connections between precast elements. The Alaska Sales and Service Building is an interesting one-story failure in this category, having a precast prestressed reinforced concrete "T" roof system on precast reinforced concrete bents. Walls were also of precast concrete. Interconnections between precast elements were usually made by means of welded metal connections. The building was in the final stages of construction. Large sections of the building collapsed while much of the remainder was out of plumb and on the verge of collapse.

Fig. 19 (upper left). Failure of precast concrete connections, Alaska Sales and Service.

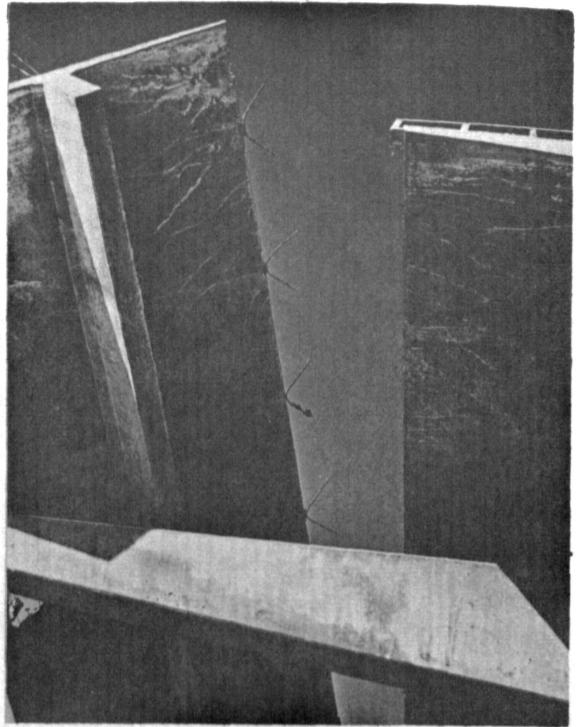
Fig. 20 (upper right). Failure of precast concrete connections, Alaska Sales and Service.

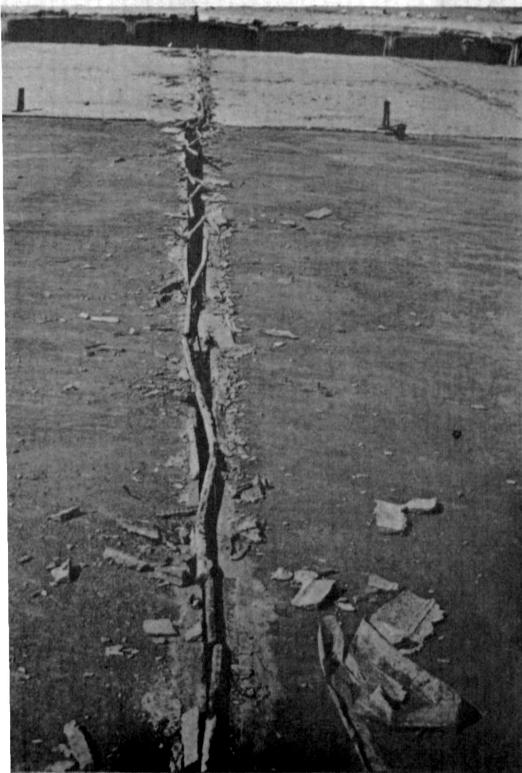
Fig. 21 (left). Failure of connections between precast roof elements, Alaska Sales and Service.

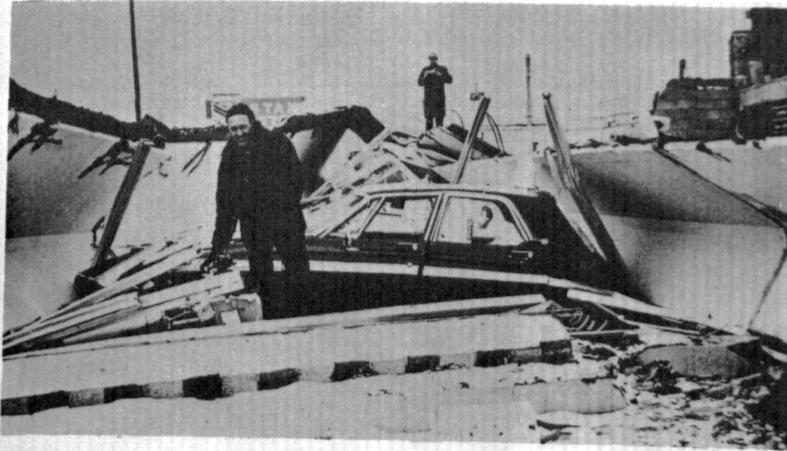
Other precast reinforced concrete buildings, or partially precast reinforced concrete buildings, also had serious damage. A precast prestressed "T" roof system on hollow concrete block supports partially collapsed at the Chrysler Center automobile sales agency.

While the interconnections between the precast elements failed, or the connections from precast elements to their backing wall failed, these failures were not always the primary cause of the collapse. For example, the hollow concrete block supports for the precast "T" roof at the Chrysler Sales apparently gave way first, with the spectacular roof damage as a consequence. Other cases could be cited. But whether the precast element failure was a primary or consequential failure, it was almost invariably the connections which were the weakest element.

Fig. 22. Chrysler Sales. Failure of precast roof was probably caused by the collapse of the hollow concrete block supporting structure.

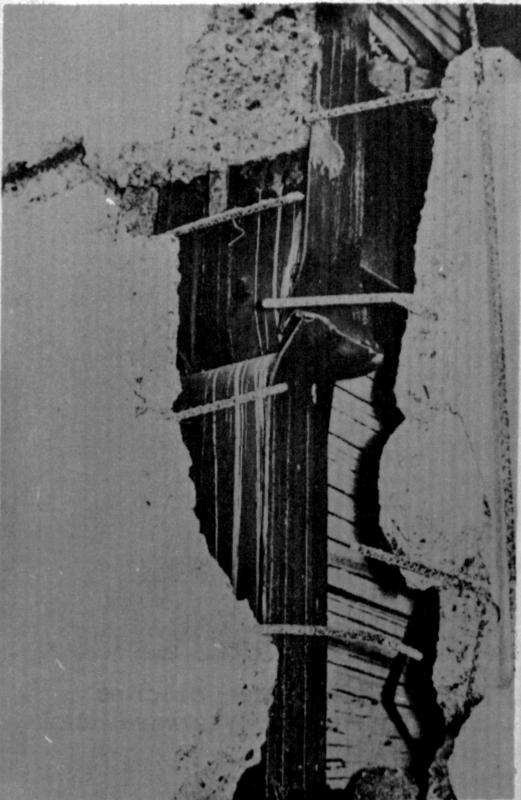
The 6-story Cordova Building also had a steel frame and interior reinforced concrete shear walls. Damage was serious along the south wall to both the concrete "skin" and to the steel frame. The failure of the north reinforced concrete wall was largely due to faulty construction joints. The severe damage to the steel column in the southeast corner is interesting and was the primary result of a stair landing framing into the column, thereby greatly increasing the column's stiffness and the lateral force going to the column.

Fig. 23. Cordova Building. Steel column failed due to stair framing into this column which greatly increased column stiffness, thereby bringing most of the lateral force to this column.

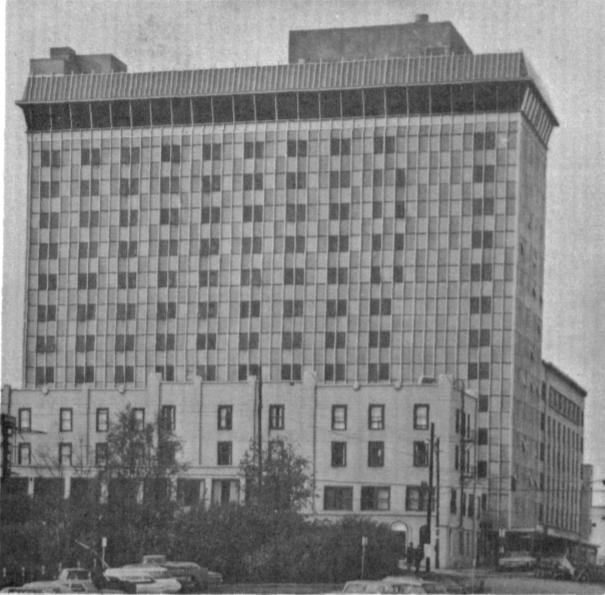
Fig. 24. Anchorage-Westward Hotel, East elevation.

The 14-story Anchorage Westward Hotel was built in two stages, with the 6-story second stage almost ready for occupancy at the time of the earthquake. It had essentially a complete steel frame, except that several reinforced concrete walls were designed, at least in part, to take column loads. Exterior walls were metal insulated panels ("metal skin"), except for the rear wall and a portion of one side wall which were reinforced concrete. Floors were metal deck with a reinforced concrete wearing surface. The earthquake resistance was provided by the exterior and interior reinforced concrete walls acting as shear walls. The metal skin had sufficient flexibility so that very little damage appeared from the exterior, but significant structural damage occurred to the more rigid structural elements within the building as may be seen by the figures.

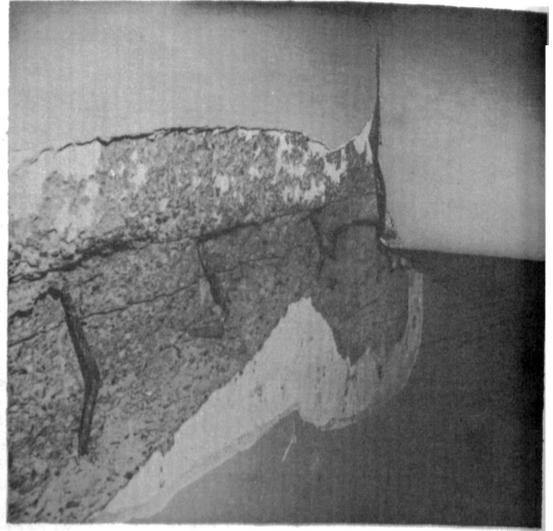
Fig. 25. Movement along construction joint of interior shear wall, Anchorage-Westward Hotel.

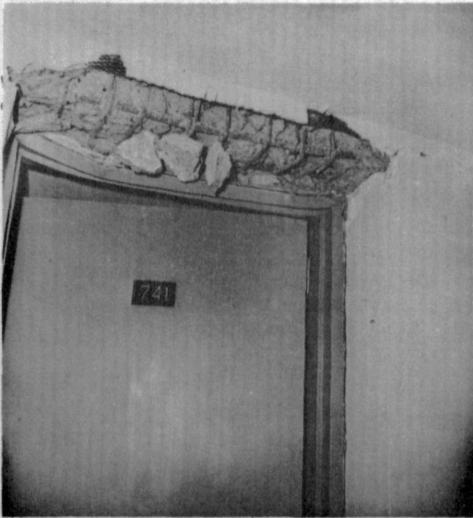
Fig. 26. Typical damage to openings piercing interior shear walls, Anchorage-Westward Hotel.

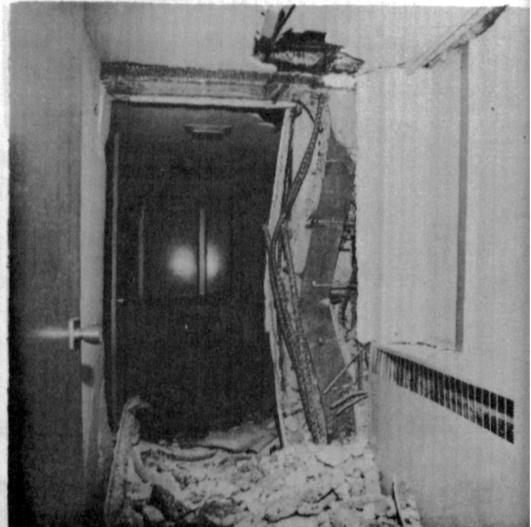
Fig. 27. Buckled steel erection column, Anchorage-Westward Hotel.
