SEISMIC BEHAVIOR STUDY OF LIFELINES IN THE OCCIDENTAL **REGION OF MEXICO**

SUMMARY

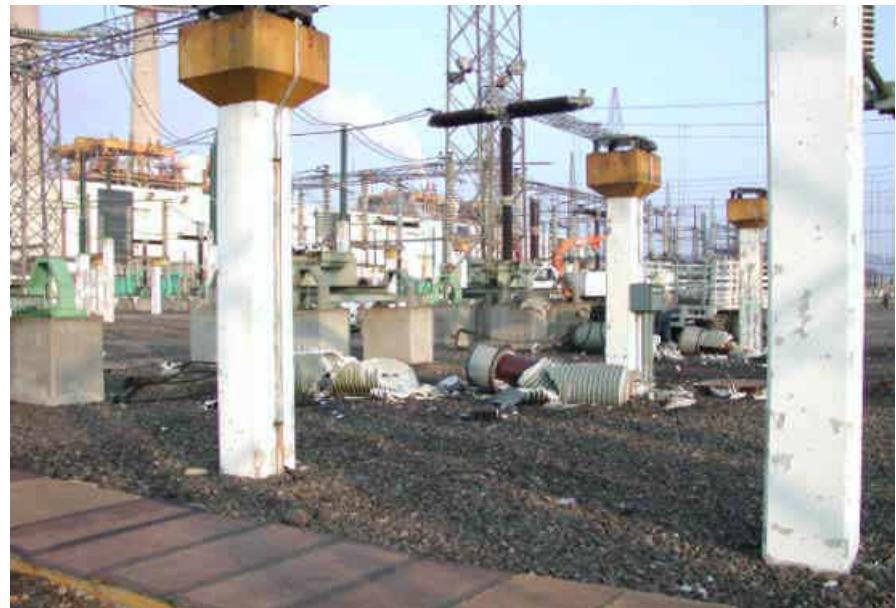
Figure 4 depicts the collapse of two 400 kV Potential transformers in the Manzanillo I-II substation. As can be seen, transformers are mounted on single concrete columns (as high as 3 m tall) with an enlarged upper end; this, coupled with the geometric characteristics of the equipment and the fact that they are of porcelain material, makes them very vulnerable to earthquakes, becoming very unstable due to ground motion.

Figure 4. Partial view of damage in the Manzanillo I and II substation during the Tecoman earthquake.

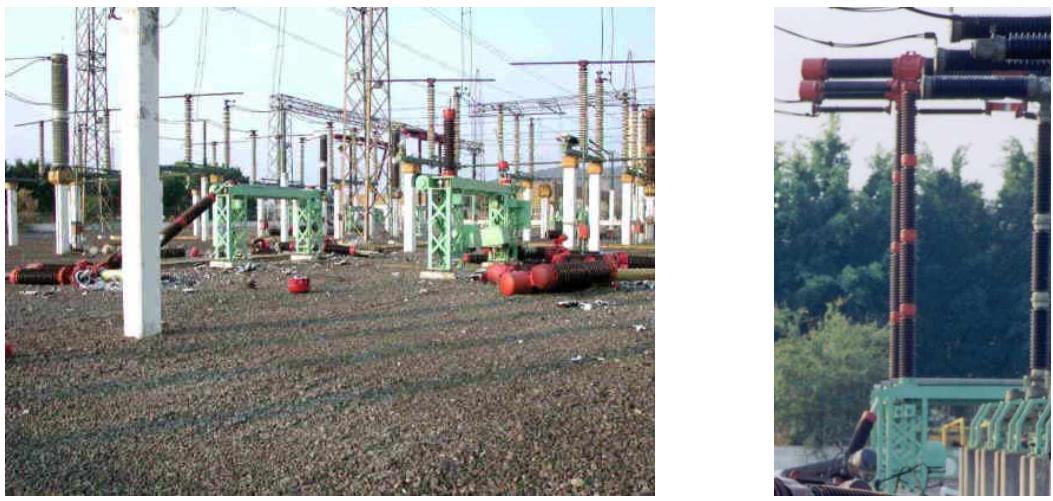
Figures 5 and 6 show failure of several circuit breakers due to the Tecoman earthquake. As shown in the first of these figures (see Figure 5a), circuit breakers were installed on a steel frame, about 1.5 m high and 4 m long. It can be seen in Figure 5b, that these circuit breakers had an original "T" shape, made up by a group of 4 porcelain vertical elements and another 4 horizontal elements of the same material.

Figures 5. A) Circuit breaker collapsed ; B) Original set up of circuit breakers (far end)

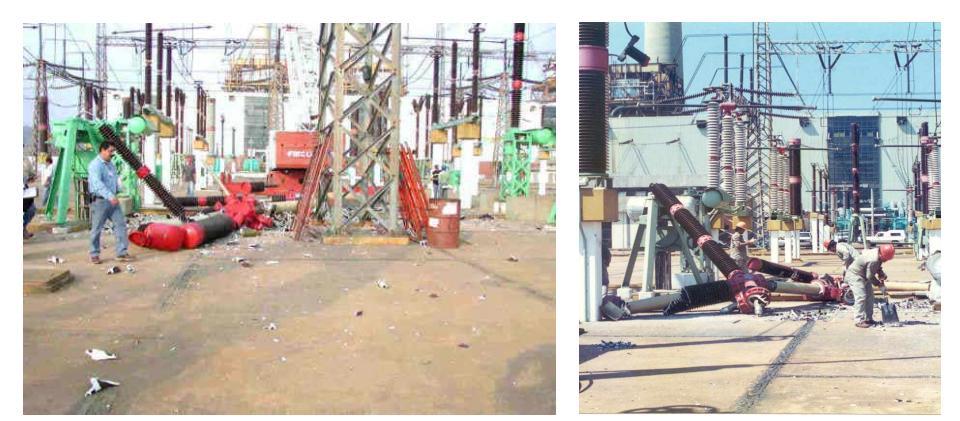
Another type of arrangement is shown in Figure 6; here each circuit breaker rested on a steel tripod base (see Figure 6a). This type of arrangement did not behave any better than the one just described, and most of them collapsed. This type of failure was observed on the 1995 Manzanillo earthquake (Figure 6b), thus it is apparent that such arrangements for this type of equipment is highly vulnerable to the earthquake action.

Figure 6. Circuit breakers on isolated supports. A) 2003 earthquake B) 1995 earthquake

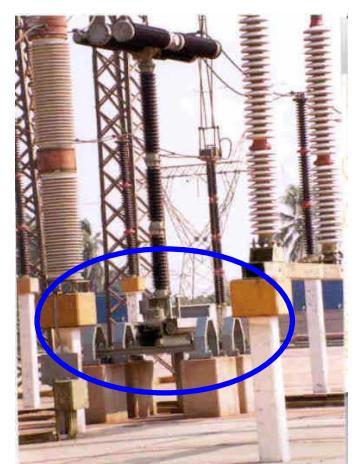
It is worth noting that after the failure of circuit breakers during the 1995 earthquake, CFE installed damping devices of the type shown in Figure 7, in many such pieces of equipment for several of the Manzanillo area substations. Most of the circuit breakers with such protection behaved well and survived the 2003 earthquake, as can be seen in Figures. 5b (near end) and 7. These pictures were taken after the January Tecoman earthquake.

Figure 7. Circuit breaker with damping devices in the Manzanillo I-II substation

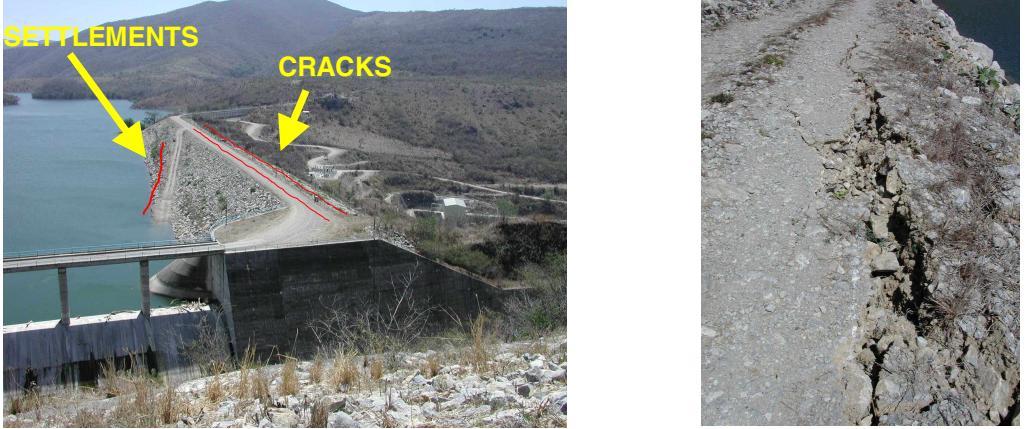
Large urban water systems normally include a source, treatment, storage (reservoirs and tanks), and distribution. Following the 2003 Tecoman earthquake the Water National Commission (CNA) reported damage in both the storage and distribution systems. The Trojes (Figures 8A and 8B) and Basilio Badillo

reservoirs suffered a slight damage, however none of these turned out to be in a danger situation and continued working normaly. Both reservoirs are used to supply the potable water to some towns of the region as well as for irrigation purposes.

Figure 8. Trojes reservoir. A) An important cracks appeared in the top of gravity dam. B) The auxiliary road had a settlements of several centimeters.

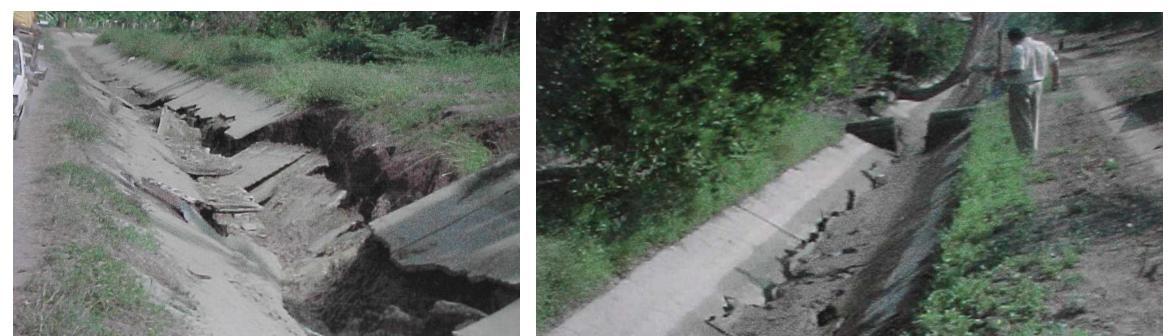
Nevertheless, the earthquake inflicted extensive damage to eight water aqueducts. The bulk of the observed aqueducts damage was due to soil compaction at stream crossings (See Figure 9). The aqueducts' damage cut off the water supply to the region's populations. The repair time of all aqueducts to supply potable water to all towns which had such service before the earthquake was approximately a month and the cost of the repair work was more than 600,000.00 USD.

Figure 9. Extensive damage of aqueducts lines. The damage cut off the towns water supply.

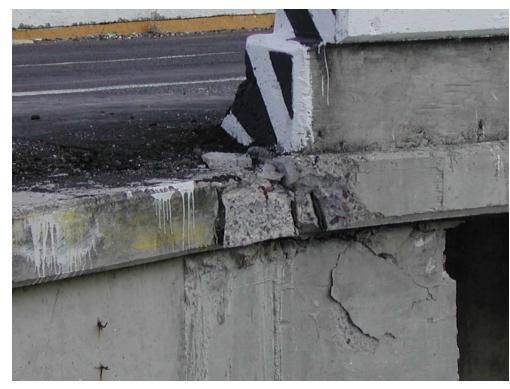
Bridges are very important elements in the modern transportation systems, and they are prone to suffer damage due to earthquakes. The damage induced in bridges can take many forms, depending on the ground motion, site conditions, structutal configuration, and specific details of the bridge. The Communications and Transports Secretary of Mexico (SCT) reported that several bridges suffered slight to moderate damage due the Tecoman earthquake. The Coahuayana bridge suffered an important damage, which cost of restoration ammounted to close to 700,000.00 USD. The slopes of Jiquilpa bridge had a settlement of 10 cm approximately. It was reported also that the bridges' columns had substantial movements, causing the total destruction of seismic stops on several bearings. Another kind of bridge damage was due the collision of bridge decks and lateral displacement between two decks (Figures 10 and 11). In spite of bridges' damage, all of them continued working normally.

Figure 10. Damage due to collision of bridge deck and the embankment.

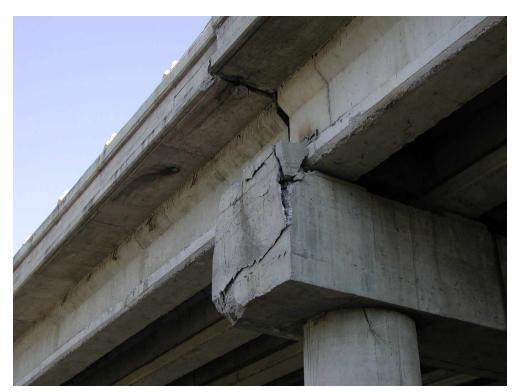
Figure 11. Damage in the limit stops due to lateral displacement.

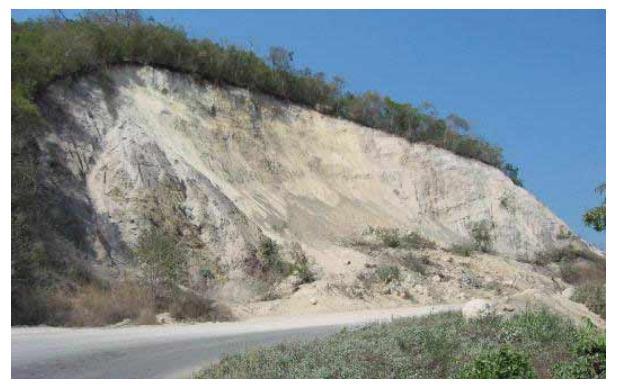
On the other hand, landslides triggered by the Tecoman earthquake were observed (Figure 12). This landslides obstructed the vehicular traffic during several hours. The most important landslide was on the Colima – Manzanillo highway with a cut of $18,000 \text{ m}^3$ of material closing the traffic temporarily. The total cost of cleaning and restoration was close to 900,000.00 USD.

Figure 12. Landslides on a federal road due the Tecoman earthquake.

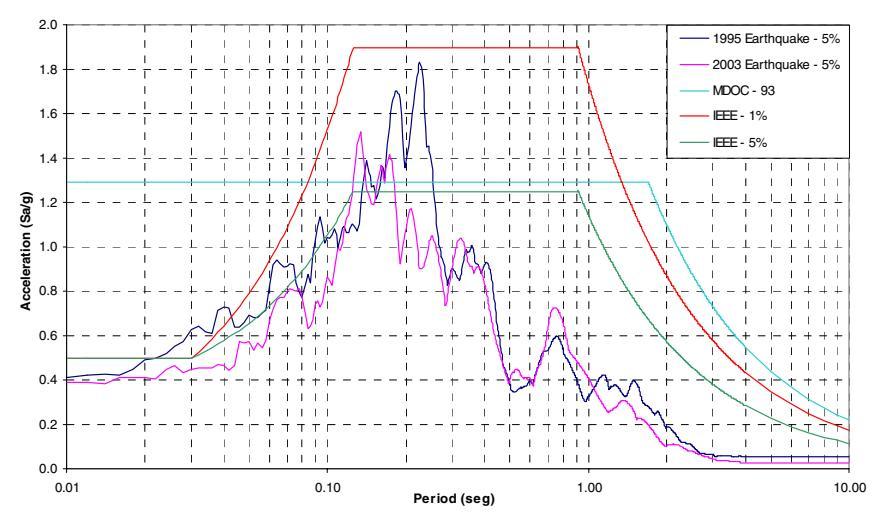
Figure 17. Comparison of the 1995 and 2003 earthquake response spectra with design spectra from recommended design manuals

As Figure 17 shows, the response spectra for both earthquakes are considerably larger than the design spectra obtained from the Mexican seismic design standard as well as the design spectra defined by the IEEE-693 document. This clearly shows that equipment was under designed in view of those documents. It should be noted that if the IEEE-693 design guidelines are used, considering a damping factor of 1% (see Figure 17), the design spectra obtained would envelope both Colima earthquake response spectra. However, it is not customary in practice to use design spectra for such low damping value.
