DYNAMIC FAILURE AND DEFORMATIONS OF DAM-MODELS ON SHAKING TABLE TESTS

Susumu MASUKAWA¹, Masami YASUNAKA² and Yuji KOHGO³

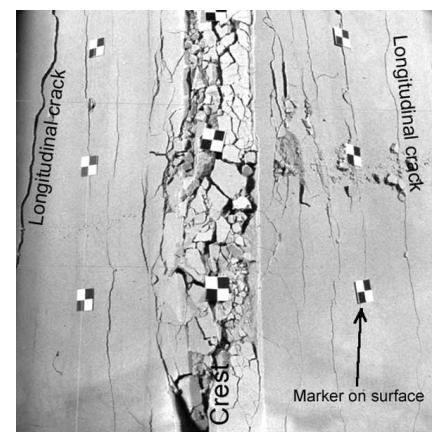
Figure 9 shows a plane view of the collapse in Case 1 (3D model). A large number of complex honeycomb-pattern cracks were seen on the crest. Cracks along the longitudinal direction also occurred on both slopes.

Fig. 9 Collapse in Case 1 (HV case, 3D model)

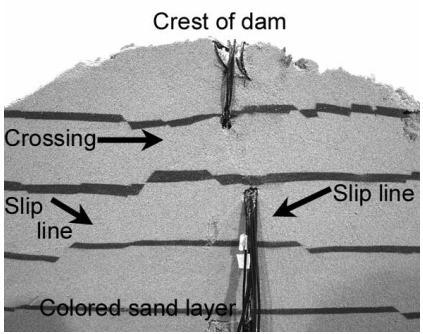
Figure 10 shows an excavated cross section in Case 3 (3D model). Slip lines toward both slopes were visually observed from sequential level differences of colored sand layers.

Fig. 10 Collapse at an excavated cross section in Case 3 (HV case, 3D model)

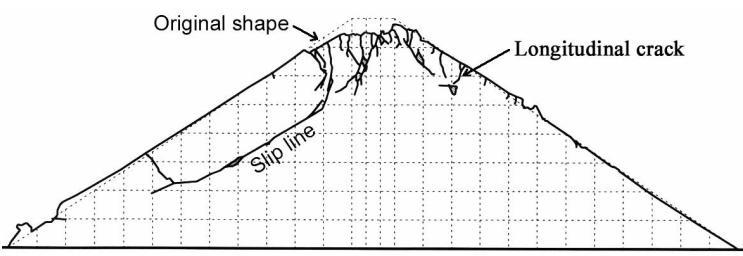
Fig. 11 Traced drawings at an excavated cross section in Case 9 (H case, 2D model)

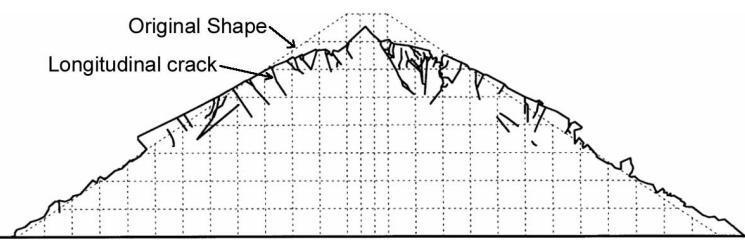
Fig. 12 Traced drawings at an excavated cross section in Case 8 (H case, 3D model)

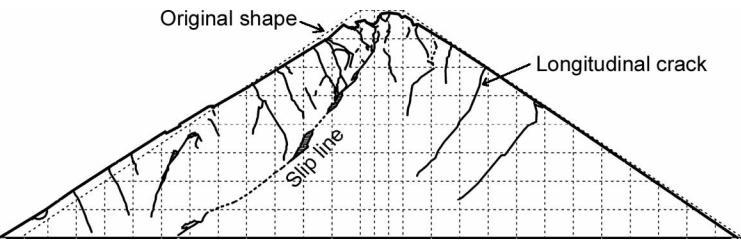
Fig. 13 Traced drawings at an excavated cross section in Case 1 (HV case, 3D model)

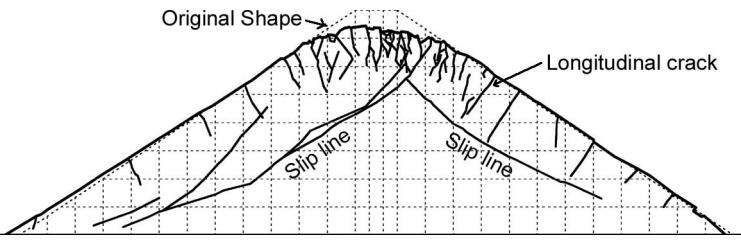
Fig. 14 Traced drawings at an excavated cross section in Case 3 (HV case, 3D model)

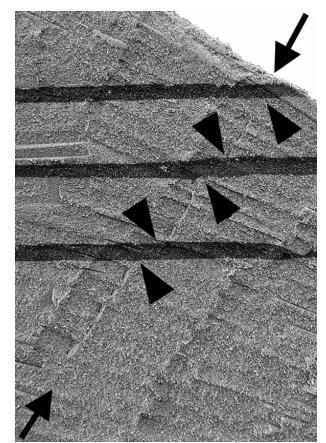
A typical shape of longitudinal cracks, as described above, on the excavated cross section is shown in Fig. 15. The cracks traced on a line connecting two arrows shown in this figure. Triangles shown in this figure indicated that transverse cracks crossed the colored sand layers and there were no level differences of colored sand layers. Thus, it was concluded that the cracks toward the longitudinal direction were tensile cracks, not cracks caused by slidings.

Fig. 15 Longitudinal crack at an excavated cross section in Case 1 (HV case, 3D model)

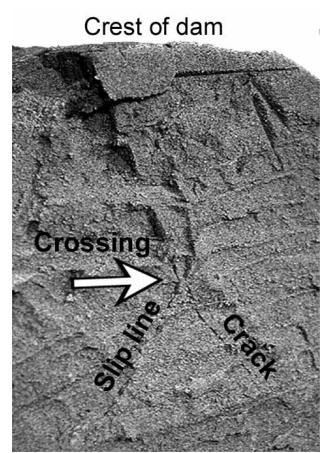
The characteristics of the slip lines in H cases and HV cases were the sliding that occurs just under the crests in a crisscross pattern (Figs. 11, 12 and 14). For Case 1 shown in Fig. 13, crack crossing the slip line were observed just under the crest as shown by Fig. 16.

Fig. 16 Crossing crack just under the crest in Case 1 (HV case, 3D model)

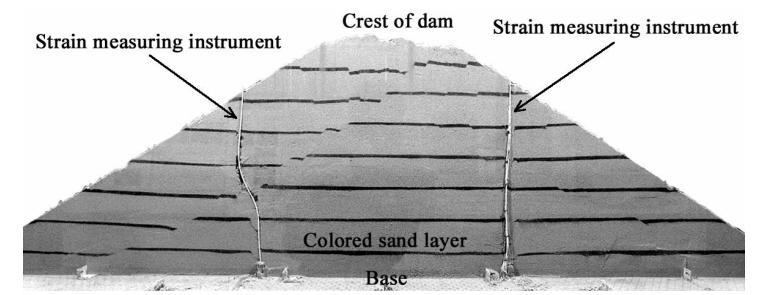
Figure 21 shows the shape of the strain measuring instrument at an excavated cross section of Case 3. The strain measuring instrument was considerably bent at the points where the slip line crossed. Even in cases where no apparent slip line was observed, the strain measuring instruments were bent. Therefore, the positions of the slip lines could be clarified with the strain measuring instruments inside the embankments.

Fig. 21 Strain measuring instruments at an excavated cross section in Case 3
