WOODEN HOUSE DAMAGE ON IMPROVED HILLS CAUSED BY THE 2001 GEIYO EARTHQUAKE, JAPAN AND MICRO-TREMOR PROPERTIES OF THE GROUND

Satoshi IWAI¹ and Teruo ASANO²

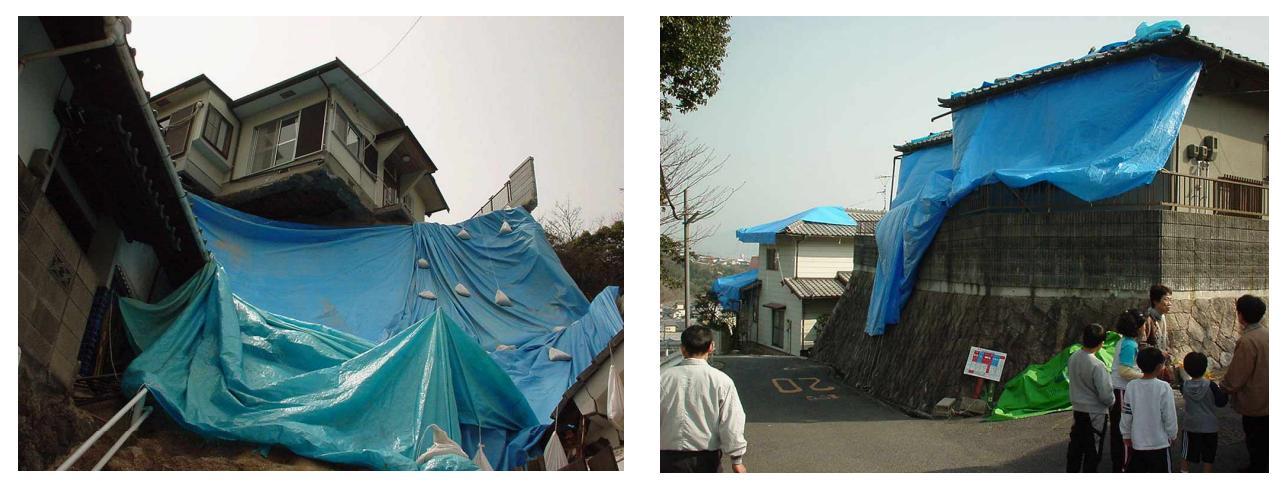
Photo 1 Damaged house stood on the steep slope land Photo 2 Tile-roof damage of wooden houses on (Kure City)

improved hills (Hiroshima City)

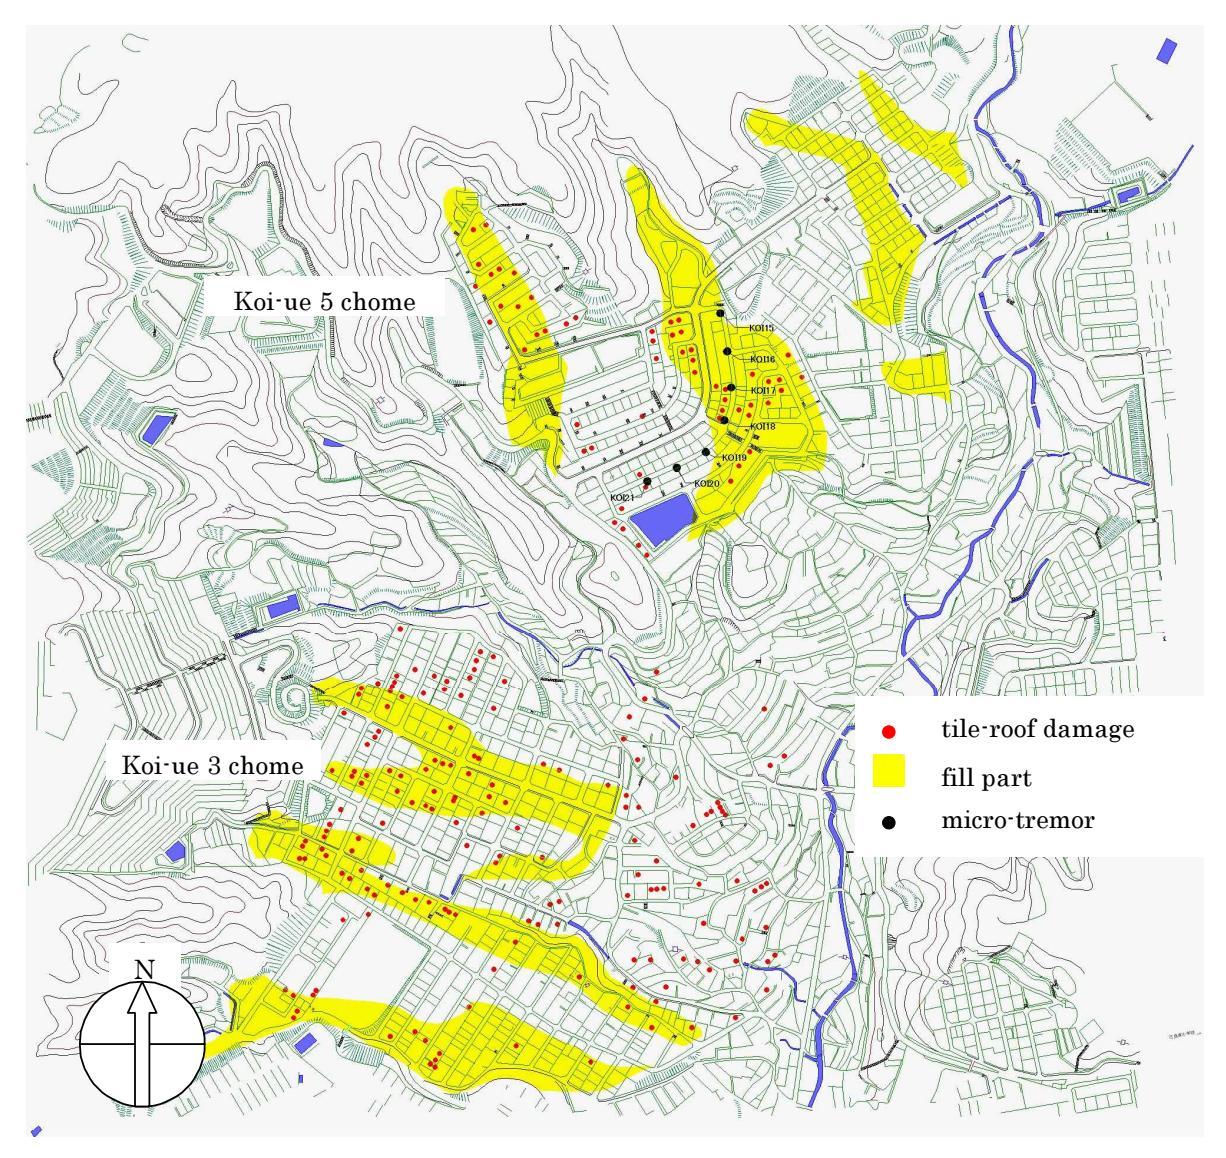
Figure 1 Housing damage state (Koi-ue, Nishi Ward, Hiroshima City)

The damage of the wooden house tile-roof was surveyed in 3 chome and 5 chome areas on Koi-ue district in Hiroshima City, on April 4 of about ten days after the earthquake occurrence. Figure 1 shows the housing damage state. The red round mark shows the house with damage, whose roof is covered by a blue waterproof seat. The houses were made on the hill ground, and passes about 30 years. As for tile-roof damages, there is considerably a lot of damages in the Koi-ue district compared with damages in the delta soft-subsoil region in the center of Hiroshima City, where the house damages were hardly seen. The house site is piled up with the having retaining wall, and damage is caused by the crack and the collapse of the retaining wall.

The classification of the cut and the fill ground in the Koi-ue district⁴⁾ was shown in Figure 1. A lot of tile-roof was damaged in the fill part than in the cut part.

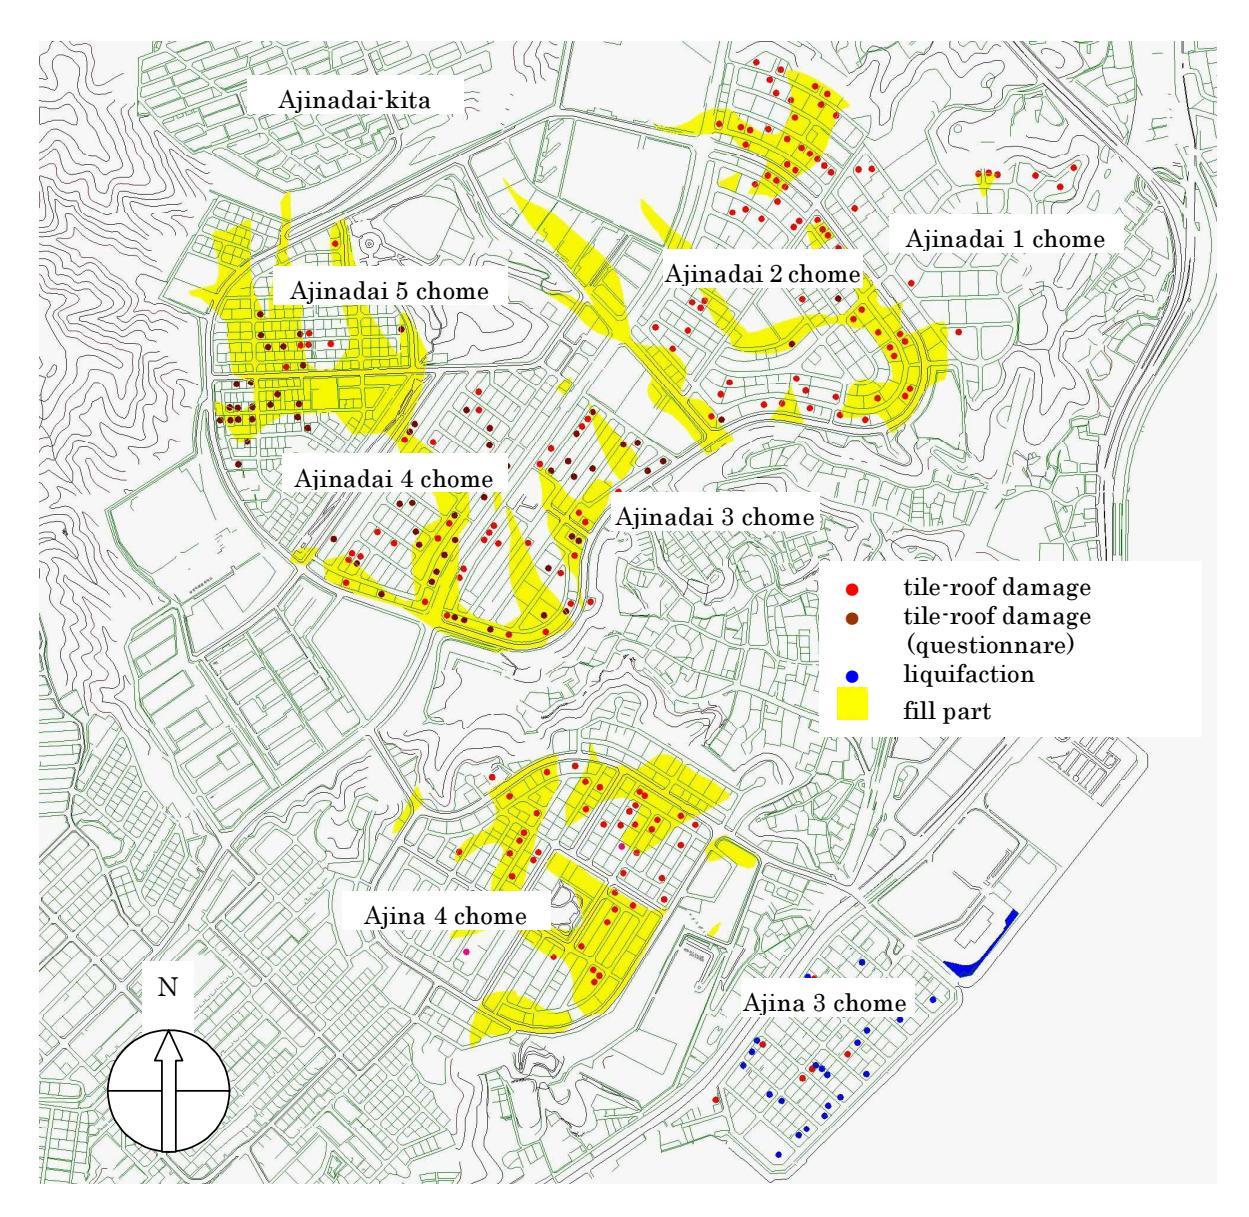
Figure 2 Housing damage state (Ajina and Ajinadai, Hatsukaichi City)

The roof damage states of the residential quarter in Ajina and Ajinadai, Hatsukaichi City, were investigated on the 28th April and 8th of May, on which one month passed from the earthquake occurrence. Figure 2 shows the tile-roof damage states. A red round point indicates a house observed roof damage, a brown round point a house with roof damage reported due to a questionnaire survey described later, and a blue round point liquefaction, respectively.

The fill of yellow area in Fig. 2 shows the results that the author distinguished the cut and fill according to difference of the altitude data of each 10m of the geographical features before and after improvement. The fill thickness is thought to be about 5-10m in average. The maximum thickness of the fill shows 20m under some circumstances. The tile-roof damage by a questionnaire and a site investigation confirmed the considerable correspondence. A lot of tile-roof damage on the fill land is obviously recognized.

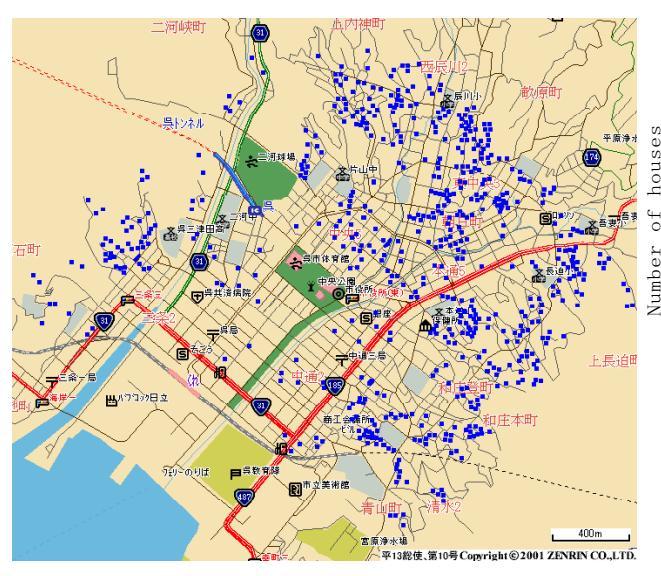
Fig. 3 Distribution of blue waterproof seat in Kure City

Figure 3 shows the distribution of the waterproof seat on damaged roof in Kure City. It is understood that there was a lot of tile-roof damage on the hill ground around the town compared with the city center. In Fig. 4, the presence of the tile-roof damage of each town by the questionnaire is summarized. From total of questionnaire seismic intensity of Fig. 5, it is understood that the seismic intensity was 5.5-6.5 and relatively high in the steep slope land which is adjacent to ridge convex. On the other hand, seismic intensity was 5.0-6.0 in seismic intensity at the city central on flat ground in which tile-roof damage does not exist. Relation of the average value of the questionnaire seismic intensity to the presence of the tile-roof damage is shown in Fig. 6. A structural condition of an individual building and a ground condition that the building is located are included in the questionnaire seismic intensity. The questionnaire seismic intensity in the house with the tile-roof damage appears is seen roughly from 5.5 to 6.0.

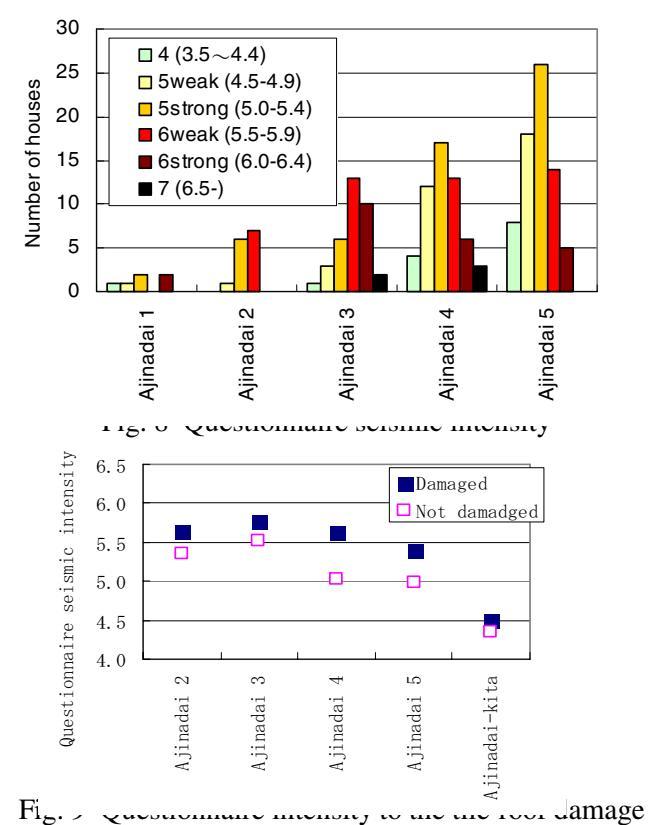
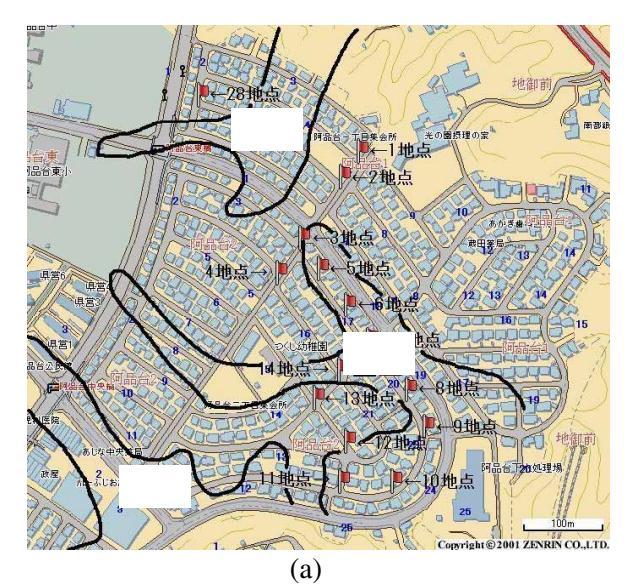
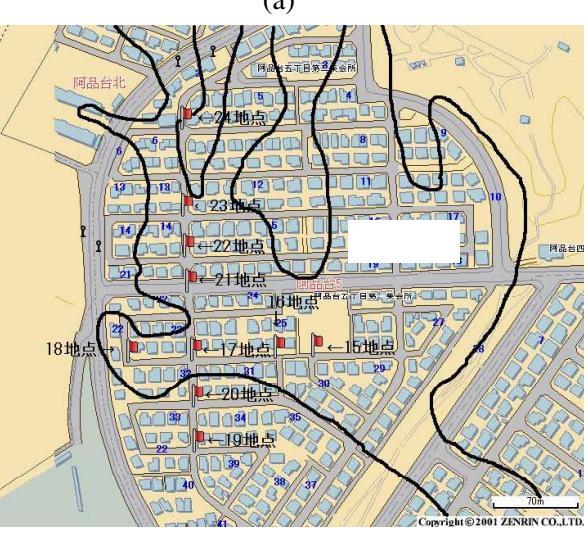
Fig. 10 Measurement locations in Ajinadai

Figure 10(a)- (c) shows the micro-tremor measurement locations selected 28 points as shown in Ajinadai crossing the fill and cut ground. The measurement points were (a) 7 places in the cut ground, (b) 2 places in the cut ground near boundary between the fill and the cut, (c) 9 places in the fill ground near boundary between the fill ground. The micro-tremor measurement was executed at nighttime when an external noise was few. The power spectrum of the velocity record of these horizontal east-to-west component was shown in Figure 11 divided into four

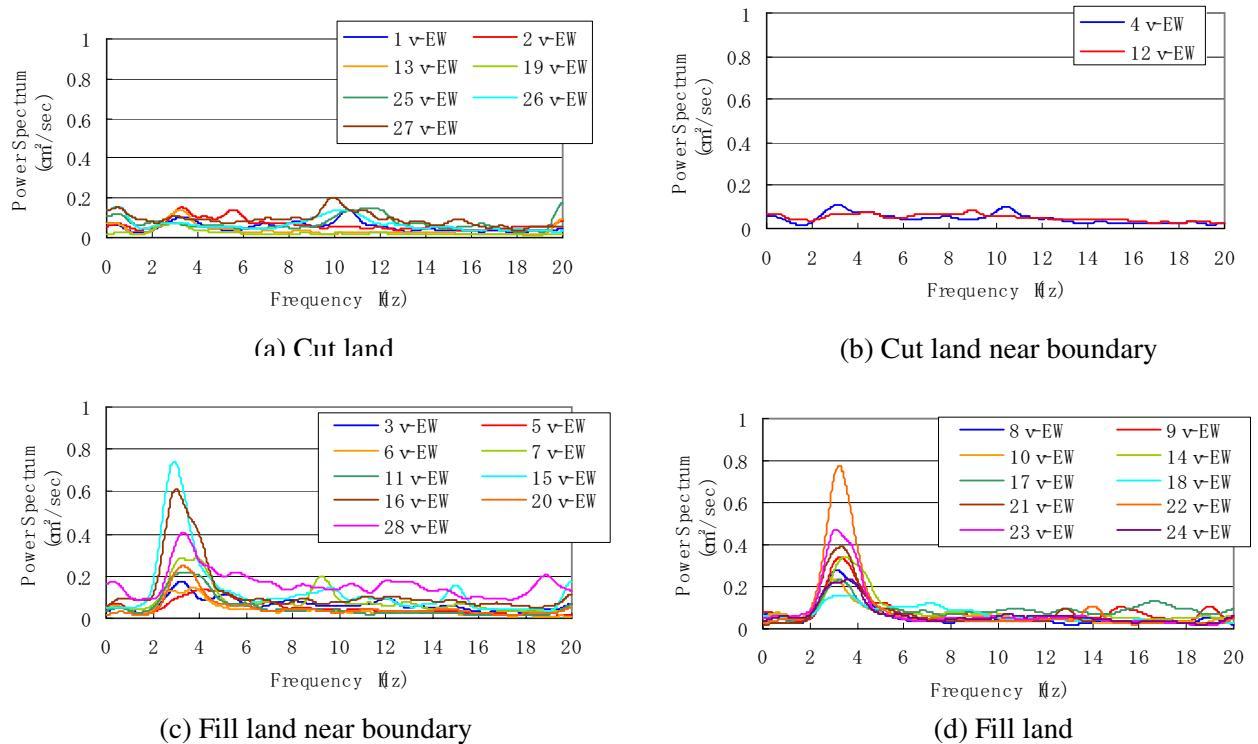
Fig. 11 Power spectrum of the velocity record of these horizontal east-to-west component

categories, correspond to the type of the ground, respectively. The first figure such as "1v-EW" shows the micro-tremor measurement point number in Figure 10, and "v" means a velocity record, and "EW" is an east-to-west component (Hereafter, Figures 12 and 13 are also similar).

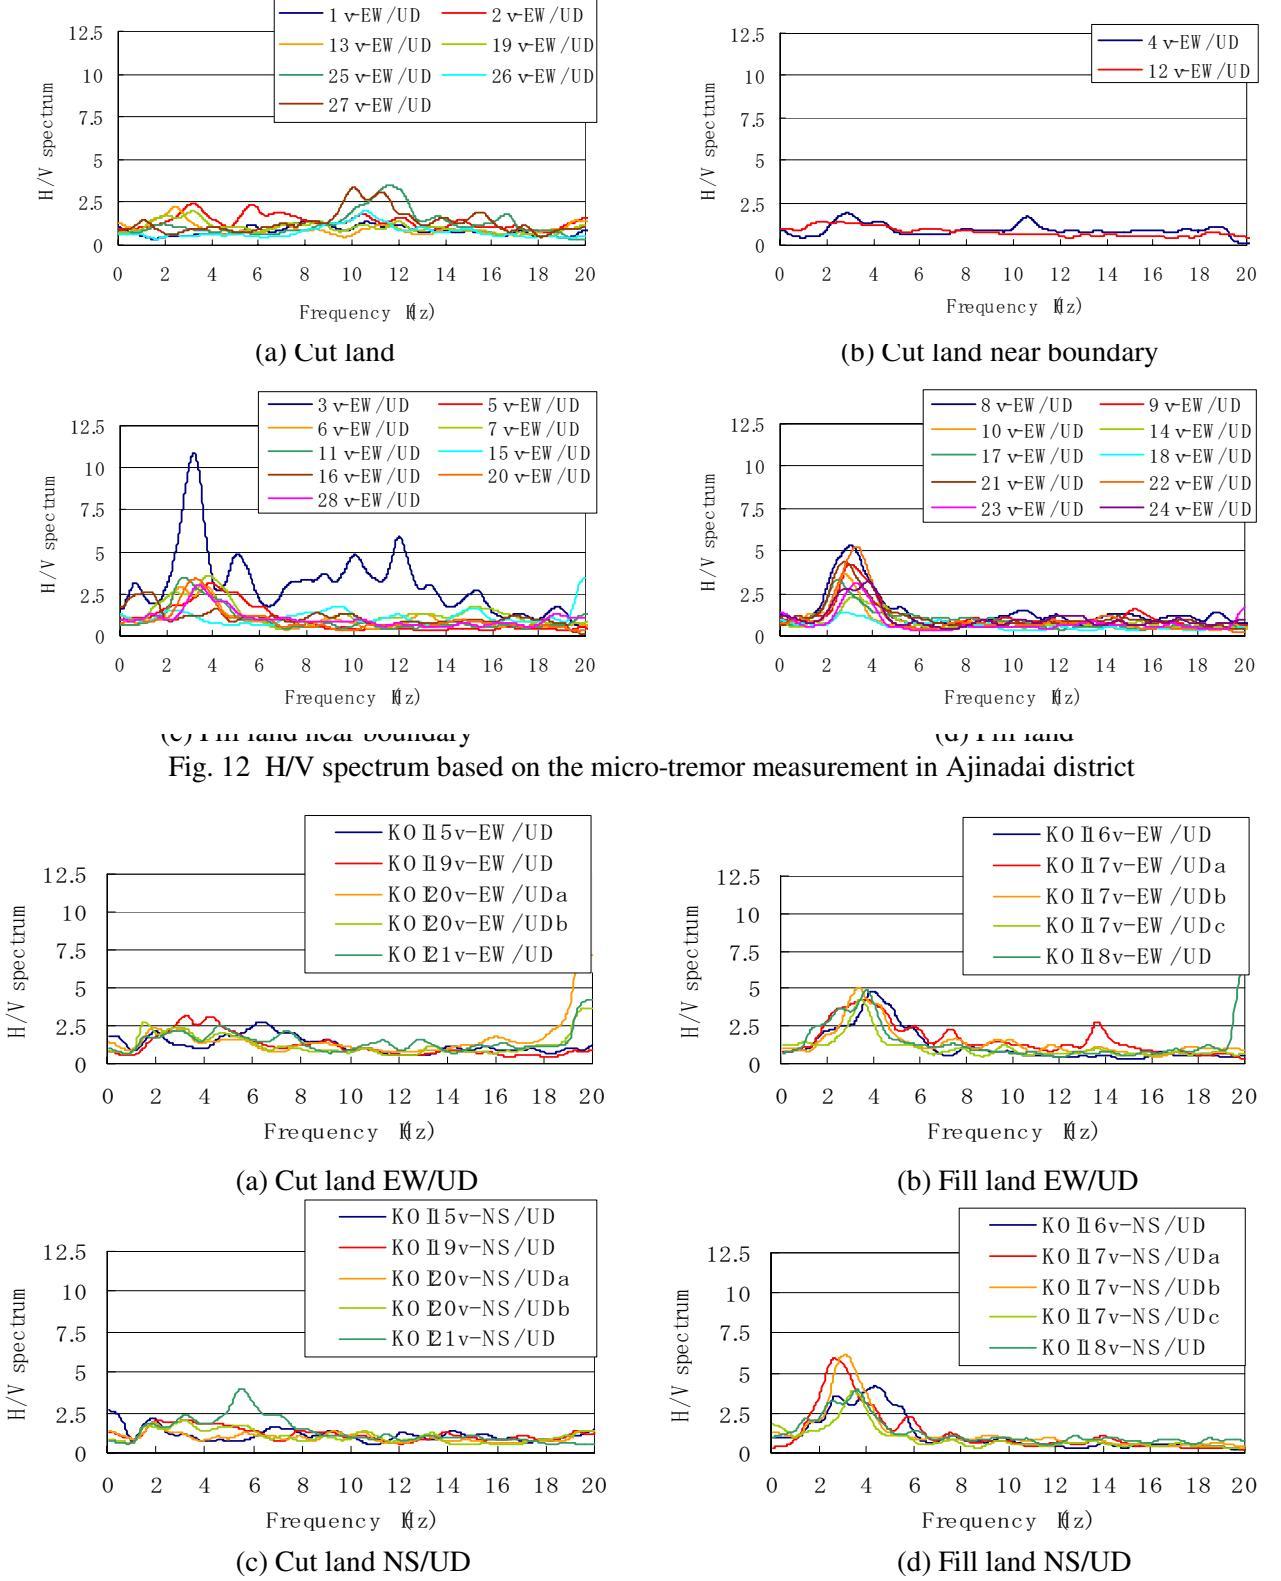
Fig. 13 H/V spectrum based on the micro-tremor measurement in Koi-ue district

The micro-tremor measurement was executed at seven points, shown in Fig. 1, at the daytime on Koi-ue 5 chome district, Hiroshima City. An H/V spectrum is shown in Fig. 13. The a, b, and c in explanatory notes show the results of several measurements at the same point, thus they designate the difference of the spectrum. Although Koi-ue district has a little complicated geographical features between cut and fill, micro-tremor characteristic has the harmonized result with Ajinadai. The predominant frequency of H/V spectrum of the velocity record of the micro-tremor is 3-4Hz in a fill part of the ground where comparatively a lot of tile-roof damage is observed. On the other hand, the vibration characteristic at the site in cut ground is almost flat in frequency range about from 0.5Hz to 20Hz.

the noise between the velocity and displacement records. A clear difference of the characteristics by the observation in both the south-to-north and east-to-west direction was not seen. As mentioned above, the H/V spectrum tends to be almost flat at sites in the cut ground, except a little predominant frequency in about from 10Hz to 12Hz range. On the other hand, the H/V spectrum has a clear peak in about 3Hz in the fill ground, and it is understood to have combined vibration characteristics of both ground in the vicinity of boundary between the cut and fill. Thus, the difference between the cut and fill appears to the characteristic of the H/V spectrum.
