TO OBTAIN SEISMIC SHOCK DIRECTION OF ANY EARTHQUAKE BY USING CRACK MEASUREMENTS

Ozkan ISLER¹

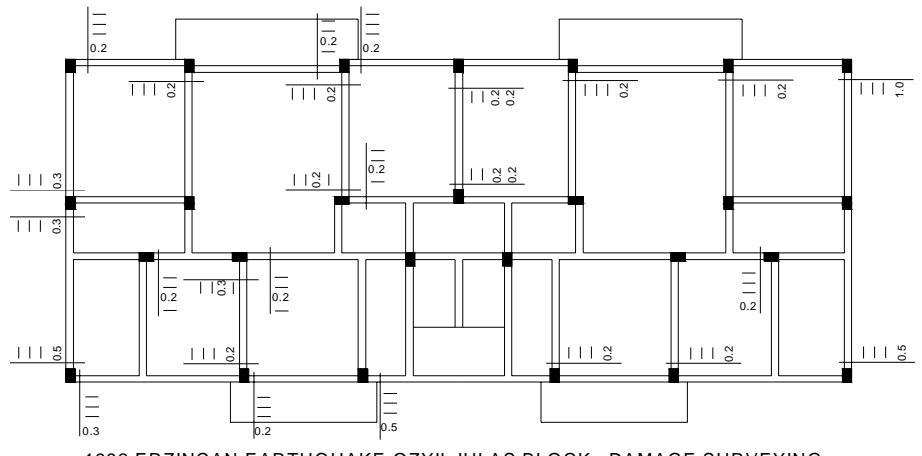
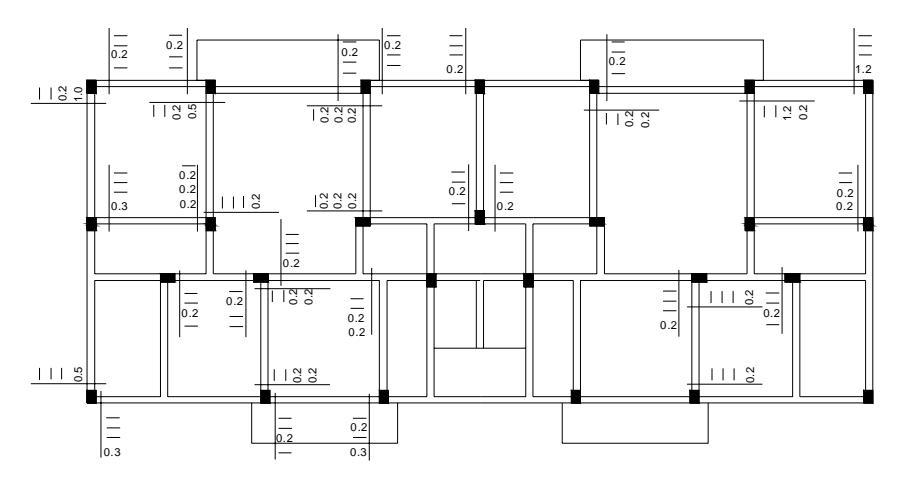
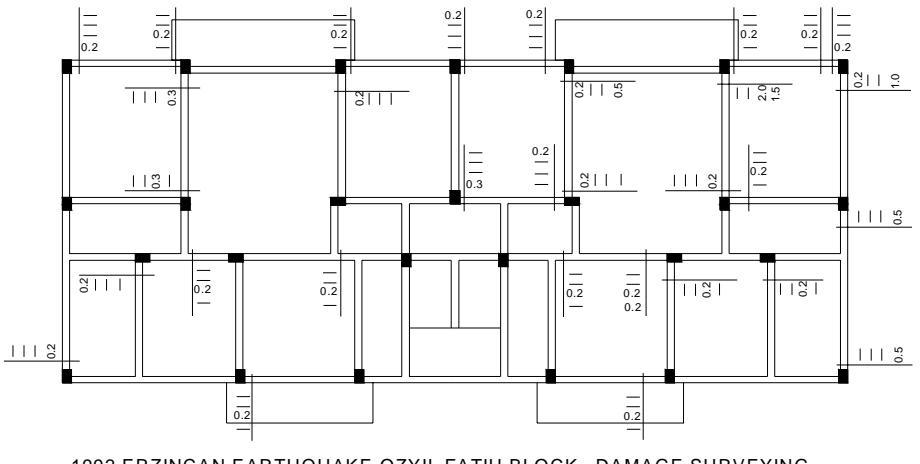
Fig. 4 Cracks with measurements on the Ozyil buildings (in mm.)

The fracture widths forming in the nodal points of the beam-column of the reinforced concrete frames and the beams web in the areas near to the support have been measured and recorded in visual determinations in the buildings damaged in the medium level after 1992 Erzincan earthquake. These buildings are those having the concrete skeleton structral system with totally 4 floors, including (basement + ground floor + 2 regular floors).

1992 ERZINCAN EARTHQUAKE-OZYIL SINAN BLOCK, DAMAGE SURVEYING

1992 ERZINCAN EARTHQUAKE-OZYIL FATIH BLOCK, DAMAGE SURVEYING

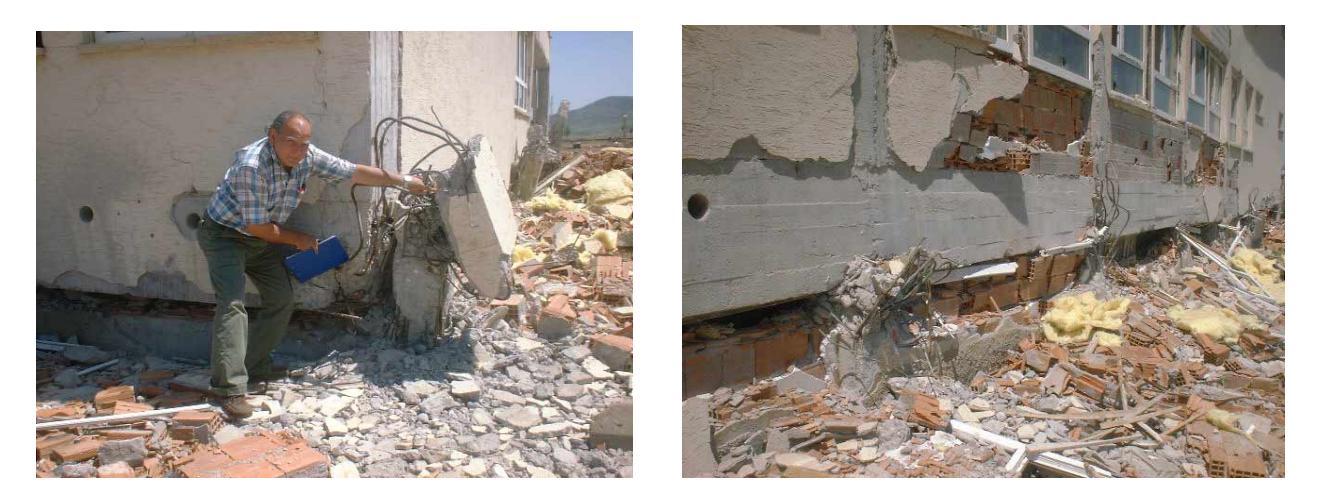
(F1) (F2) Fig. 7 Horizontal replacements of the first floor and damaged columns after collapse

Ex= V. $\delta x = V.(27.5cm) = 27.5V$ Ey=V. $\delta y = V.(15cm) = 15V$

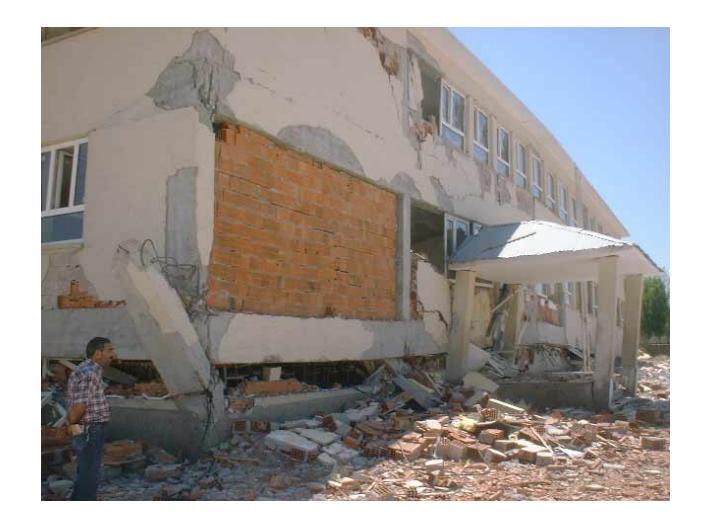
Celtiksuyu Regional Boarding Primary School Buildings, having quite interestingly collapsed in 2003 Bingol earthquake has been selected as the sample building for this study. No basement exists in this building having a concrete support structural system with 3 floors. The building has interestingly collapsed after the earthquake. In the building that the concrete quality is too bad, all the ground floor columns have completely been broken during the earthquake and the headlining of the ground floor has been destroyed. Only two floors on the upper side have been able to achieve last as heavily damaged. The seismic energy coming from the ground to the building has firstly broken all the ground floor columns and then caused shifting the upper floors in the direction of the shock that the earthquake is effective. The situation plans belonging to these buildings and the structural system plans have been illustrated in the figures 1, 2 and 3.

(F3) Fig. 8 Collapse of the ground floor of Celtiksuyu Primary School

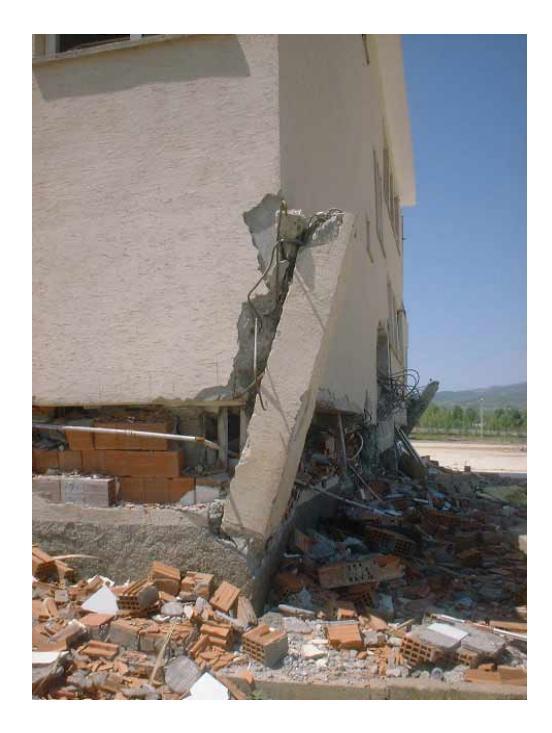
(F4) Fig. 9 Heavy damaged ground floor column at the corner

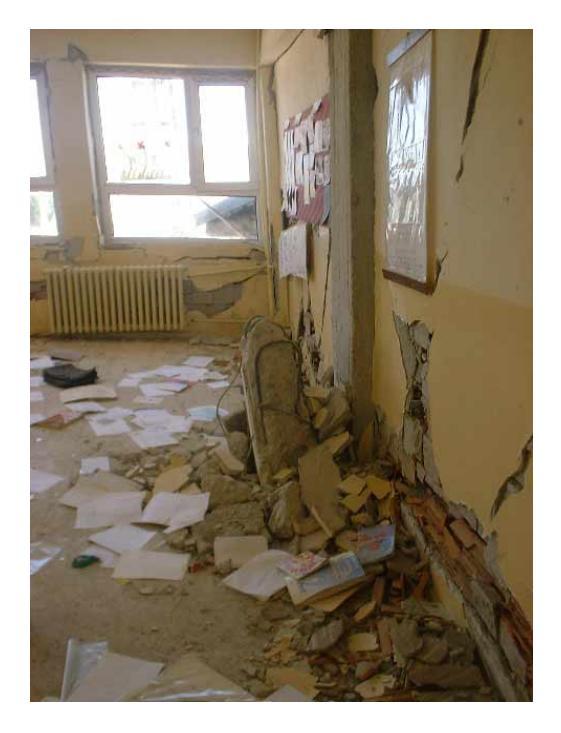
(F5) Fig. 10 Punching in 1st floor slabs by ground floor columns
