PERFORMANCE OF BUILDINGS OVER LIQUEFIABLE GROUND IN ADAPAZARI, TURKEY

SUMMARY

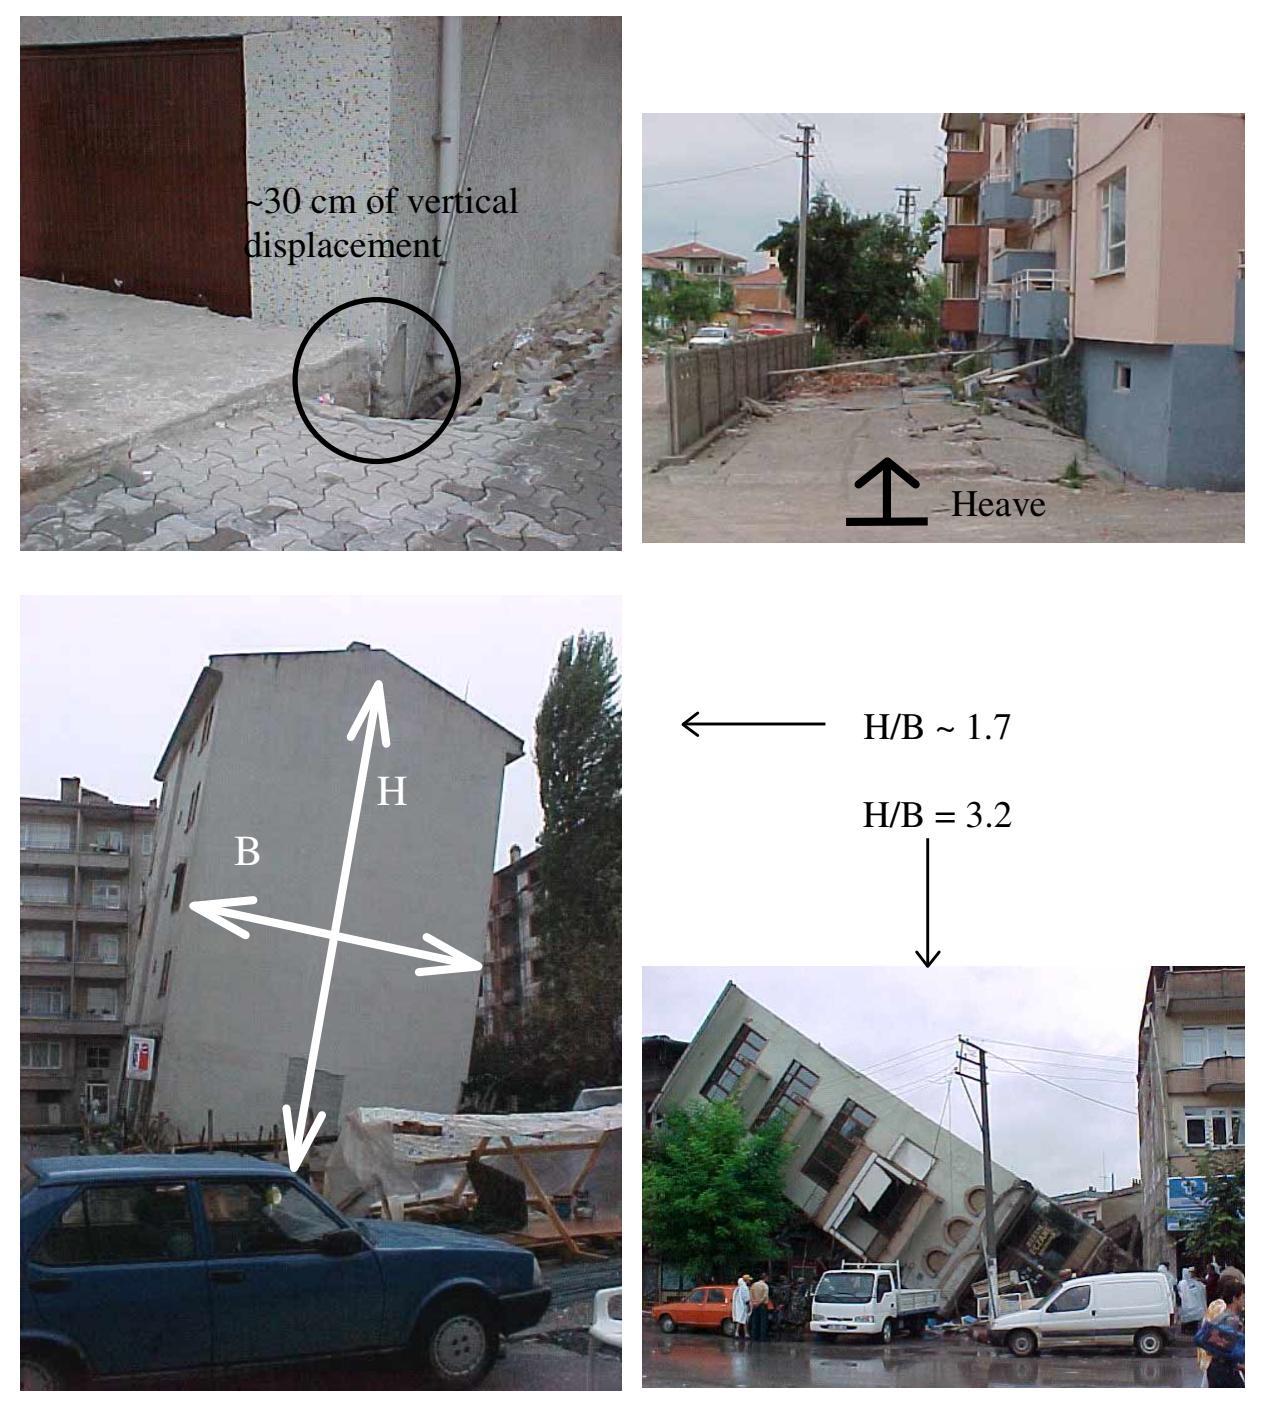
<u>Uniform vertical displacement</u>: Many buildings in Adapazari sunk into the ground, many times without noticeable tilt as is shown for the case of Figure 2a. At times, heave of the surrounding ground was observed as in the case of Figure 2b.

<u>Vertical displacement with tilt</u>: Some buildings experienced non-uniform vertical deformation, causing the building to be condemned albeit devoid of structural damage as for the example shown in Figure 2c. Toppling of buildings, depicted in Figure 2d, was typically observed in laterally unconstrained slender buildings, i.e. large ratio of building height (H) to its width (B).

Figure 2: Examples of ground failure-induced building damage in Adapazari after the August 17, 1999 Kocaeli earthquake: a) vertical displacement, b) vertical displacement with ground heave, c) vertical displacement with significant tilt, and d) bearing capacity failure (Sancio [12]).

Given that the failure is shallow, the initial squeezing causes some heave at the surface as was observed at some of these sites (Figure 2b). Conventional methods used to calculate deformations along potential sliding surfaces (i.e. Newmark-type analysis) are not directly applicable, because the soil in this case is not sliding along a surface but deforming over it. The implementation of the finite element method to model the problem is perhaps a better way to analyze the deformations to which soil elements are subjected. These analyses should be the work of continuing research into the performance of buildings over liquefiable ground to develop methodologies that allow design engineers to estimate seismically induced settlement of foundations over potentially liquefiable ground.

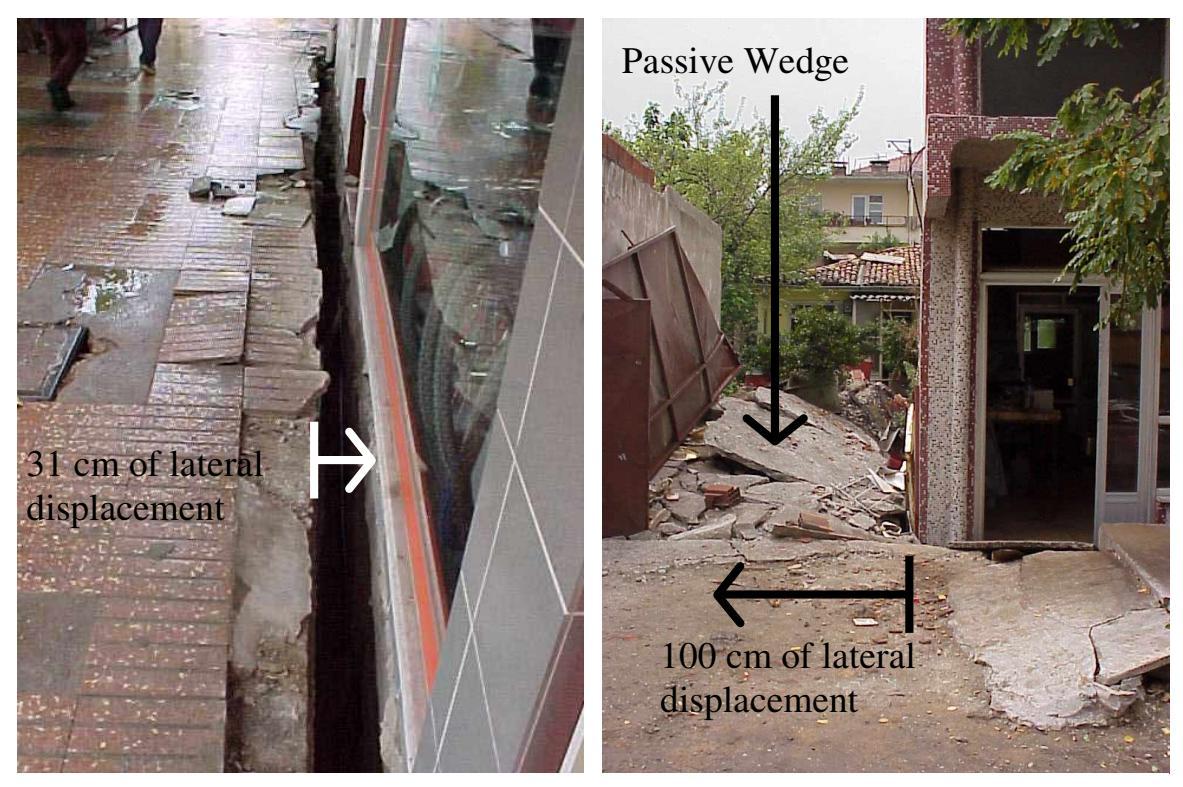
Lateral translation: A previously undocumented failure mode was also observed in Adapazari. Some buildings translated laterally over liquefied soil directly beneath their foundation. Two such cases are depicted in Figure 3. In the first case, the structure displaced 31 cm away from the previously adjacent sidewalk. In the second case, the structure displaced approximately 110 cm in the direction of an open alley mobilizing a wedge of soil. This building also translated 50 cm to 55 cm in the perpendicular direction.

Figure 3: Examples of lateral displacement of structures on mat foundations in Adapazari after the 1999 Kocaeli earthquake. Note the development of a passive resistance wedge in the photograph on the right.

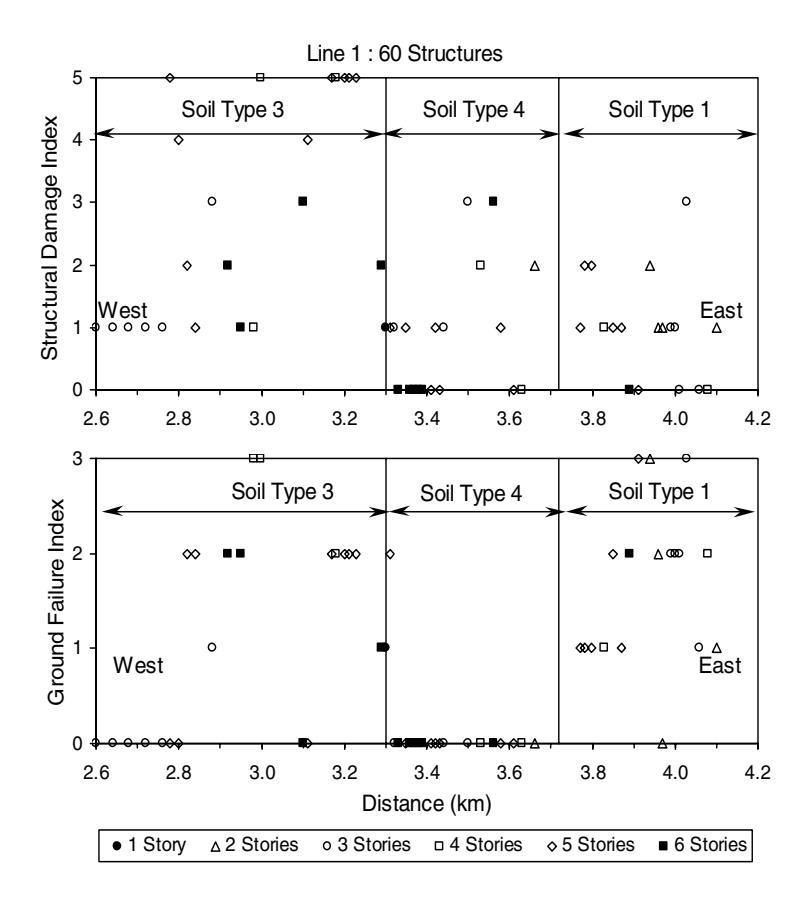
Figure 4 presents the surveyed data for 60 buildings along the portion of Line 1 that traverses the four central districts shown in Figure 1 for which the structural damage index and the ground failure index were obtained. Overall, 81 buildings were surveyed, however, the ground failure index could not be obtained for 18 buildings that underwent total collapse (D5), and 3 buildings with none or minor damage (D0 and D1). Structural damage was pervasive along this portion of the city. Thirty-three percent (33%) of the buildings surveyed exhibited complete or partial collapse (D4 and D5), and only 19% of the buildings did not suffer any structural damage. Similarly, ground failure was also widespread, although not as widespread as structural damage. Thirty-six percent (36%) of the building sites surveyed exhibited moderate to high ground failure (GF2 of GF3), but 47% of the building sites surveyed (28 buildings) did not exhibit any type of noticeable ground failure. As shown in Figure 4, these buildings appear to be concentrated in that part of the survey line between 3.3 km and 3.7 km, where the subsurface soils are not susceptible to liquefaction (i.e. soil type 4) [5]. In general, along this line, greater structural damage tended to coincide with manifestations of ground failure.

Examining the survey data of Line 1 further, of the 60 buildings where both structural damage and ground failure indices were available, 28 buildings have either four or five stories. Of these 28 buildings, 15 buildings exhibited no damage or cosmetic cracking (i.e. DO or D1). Of these 15 buildings with no to little damage, 10 buildings (i.e. 67%) had no or minor ground failure (i.e. GF0 or GF1). Of the 28 buildings with either four or five stories, 9 buildings exhibited partial or total collapse (i.e. D4 or D5) and of these 9 buildings, 6 buildings (i.e. 67%) also underwent moderate to significant ground failure (i.e. GF2).

Figure 4: Plot of structural damage index (D) and ground failure index (GF) along the portion of Line 1 of Bray and Stewart's [1] survey data shown in Figure 1.

or GF3). Thus, all else being equal along this line, most of the buildings with four or five stories that suffered significant structural damage also underwent significant ground failure. Conversely, most buildings with none to minor structural damage were located at sites that did not experience significant ground failure.

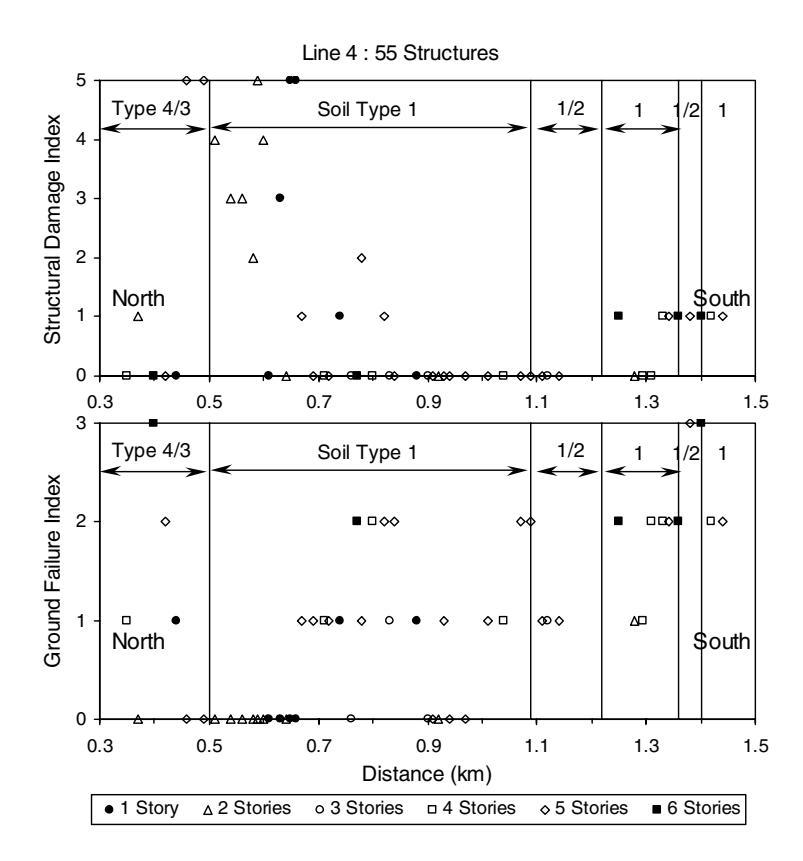
Figure 5 shows the plots of structural damage and ground failure index for 55 buildings along a portion of Line 4 (see Figure 1). As opposed to the example described previously, ground failure along this line was pervasive. Sixty four percent of the buildings surveyed (35 buildings) exhibited minor to significant ground failure (GF1 to GF3). Buildings towards the South appear to exhibit a higher degree of ground failure. Conversely, the same degree of structural damage was not observed throughout the line. Structural damage appears to decrease between 0.5 km and 0.9 km. Buildings between 0.9 km and 1.5 km only exhibited none to low structural damage (i.e. D0 and D1), while most underwent minor to moderate ground failure.

Thus, structural damage in Adapazari was observed in areas with and without ground failure. As may be observed from these two line surveys, extensive ground failure does not always produce heavy structural damage. However, this may be largely due to the robust foundation mats with intersecting grade beams that are built in Adapazari. Additionally, heavy structural damage may occur in combination with extensive ground failure or in the absence of ground failure due to just strong ground shaking and poor structural performance due to inadequate design or construction.

Figure 5: Plot of structural damage index (D) and ground failure index (GF) along the portion of Line 4 of Bray and Stewart's [1] survey data shown in Figure 1.

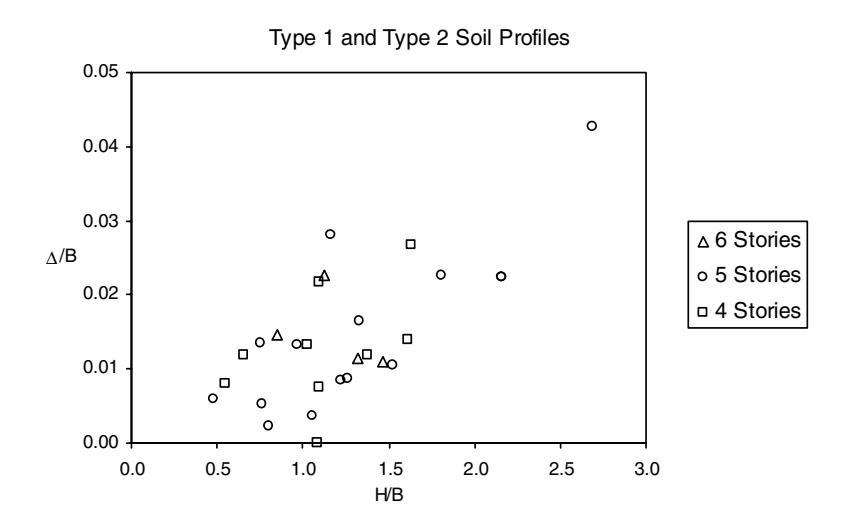
The average measured relative vertical displacement (Δ) divided by the width of the building (B), is plotted in Figure 6 as a function of the height of the building also divided by the width of the building (H/B) for structures founded on soil profiles that classify as Type 1 and 2. The height of the building divided by the width (H/B) is known as the aspect ratio, but it is also related to the contact pressure (q). As was described previously, excessive building tilt or toppling was sometimes observed in laterally unconstrained buildings with high aspect ratios. Buildings that experienced excessive tilt or toppling have been excluded from Table 1 and Figure 6.

Examining Figure 6, the amount of vertical displacement of the building relative to the surrounding ground is found to be roughly proportional to the aspect ratio of the building (i.e. H/B), which is relatively equivalent to the applied contact pressure. All else being equal, buildings of higher contact pressure (and also higher aspect ratio) experienced more vertical displacement. Regardless of the width of the foundation, on average, the taller, heavier buildings experienced greater vertical movement than the smaller, lighter buildings.

Figure 6: Relationship between building settlement (Δ) and the building height (H) normalized by the foundation width (B).

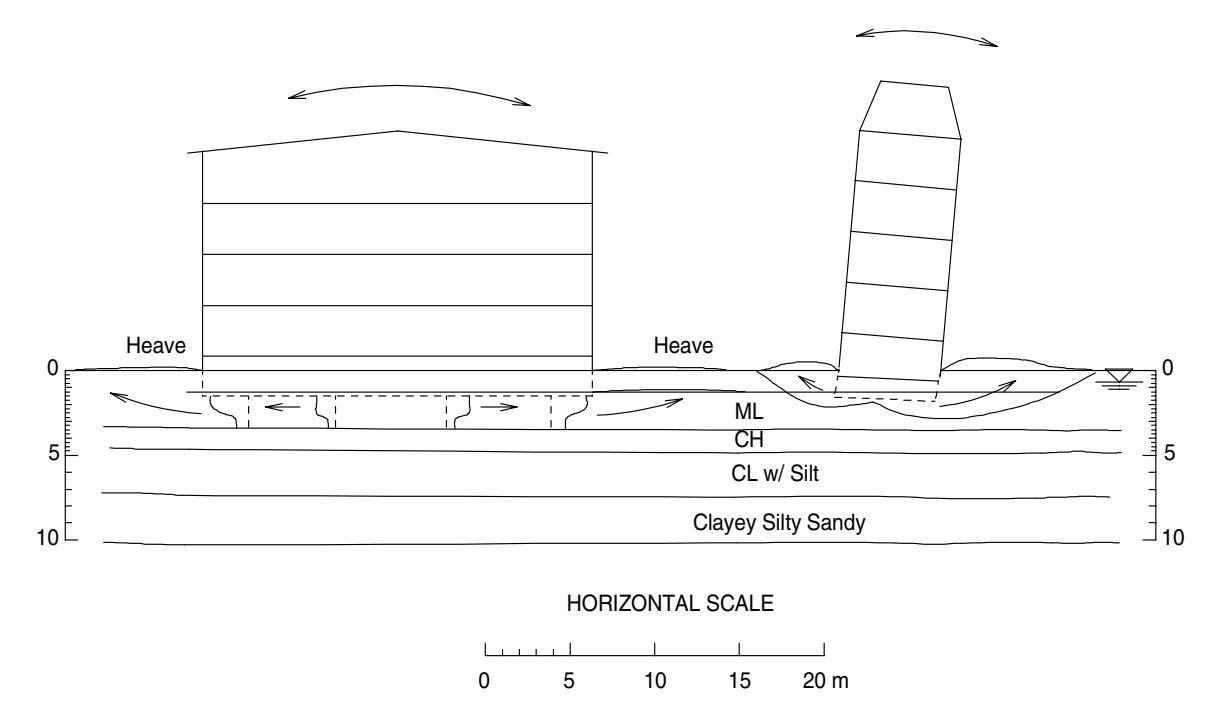
Figure 7: Modes of failure of stout and slender buildings in Adapazari.

Figure 7 depicts two common modes of building performance in Adapazari after the Kocaeli earthquake. The drawing to the left shows a stout building with a large mat foundation where its width is much greater than the thickness of the underlying liquefiable silt deposit. The drawing to the right depicts a slender building with a narrow foundation width.

The second failure mechanism shown is more representative of a typical bearing-type failure where the soil slides along a circular or semi-circular surface. In this case, as in the one previously described, the generation of positive pore water pressures causes the soil to temporarily lose strength. Additionally, horizontal shaking causes the building to apply an overturning moment at the foundation level, or equivalently, an eccentricity of the vertical load. The magnitude of the overturning moment and thus the eccentricity is a function of the seismic response of the building and the height of the building.

If the mat foundation is narrow, the effect of the eccentric load is greater because it causes stress concentrations over a smaller area of the mat foundation. When this stress approaches or exceeds the seismic bearing capacity of the soil (i.e. considering the reduction of strength due to excess pore water pressure), the building begins to tilt. As tilting is initiated, the area over which the stresses are applied is reduced, thus the magnitude of the stress increases. Under these conditions, a progressive failure is possible. Continuing tilt will cause toppling unless the bearing capacity of the soil increases sufficiently due to dilation of the soil or due to an increase of effective stress due to dissipation of excess pore water pressure, or cessation of shaking which causes the overturning moment to reduce significantly.
