# UMBRIA-MARCHES EARTHQUAKE OF 26 SEPTEMBER 1997: DAMAGE SCENARIOS AND VULNERABILITY SOURCES IN THE NOT-ASEISMIC MASONRY BUILDINGS

### SUMMARY

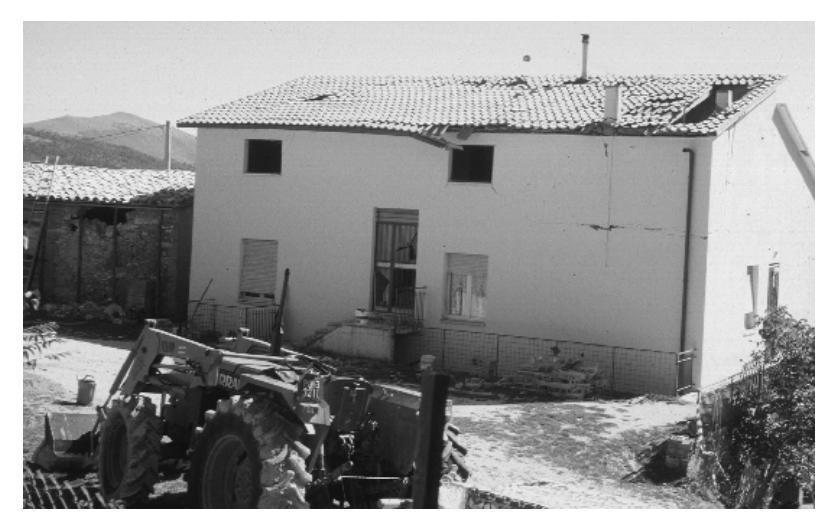
Figure 2. Civil building in Annifo (Perugia): damage of the structure of the roof and of the border elements connected to walls.

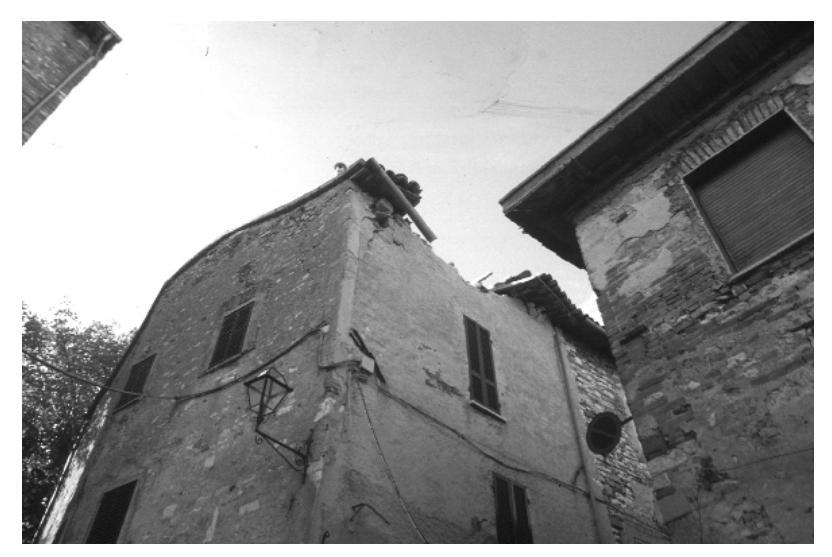
Figure 3. Civil building in Nocera Umbra (Perugia): collapse for overturning of the upper part of masonry panel supporting the roof.

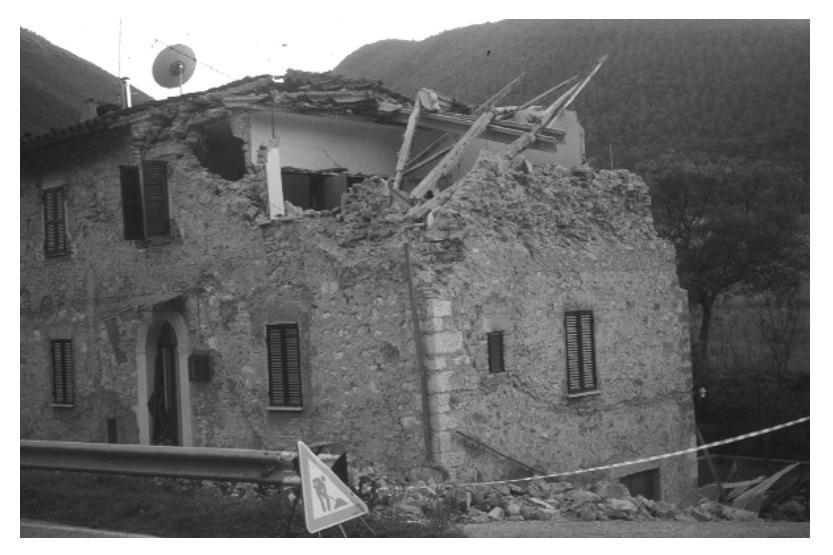
Figure 4. Civil building in Serrone (Perugia): collapse for overturning of the masonry walls supporting the roof.

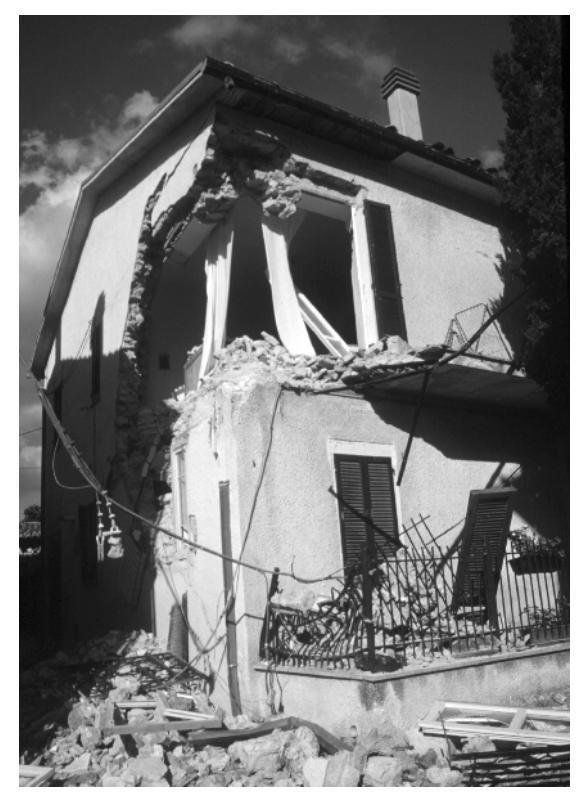
Figure 5. Civil building in Cesi (Macerata): overturning of the corner walls.

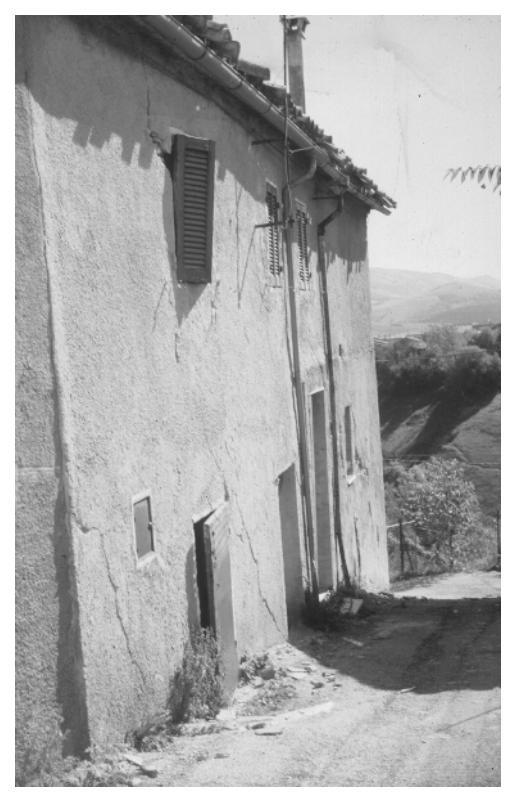
Figure 6. Civil building in Annifo (Perugia): simple diagonal cracks at the facade wall.

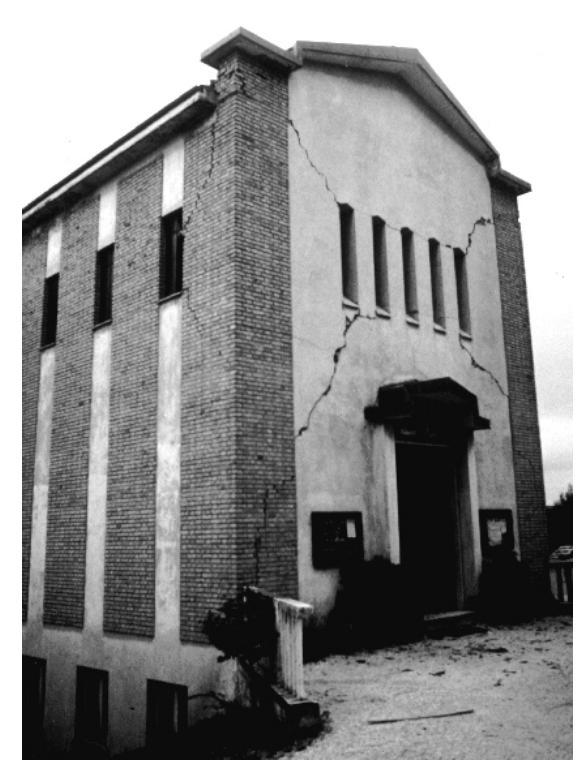
Figure 7. Church in Nocera Umbra Scalo (Perugia): double diagonal cracks at the facade wall.

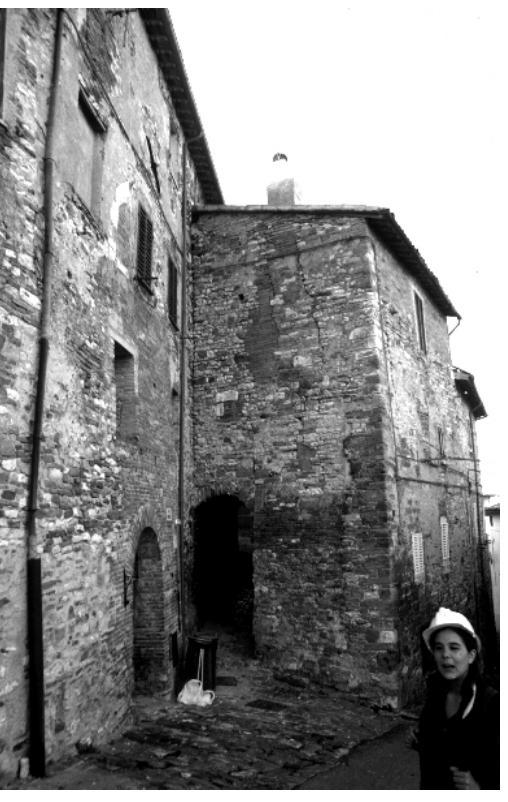
Figure 8. Civil building in Nocera Umbra (Perugia): vertical cracks in the wall due to the chimney-flue.
