LESSONS LEARNT FROM BUILDINGS DAMAGED IN THE 2018 HUALIEN EARTHQUAKE, TAIWAN

Y. H. Tu⁽¹⁾, T. Yeh⁽²⁾

Keywords: Building; Damage; Reconnaissance; Reinforced Concrete

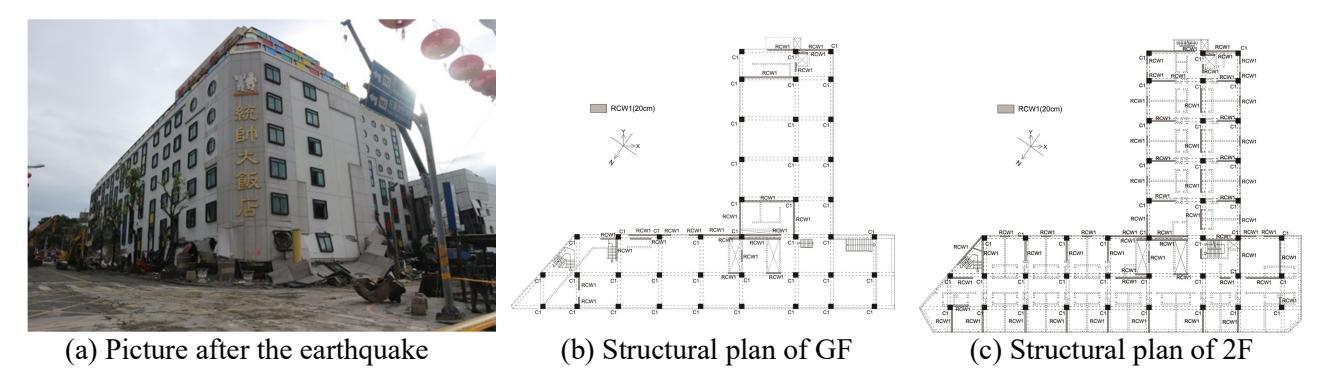
Fig. 7 – The picture and structural plans of Marshal Hotel

The picture of the damaged Marshal Hotel showed a typical soft/weak-base-floor failure pattern as shown in Fig. 7(a). It was obviously caused by the ground lobby floor that had few walls and upper guestroom floors with a lot of partition walls made of RC and masonry, as shown in Figs. 7(b) and 7(c). Pictures of the hotel before the earthquake showing steel members attaching to the veranda at the ground floor can be found on Google Street-view. It was rumored that the steel members were used as part of a seismic retrofit. However, they were found severely distorted after the earthquake and were obviously inefficient in resisting lateral load. There were signs indicating that the hotel had been renovated and a new façade had been added. It is possible that the earthquake inertial force was increased due to the additional weight of the added materials.

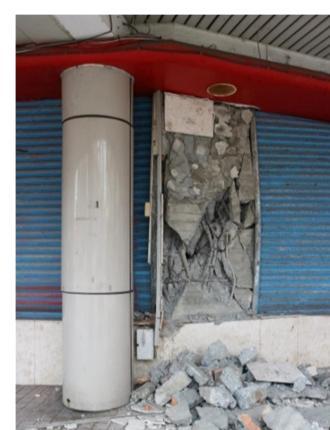
(a) Shear failure of the columns

The building was subjected to moderate damage during the 1999 Chi-Chi earthquake. Although it had been retrofitted after the 1999 earthquake, the columns at the GF facing the street all failed by shear force during the 2018 earthquake, as shown in Fig. 8(a). Hoops at a spacing of 200 - 250 mm were found fractured as shown in Fig. 8(b). The non-ductile design was obviously responsible for the shear failure of the columns. Fig. 8(c) shows that the steel braces installed for retrofit stopped at the second floor instead of continuing to the foundation for some unknown reason. The insufficiency of the retrofit might be the reason that the building was damaged again.

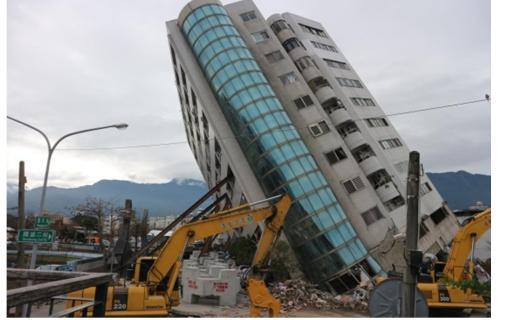
(a) Picture after the earthquake

There was a lot of speculation about the reason for the collapse of this building that caused 14 fatalities. The first speculation was that the damage was due to the soft-base-floor effect because it was a complex building with a restaurant at the GF and residential upper floors. A lot of masonry partition walls were added to the second floor when this floor was renovated to be a hotel. However, the collapsed floors included not only the soft GF, but also the B1F, 1F/GF, 2F, and 3F. Construction flaws have been found in the broken columns as shown in Fig. 9(b). 90-degree hooks were found on the loosed hoops. The longitudinal reinforcing bars were obviously too dense and all the lap splices in the column were located on the same section. Fig. 9(c) shows a longitudinal reinforcing bar of the beam not anchored in the core of the column at a failed beam-column joint. The collective result of the structural and construction flaws might have been the cause of the tragic damage that occurred during the earthquake.

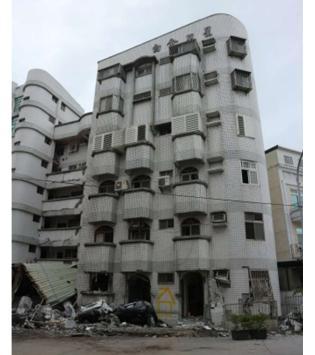
(a) Picture after the earthquake

These two buildings were located on the same street and opposite to each other. Both buildings that collapsed had typical soft-base-floors: the GFs were used as parking spaces and had almost no walls supporting the upper residential floors, which contained lots of partition walls. However, their neighbor building (C) and another residential building (E) both have similar designs and heights but were only subjected to moderate and light damage, respectively. Fig. 3 and Table 3 show that the buildings C and I had similar open GF with similar vertical member ratios. It seems that there should be other factors that aggravated the damage in the buildings I and M. Fig. 10(b) shows one of the few columns that was not buried in the collapsed GF of building I. An inclined breaking line indicating shear failure can be found on

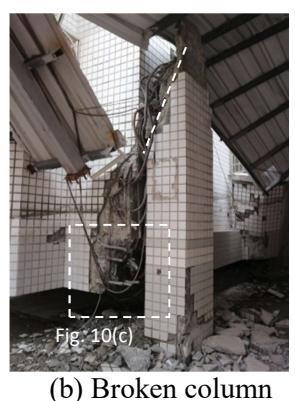
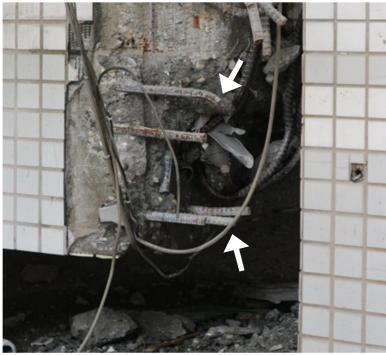
(c) Failed beam-column joint

the top beam-column joint. Fig. 10(c) magnifies the broken beam end in Fig. 10(b). It appears that there were no proper anchorages or the anchorages that did exist fractured at the ends of longitudinal reinforcing bars in the beam. Building M was reported to be 9-stories high. However, the upper three stories as framed in Fig. 11(a) were illegally added on to the originally 6-story building. Fig. 11(b) shows the strange arrangement of reinforcing bars in the broken column right beneath the add-on at the GF. The picture of the column can be found on Google Street View, as shown in Fig. 11(c). It shows that the column in GF deviated from its position at the upper floors in order to provide sufficient space for parking. The weight of the added three stories might have increased the earthquake inertial force as well as the axial force in the column. Although it is difficult to verify, the GF column might be the first victim of the P- Δ effect due to the deviation and the increased axial force.
