The 17th World Conference on Earthquake Engineering

CONVENTIONAL EARTHQUAKE RESISTANT DESIGN AND CUMULATIVE DAMAGE. THE CASE OF THE MEXICO CITY SEPTEMBER 2017 EARTHQUAKE

M. E. Rodriguez⁽¹⁾

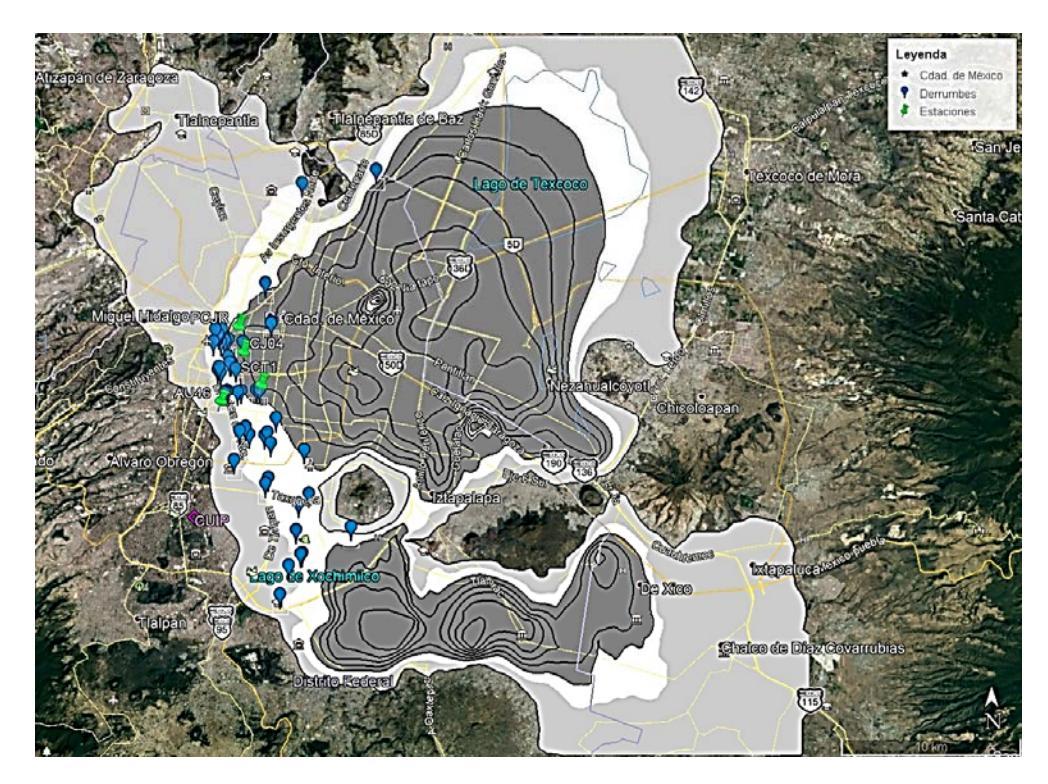
Fig. 1 shows a map of equal soil periods with the distribution of observed collapses (blue marks) for the September 19, 2017 earthquake in Mexico City as reported by reconnaissance teams organized by the Mexican Society of Structural Engineering [4]. Fig. 1 also shows (green marks) the location of a group of several ground motion recording stations located in the area of the highest rate of observed building collapses in the September 19, 1985 earthquake. This group of stations includes the SCT station. Also shown is the location of the CUIP station at the UNAM Campus, which recorded typical ground motions in rock in Mexico City in the 1985 and 2017 earthquakes. It must be mentioned that in the 1985 earthquake in Mexico City, only the SCT station recorded ground motions in the area of the city with the highest rate of observed collapse or damage of buildings in this seismic event. In the September 19, 2017 earthquake, the SCT station recorded ground motions together with a large number of accelerometers in Mexico City that were installed in several stations after 1985. Due to this unique feature of the SCT station, this study considers only buildings damaged in the 2017 event that are located near this station.

Fig. 1 – Distribution of building collapses observed in Mexico City in the September 19, 2017 earthquake (blue marks), ground motion recording stations near observed collapses in the September 19, 1985 earthquake (green marks) and CU station (CUIP) at the UNAM campus.

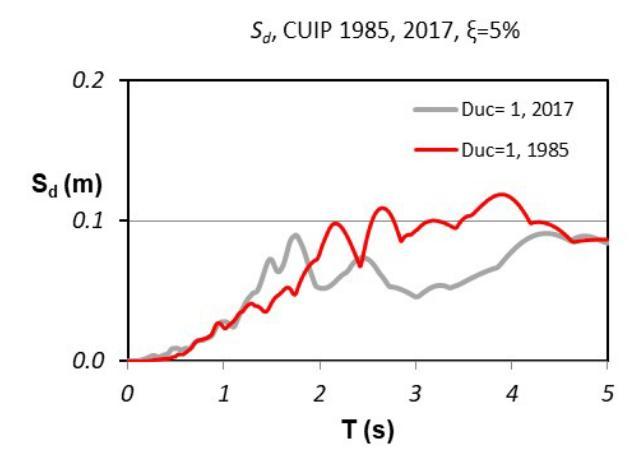
Fig. 2 compares the elastic displacement spectra S_d for the ground motions recorded by the CUIP station in the 1985 and 2017 earthquakes. These spectra were calculated assuming a fraction of critical damping ξ equal to 5%. The results from the CUIP station show that the spectral ordinates for the 2017 earthquake are slightly higher than those for the 1985 earthquake only in the period range of 1.3 s to 1.8 s. Nevertheless, it can be shown that the design response spectra for S_d specified by the MCBC 2004 [3] are significantly higher than the spectral demands for the 2017 seismic event.

Fig. 2 – Displacement response spectra for the ground motions recorded by the CUIP station in the 1985 and 2017 earthquakes in Mexico City.

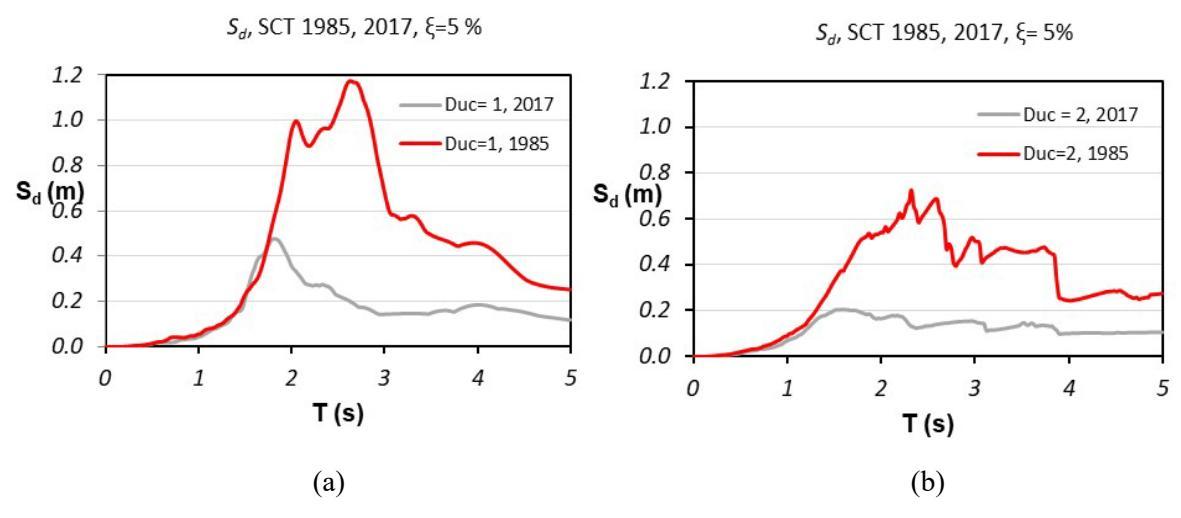
Fig. 3(a) shows the elastic spectral displacement S_d for the ground motions recorded by the SCT station in the 1985 and 2017 earthquakes, assuming 5% for ξ . It can be observed that for periods less than approximately 1.5 s, the spectral S_d ordinates are comparable for the recorded accelerations in both earthquakes, and for periods greater than approximately 1.5 s, the spectral demands in the 1985 earthquake are higher than those of the 2017 earthquake, with the highest demands occurring in the range of approximately 2 s to 2.8 s. Fig. 3(b) shows the inelastic S_d spectra for the same ground motions, assuming a displacement ductility factor μ equal to 2. The inelastic spectra were obtained using the Takeda hysteresis rule [5]. These results for the inelastic case indicate trends similar to those observed in Fig. 3(a) for the elastic case.

Fig. 3 – (a) Elastic spectral displacements (b) Inelastic spectral displacements (μ =2) for accelerations recorded by the SCT station in the 1985 and 2017 earthquakes.

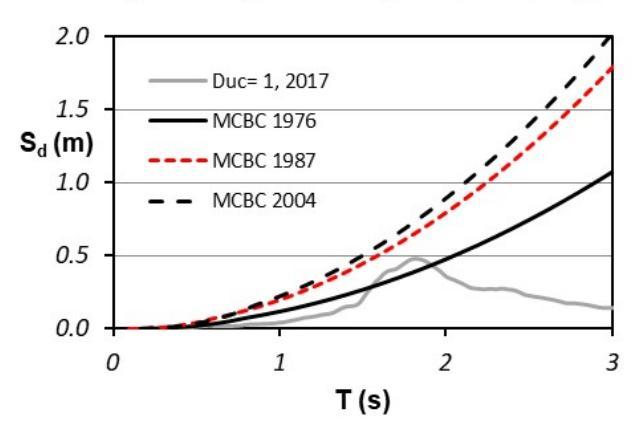
Fig. 4 shows (gray line) the spectral displacement demands computed with the accelerations recorded by the SCT station in the 2017 earthquake, considering that ξ is equal to 5%. The continuous, dotted, and dashed lines correspond to the results for the design spectral displacement demands according to the MCBC 1976 [6], 1987 [7], and 2004 [3] (zone IIIb), respectively, and assuming an overstrength factor equal to 2. As shown in Fig. 4, the values of the spectral displacement demands for the SCT 2017 record exceed the design values specified in the MCBC 1976 [6] only in a small period range, and in most cases, these demands for the SCT 2017 record were smaller than the demand values specified by several versions of the MCBC. The results indicate that buildings in the area under study should not have collapsed or suffered severe damaged in the 2017 earthquake, which is not consistent with the numerous cases of severe damage or collapse of buildings observed in this seismic event. This feature is discussed later.

Fig. 4 – Design elastic spectral displacement demands and elastic spectral displacement demands computed with accelerations recorded by the SCT station in the 2017 earthquake.

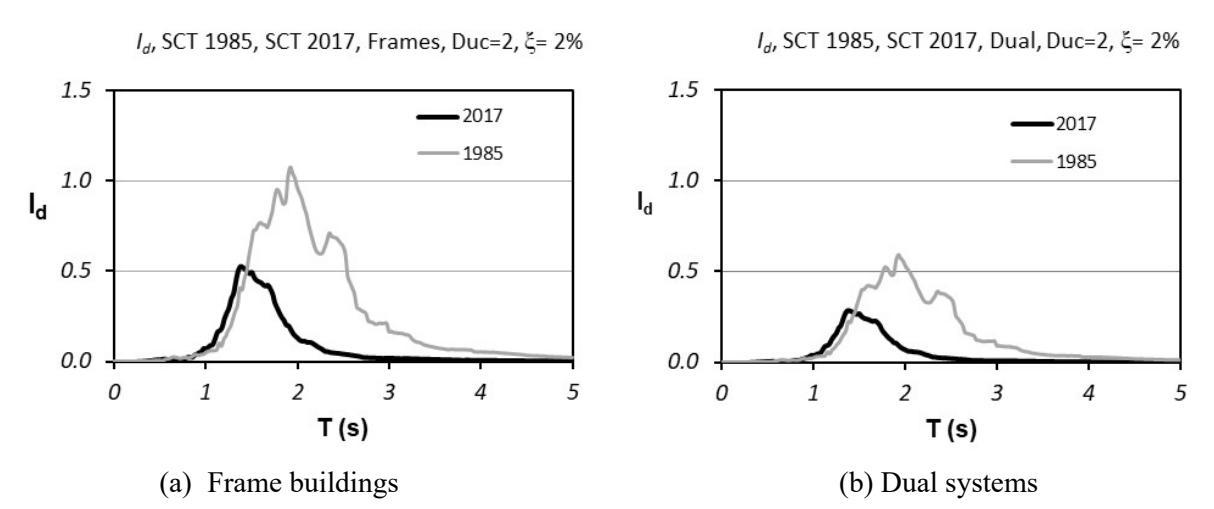
Fig. 5(a) shows a plot of values of I_d computed using Eq. (1) as a function of period *T* for the case of frame buildings (λ = 7), I_d = 2, and the EW component of accelerations recorded by the SCT station in Mexico City in both the September 19, 1985 and September 19, 2017 earthquakes. As observed in Fig. 5, the computed values for I_d for the 1985 seismic event (gray line) are consistent with the observed damage and collapse of buildings in Mexico City in this seismic event, where the damage was concentrated in buildings for periods near 2 s, and this is also the period with the highest computed values of I_d in this seismic event (see Fig. 5). However, the computed values of damage index I_d for frame buildings in the 2017 seismic event, shown with a black line in Fig. 5, were significantly smaller than one, indicating that frame buildings should not have collapsed in the 2017 earthquake. This finding is not in agreement with the fact that a number of frame buildings were damaged or collapsed in the 2017 earthquake, suggesting the need to perform damage analysis of these buildings.

Fig. 5 – Damage index I_d computed for RC buildings responding to accelerations recorded by the SCT station in the September 19, 1985 and September 19, 2017 earthquakes: (a) Frame buildings, (b) Dual systems

Fig. 5(b) shows the computed values of I_d for dual systems (λ = 10), μ = 2, when responding to the EW component of accelerations recorded by the SCT station in Mexico City in the September 19, 1985 and September 19, 2017 earthquakes, as shown with gray and black lines, respectively. These values of I_d are smaller than one, indicating that the dual system could have experienced the 1985 or the 2017 earthquake without significant damage or collapse. These results are consistent with the observed structural behavior of dual systems in both earthquakes, although in 1985, the number of RC buildings with dual systems was significantly smaller than that of frame buildings. The number of buildings in Mexico City with dual systems significantly increased after 1985 because later building codes increased the seismic design forces and reduced the allowable interstory drifts, which encouraged the use of dual systems. Nevertheless, it remains to be observed whether the effects of a subsequent earthquake in dual systems might be relevant when considering cumulative damage. This case is discussed later.

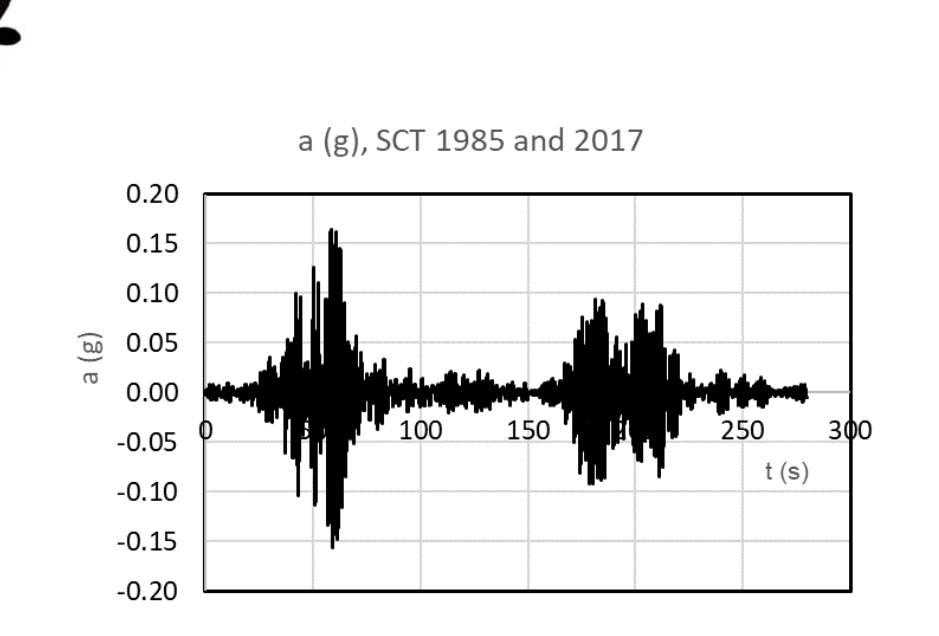
Damage analysis is discussed in the following with consideration of a ground acceleration record defined as the combination of the accelerations recorded in the SCT station in the 1985 and 2017 seismic events. Such a record is shown in Fig. 6, in which the left portion of the record (approximately 150 s) corresponds to the EW component of ground accelerations recorded in the SCT station in the 1985 earthquake, and the right portion of the record (approximately 130 s) corresponds to the EW component of ground accelerations recorded in the SCT station in the 2017 seismic events.

Fig. 6 – Ground acceleration record result of adding the ground acceleration recorded by the SCT station in the September 19, 1985 earthquake (left) and the ground acceleration recorded in the September 19, 2017 earthquake (right).

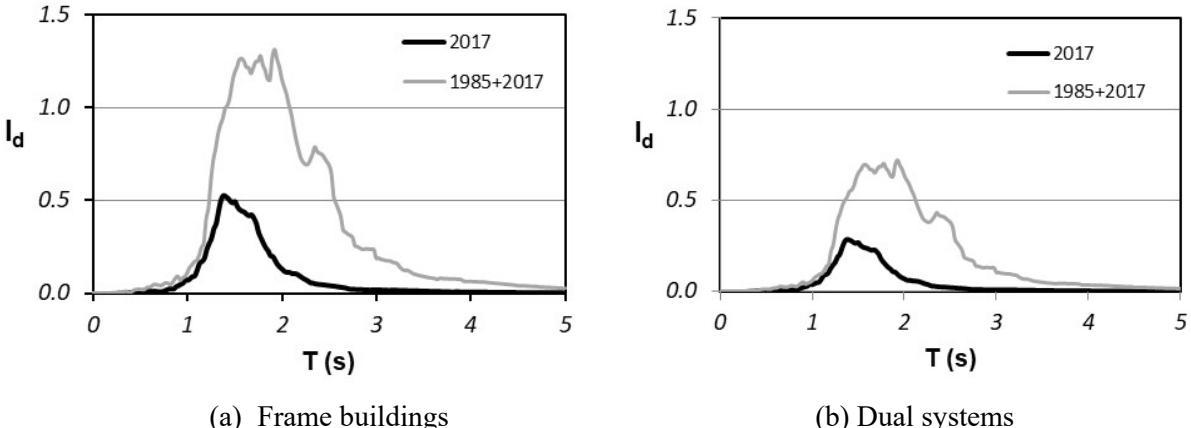
The gray line in Fig. 7(a) shows a plot of the computed values of I_d as a function of period *T*, considering frame buildings (λ = 7), μ = 2, and the ground acceleration record shown in Fig. 6. For the sake of comparison, the black line in Fig. 7(a) shows the computed values of I_d for the same buildings but using the input ground motion given by the EW component of accelerations recorded by the SCT station in the 2017 earthquake, as also shown in Fig. 5(a). The results shown in Fig. 7(a) indicate that if considering the building damage analysis using only the accelerations recorded in the SCT station in the 2017 earthquake, we could conclude that frame buildings had low potential for collapse or severe damage, which goes against the fact that damage or collapse of frame buildings was observed in this earthquake. In contrast, in a period range of approximately 1 s to 2 s, the values of I_d computed by considering the combined acceleration records for both earthquakes indicate severe damage or collapse of buildings. For the combined records, it is of interest that in a period range of approximately 1 s to 1.5 s, small increases of *T* lead to increases of I_d that are significantly larger than those computed using only the 2017 record. The period range of 1 s to 1.5 s corresponds to frame buildings in the range of approximately 6 to 10 stories, which displayed the highest rate of damage or collapse in the 2017 earthquake.

The results of evaluating the damage index I_d for dual systems (λ = 10), μ = 2, and the EW component of accelerations recorded by the SCT station in Mexico City in the September 19, 2017 earthquake are shown with a black line in Fig. 7(b). These results are also shown in Fig. 5(b). The damage index I_d for dual systems responding to the combined record is shown with a gray line in Fig. 7(b). These results suggest that buildings with dual systems in the area of Mexico City under study that were constructed before or after 1985 should not have collapsed in the 2017 seismic event, which is consistent with the observed behavior of dual systems in the 2017 earthquake in Mexico City. It must be mentioned that most existing buildings with dual systems in Mexico City and 10 or less floors were constructed after 1985; i.e., most experienced only the 2017 seismic event, and the effect of cumulative damage in these buildings remains to be observed in a subsequent earthquake.

Fig. 7 – Damage index of buildings with dual systems. computed for RC buildings responding to the accelerations recorded by the SCT station in the September 19, 2017 earthquake and the record obtained by combining the records of the September 19, 2017 and September 19, 1985 earthquakes: (a) Frame buildings, (b) Dual systems

The higher collapse potential of frame buildings compared with that of buildings with dual systems found in this study (Figs. 7(a) and 7(b), respectively) shows the importance of lateral stiffness for reducing the collapse potential in buildings subjected to earthquakes. It follows that wall buildings should be favored as the structural system in multistory buildings, not only to protect human life but also as an economical solution for a building with the capacity to withstand severe earthquakes (Rodriguez, 2018).
