EXPERIMENT ON SMRF CONSIDERING MULTIPLE EARTHQUAKES PART 2 TEST RESULTS

Abstract

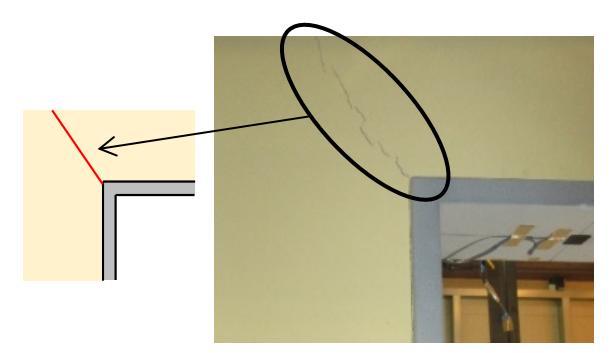
In nonstructural components, a crack of LGS wall painting was generated around the opening at -1.0 R_{max} (Photo 1). In structural components, no damage was observed.

Photo 1 - Crack around the opening of LGS wall

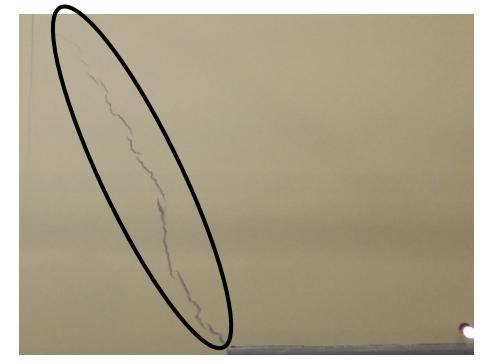
In nonstructural components, previous crack (Photo 1) reached the gypsum board (Photo 2). In structural components, slab crack due to negative bending was generated at $-1.0 R_{max}$ (Photo 3).

Photo 2 - Crack reaching the gypsum board

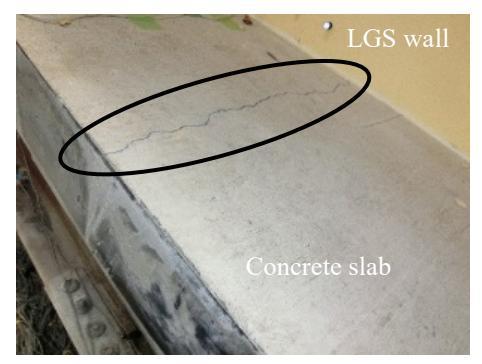
Photo 3 - Slab crack due to negative bending

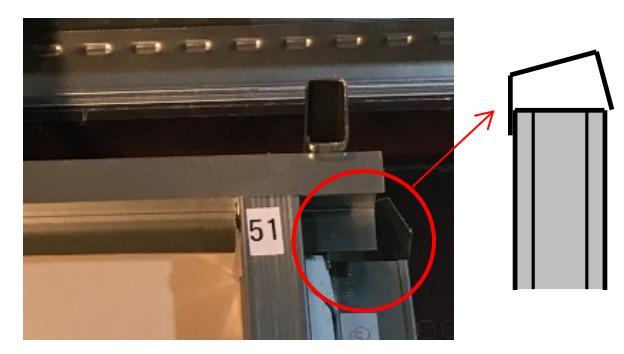
In nonstructural components, the foundation frame of the LGS wall around the eccentric part was detached at -1.0 R_{max} (Photo 4). In structural components, slab crack due to positive bending was generated at the first cycle of $\pm 0.6 R_{max}$ (Photo 5).

Photo 4 – Detachment of LGS foundation frame

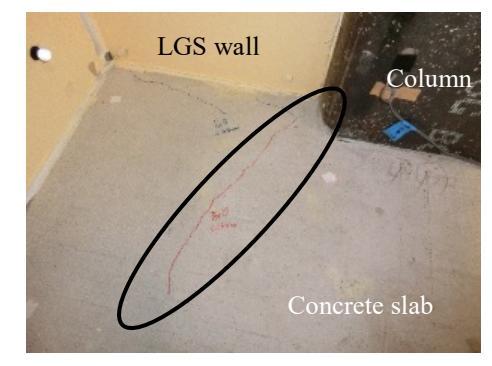
Photo 5 – Slab crack due to positive bending

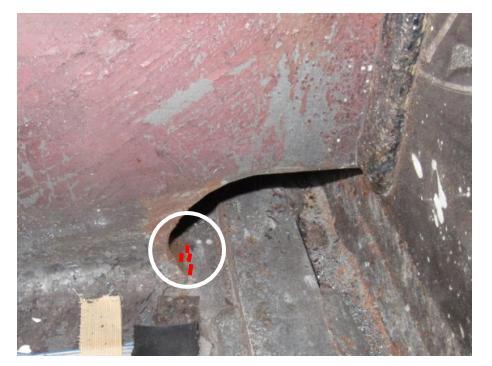
In nonstructural components, gypsum boards in the flat part (E-plane) was deformed out-of-plane. In structural components, the crack at the toe of the weld access hole (E-plane) of the lower beam end was generated at the first cycle of +0.8 R_{max} (Photo 6). In addition, local buckling of the lower flange at the lower beam end occurred in both planes at -1.0 R_{max} (Photo 7).

Photo 6 – Crack at the toe of the weld access hole

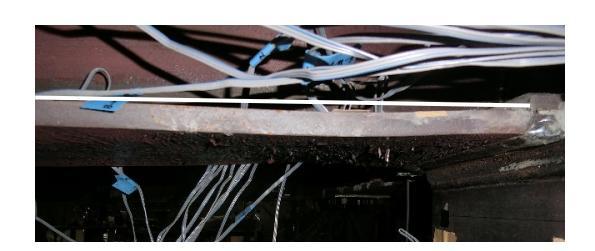
Photo 7 - Local buckling of beam end

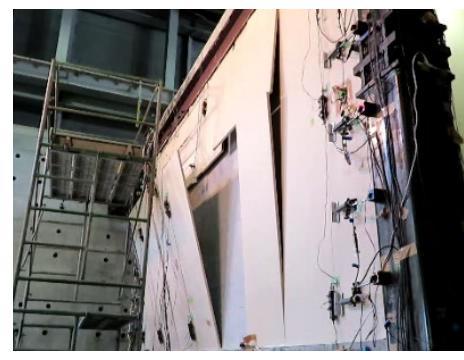
In nonstructural components, gypsum boards in flat part (E-plane) were largely deformed out-of-plane and fell off at unloading after -1.0 R_{max} (Photo 8). In structural components, the crack initiated from the toe of the weld access hole (E-plane) at the lower beam end was penetrated at -1.0 R_{max} (Photo 9). In addition, a small crack was generated at the weld toe of the lower flange of the W-plane lower beam.

Photo 8 – Gypsum board fell off

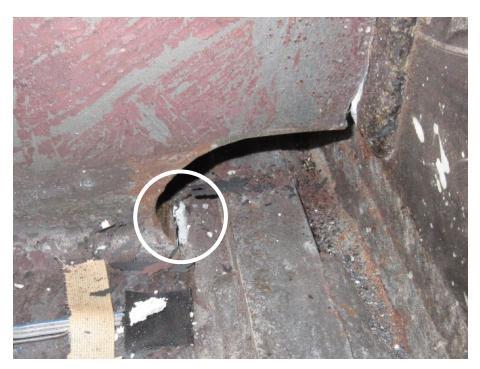
Photo 9 - Crack penetration at the toe of the weld access hole

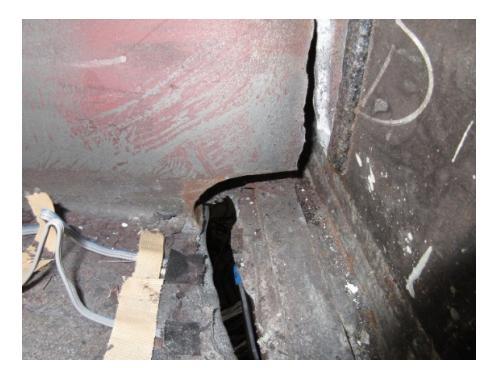
After completing all the nine sets of loading, the test was continued by applying the constant amplitude of R = 1/33 to observe the ultimate behavior of the steel frame. The lower flange of the E-plane lower beam end was fractured at cycle 1- (Photo 10), and the crack at the toe of the weld access hole (E-plane) of the upper beam end was penetrated at the cycle 10-. The loading was stopped at the cycle 11+ because the crack at the web of the E-plane lower beam reached 3/4 of the section height (Photo 11(a)). Photo 11 shows the beam end condition of the LGS frame at the final loading. Almost all sections fractured at the plane with a weld access hole (E-plane); on the contrary, almost no crack was generated at the plane without a weld access hole (W-plane).

Photo 10 – Lower flange fracture at E-plane

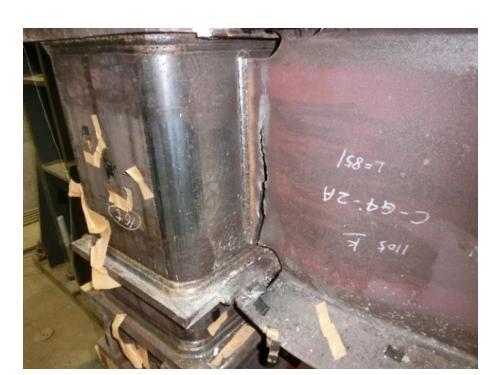
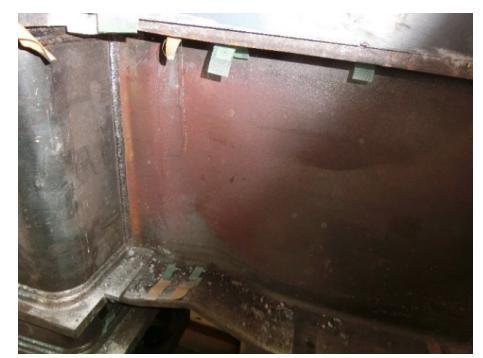
(a) E-plane(b) W-planePhoto 11 – Beam end condition of LGS frame at the final loading

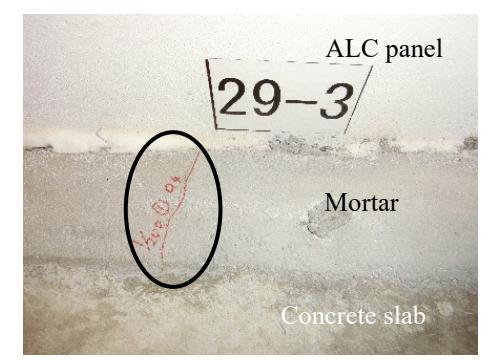
In nonstructural components, the mortar between slab and ALC panel crack due to negative bending was generated at $\pm 0.4 R_{max}$ (Photo 12). In structural components, slab crack due to negative bending was generated at the first cycle of -0.8 R_{max} (Photo 13).

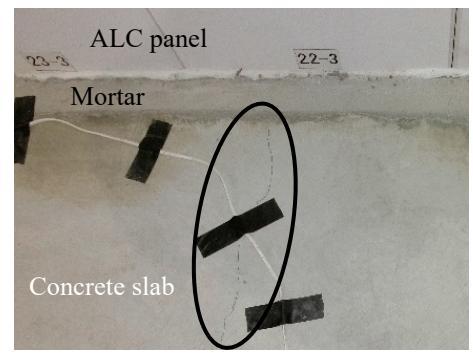
Photo 12 - Crack at the mortar due to negative bending Photo 13 - Crack at the slab due to negative bending

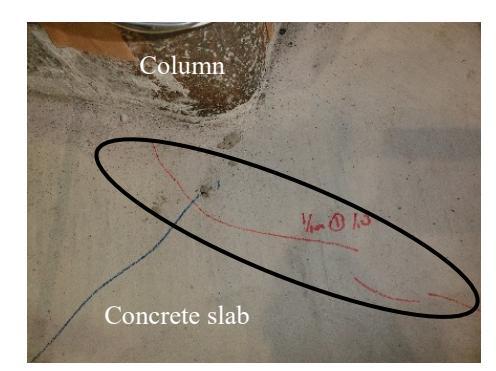
Photo 14 - Crack at the slab due to positive bending

In nonstructural components, previous damage was developed but no new damage was observed. In structural components, slab crack due to positive bending was generated at $\pm 1.0 R_{max}$ (Photo 14).

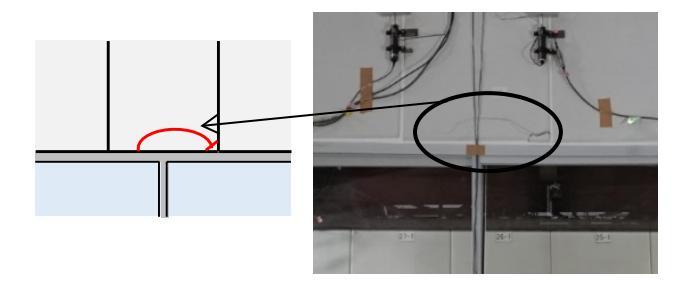
In nonstructural components, crack at the ALC panel was generated around the opening at the first cycle of -0.8 R_{max} (Photo 13). In structural components, the crack at the toe of the weld access hole (E-plane) of the lower flange at the lower beam end was generated at the first cycle of -0.6 R_{max} (Photo 16).

Photo 15 – Crack at the ALC panel around opening

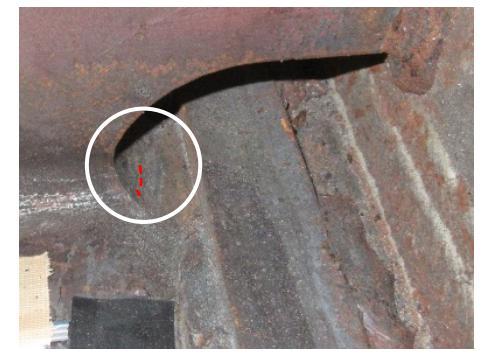
Photo 16 - Crack at the toe of the weld access hole

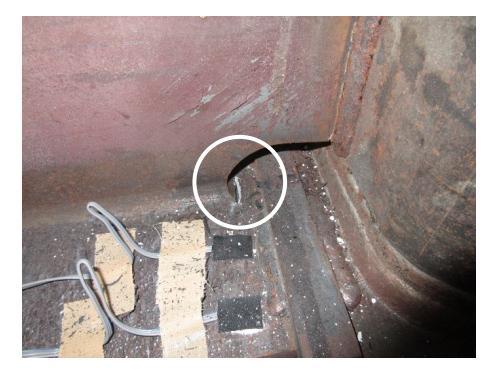
Photo 17 - Crack penetration at the toe of the weld access hole

In nonstructural components, previous damage was developed but no new damage was observed. In structural components, crack initiated from the toe of the weld access hole (E-plane) of the lower flange was penetrated at the second cycle of $-0.6 R_{max}$ (Photo 17).

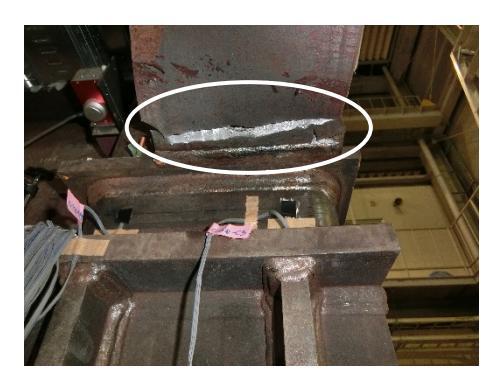
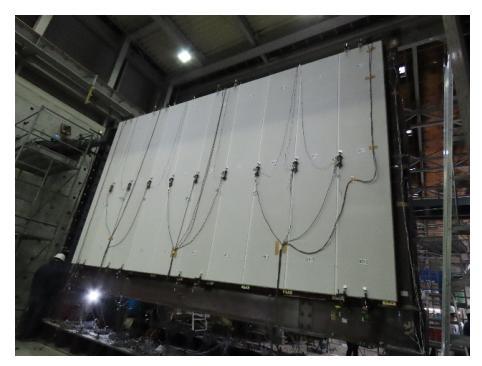
After completing all the sets of loading, the test was continued by applying the constant amplitude of R= 1/50 to observe the ultimate behavior of the steel frame. The lower flange of the E-plane lower beam end was fractured at cycle 5- (Photo 18); thus, the loading was stopped. In addition, there is almost no damage found in the ALC panel without openings (E-plane) at the end of the loading (Photo 19).

Photo 18 – Lower flange fracture at E-plane Photo 19 – Final condition of ALC wall in E-plane
