PERFORMANCE OF LOW-RISE BUILDINGS WITH NO SEISMIC DESIGN IN UNANTICIPATED EARTHQUAKES

2c-0197

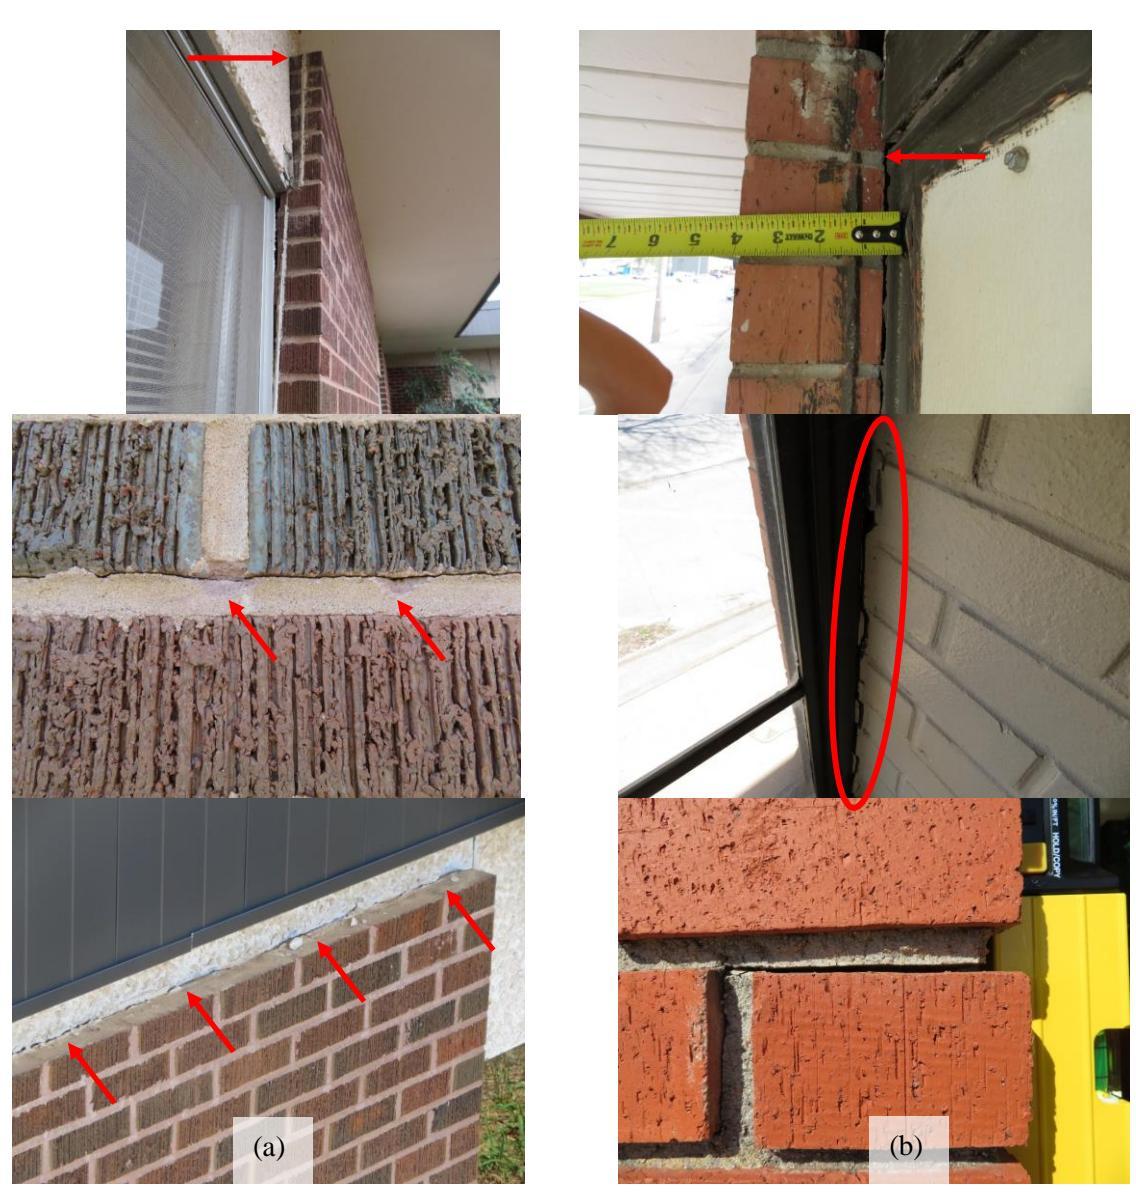
Out-of-plumb brick masonry walls were observed including load-bearing walls and exterior veneers of cavity walls (Fig.3). The out-of-plumb masonry was accompanied by horizontal cracks and spalled mortar along the bedjoints of the brick masonry as well as separations of the masonry from the surrounding window frames, stucco, and other wall finishes, which caused cracking and spalling of these finishes.

Fig. 3 – Out of-plumb walls: (a) Brick veneers on CMU walls, (b) Load-bearing brick walls

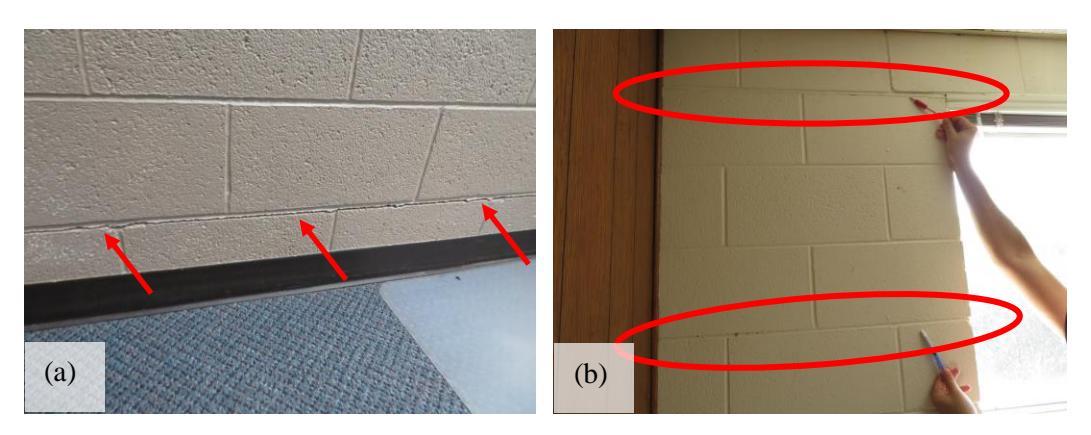
Out-of-plane damage was also observed in plumb walls in the form of horizontal cracks in the brick masonry and CMU walls, accompanied by spalled mortar, chipped off bricks, and broken blocks along the cracked bedjoint. The cracks were typically located at the base of the walls, the top and the base of wall piers, and emanating from corners of wall openings (Fig.4). Horizontal cracks were also located near midheight of walls (or higher depending on the connectivity of the top of the wall). The cracks were through-cracks penetrating the thickness of the walls as observed from both sides of the walls and the jambs of the wall openings. The bedjoint cracks extended the length of the walls and wall piers.

Fig. 4 - Horizontal cracks in CMU bearing walls: (a) At base of wall, (b) At top and mid-height of wall pier

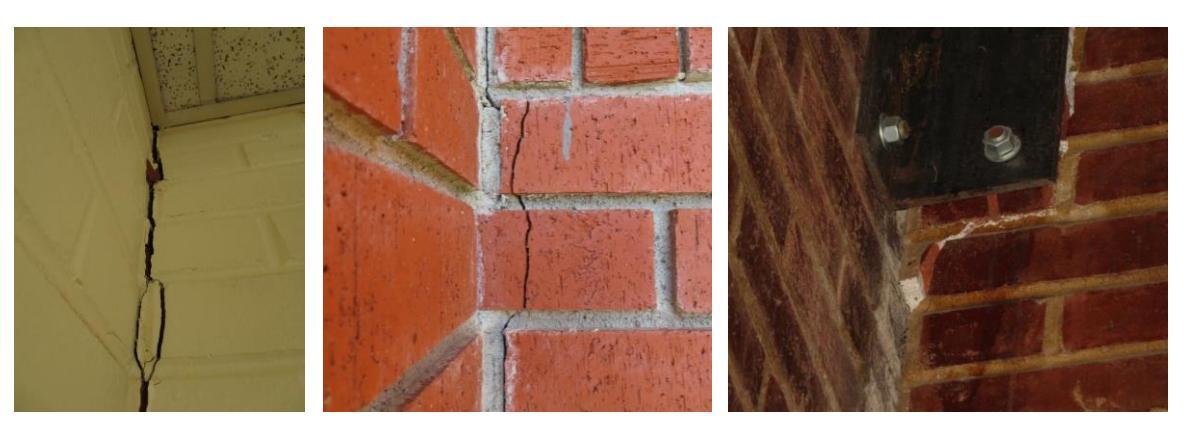
Separations were observed at the intersection of the orthogonal masonry walls (Fig.5). The separations continued to the top of the walls above the drop ceilings, accompanied by displaced and deformed grid-framing of the drop ceiling at the wall corners. Where the two intersecting walls were built integral to each other with masonry units that continued past the intersection, the separations continued through the units, resulting in broken and spalled bricks and blocks along the height of the wall intersections. Separations and spalling occurred due to the movement of the walls relative to each other and the out-of-plane action of the orthogonal wall.

Fig. 5 – Cracks and spalls due to separation between intersecting brick walls

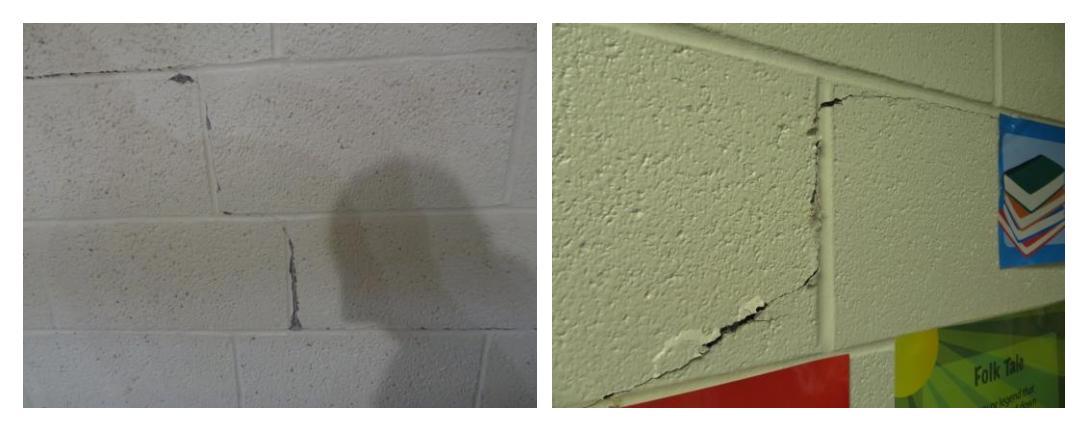
In-plane damage to masonry walls was observed coupled with the out-of-plane damage, with stairstepped cracks through headjoints and bedjoints that continued to the top of the walls above the drop ceilings and stair-stepped cracks that emanated from wall openings (Fig.6). At some locations, cracks penetrated the CMU and broke the concrete block.

Fig. 6 - Stair-stepped cracks in CMU walls

In addition, in-plane wall damage in the form of stair-stepped cracking of the masonry walls was also corroborated with structural analysis results.

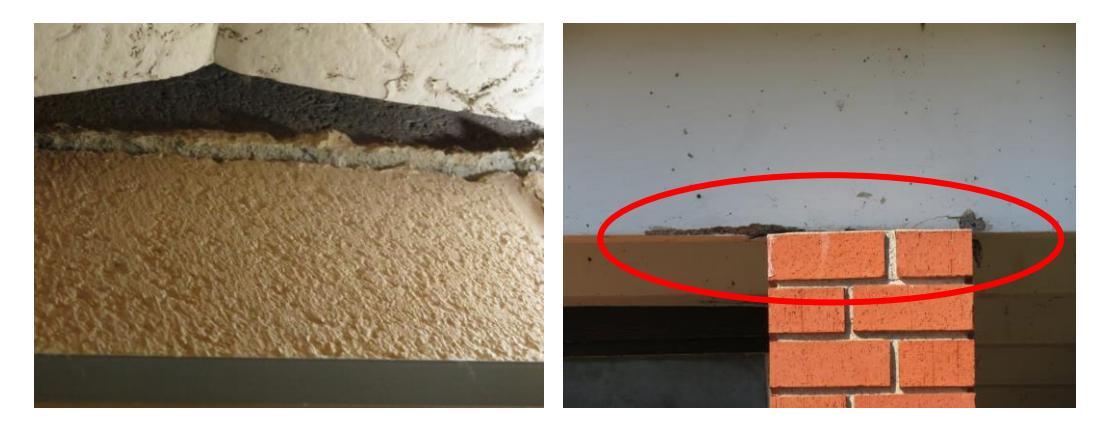
Masonry bearing walls exhibited cracking around the bearing locations of the roof joists and beams, as well as split, broken, dislodged, and offset bricks and CMU blocks at these locations (Fig.7, Fig.8, Fig.9). Broken pieces of bricks, CMU blocks, grout, and mortar were observed to have fallen off the top course or the bearing course and laid on top of the suspended ceiling and insulation systems. These observations were indicative of movement and shifting of the roof framing relative to the masonry bearing walls.

Fig. 7 - Cracks, spalls, offsets at masonry bearing wall supports of precast concrete roof joists

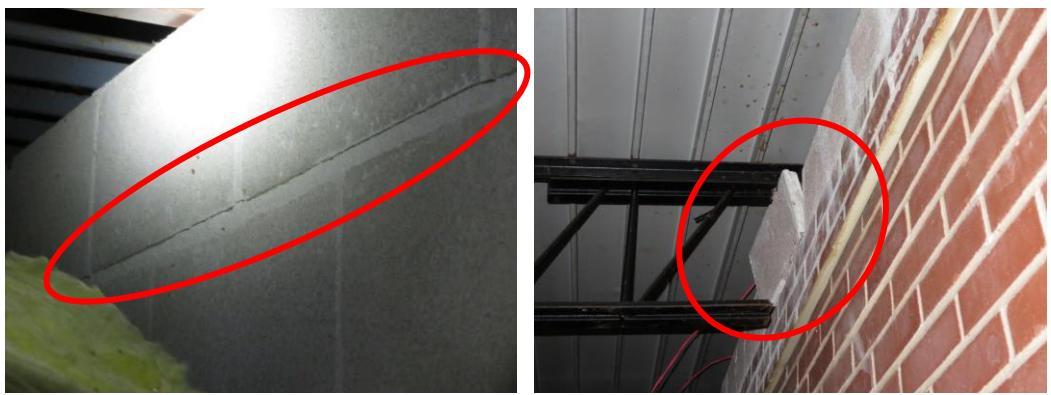
Fig. 8 - Cracks, spalls, offsets at masonry bearing wall supports of steel roof truss joists

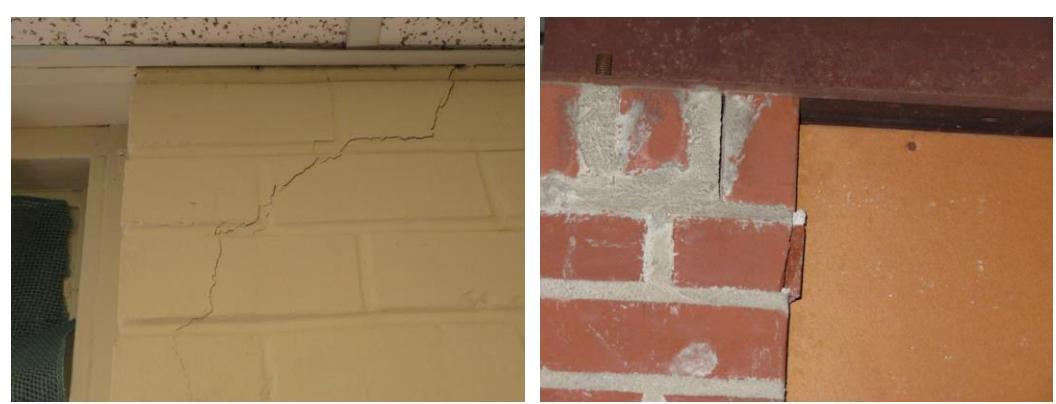
Fig. 9 – Cracks, spalls, offsets at masonry bearing wall supports of steel roof beams

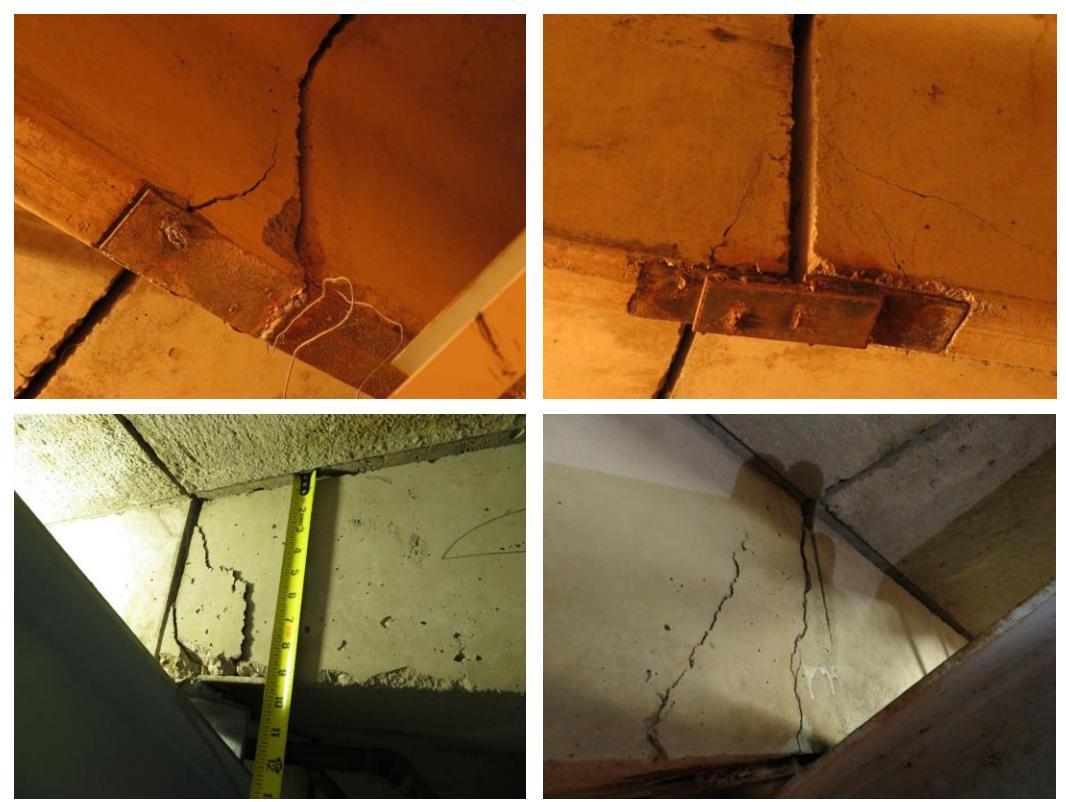
In buildings with precast concrete floor and roof framing, cracks, spalls, and offsets in the vicinity of the beam end connections were observed (Fig.10). Spalling of the concrete and CMU wall components also occurred along their interface and connections with steel framing columns and beams (Fig.11).

Fig. 10 - Cracks, spalls, offsets at precast concrete beam end connections

At locations of roof joists bearing on masonry walls, observations revealed cracking and spalling of the masonry walls and spalling of the precast concrete beams in the vicinity of their end connections.

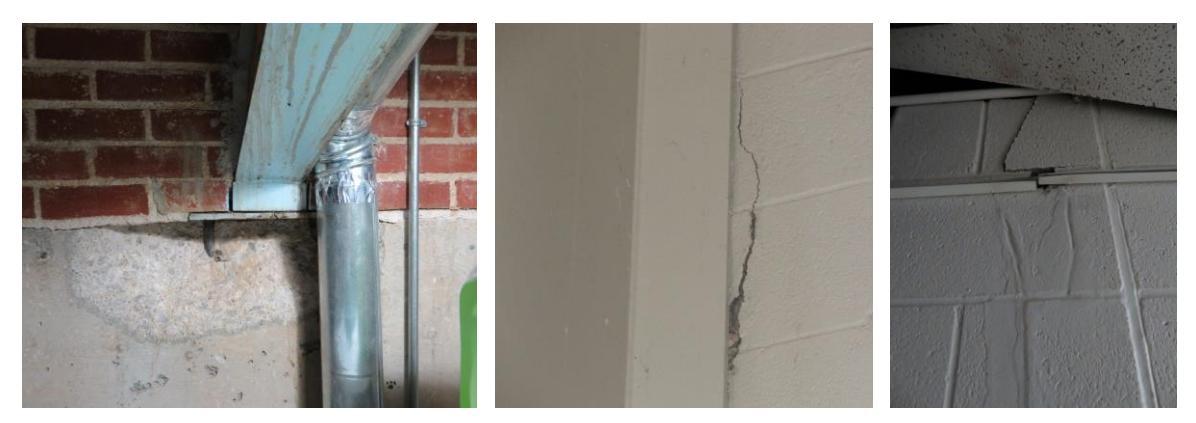
Fig. 11 – Cracks and spalls at interface with steel frames

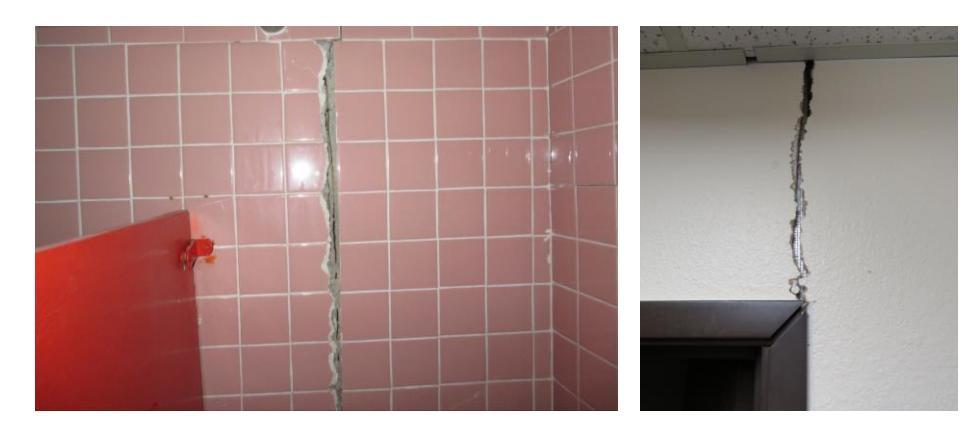
Damage to wall finishes was widespread and included, among others, cracked drywalls, separations at seams of partition wall panels, and broken ceramic wall tiles (Fig.12). Other non-structural components which sustained damage included architectural components such as ceiling sheathings, suspended ceilings, and roof insulation, as well as mechanical and electrical utilities such as pipework hung from roof framing or ductwork supported by ceiling grid framing (Fig.13).

Fig. 12 – Damage to wall finishes

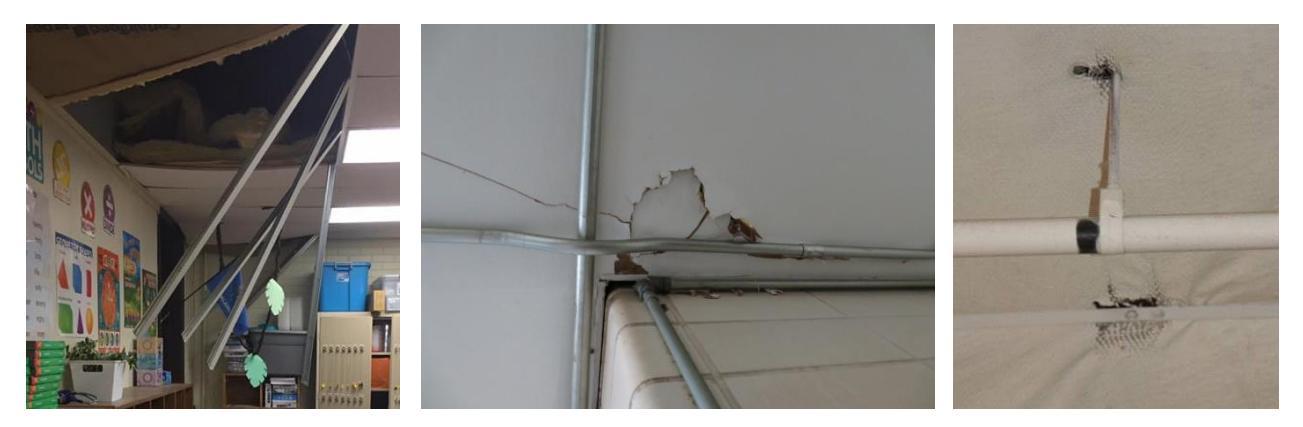
Fig. 13 – Damage to ceilings, roof insulation, utility systems hung from roof framing

Ceiling damage occurred more severely along the masonry walls than elsewhere based on on-site observations. This was an indication of out-of-plane movement of masonry walls against the ceilings, causing deformation, cracking, buckling, and collapse of ceilings. Ceiling damage was one of the indicators of out-of-plane movement and rocking of masonry walls, as well as an indicator of in-plane deformation of roof diaphragms.
