17th World Conference on Earthquake Engineering, 17WCEE Sendai, Japan - September 13th to 18th 2020

Seismic vulnerability and resilience of the water systems of Mexico City based on the evaluation of the effects of the 2017 Puebla-Morelos Earthquake

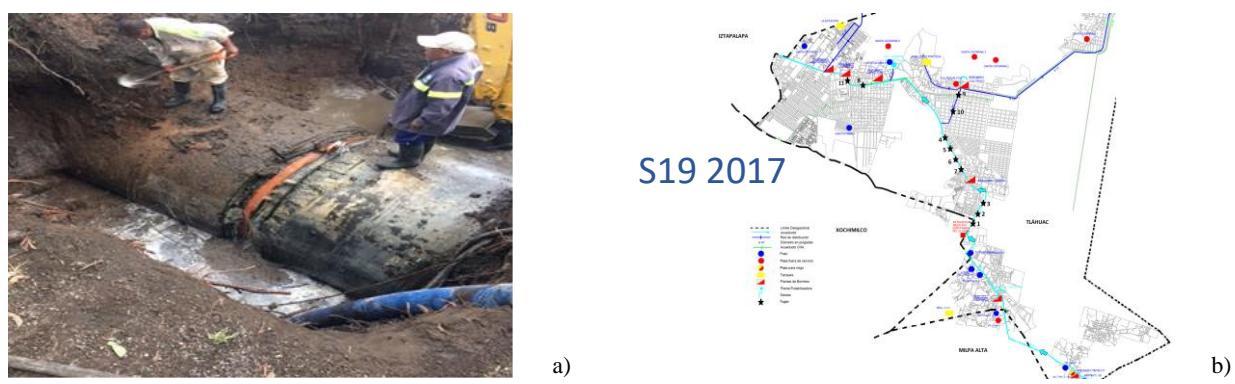
There were 52 pipeline breaks along the CDMX aqueduct (see Fig. 6b). This damage ratio of 0.4 breaks/km in the affected zone in the southeast part of CDMX. Most breaks occurred at joints where adjacent segments crushed or separated due to insufficient joint flexibility. All of these breaks were in 36" or 72" diameter "lock joint" prestressed concrete. Other breaks occurred at a "T" junction in a 72" diameter lock joint line. These failures occurred in the line which formed the "stem" of the "T" (*i.e.*, the line dead ended by the trust block.). Again these failures were due to crushing and/or separation of the joints. In addition to the pipeline joint damage described above, the earthquake caused "punching shear" cracking of valve box walls. It is worth noting that much of the above mentioned damage occurred at joints close to junctions such as "T"s or elbows. Typical breaks in aqueducts of prestressed concrete are showed in the Fig. 6a

Fig. 6 - Damage in water supply lines, a) typical broken reinforced concrete pipes (72"), b) location of the aqueducts that suffered damage during S19 2017

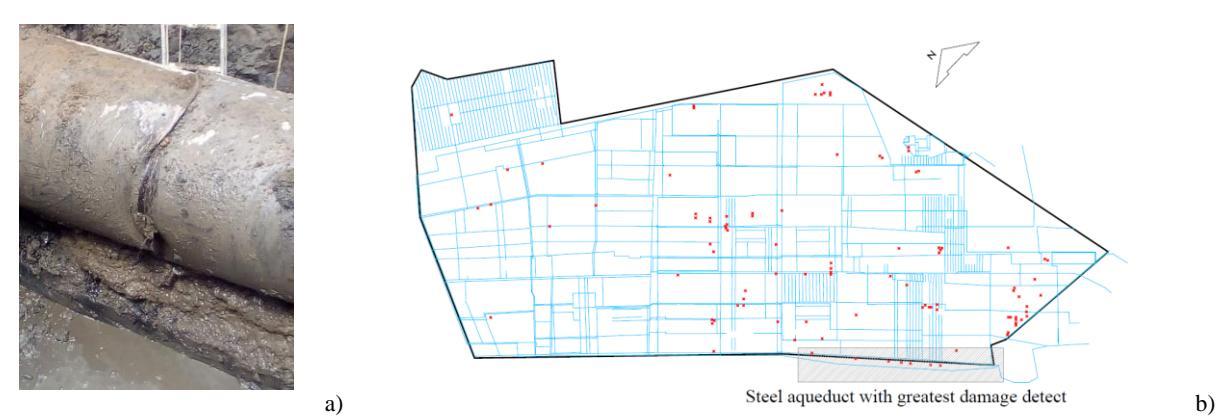
In the State of Mexico, a major transmission pipeline supplying about 1.6 m³/s was severely damaged. The flow supplied by this pipeline represented 50% of the total in Ciudad Nezahualcóyotl. There were 9 pipeline breaks along the aqueduct (see Fig. 7b). The system was restored to its pre-earthquake condition by November. During the recovery period, water was also distributed using tank trucks. In this aqueduct, there were 8 breaks in a 48" lock joint" pipe and one break in a 42" pipe. Although the aqueduct damage was different in many respects to that which occurred in the CDMX. Aqueducts with a number of leaks significantly lower. The damage was due to seismic wave propagation in soft ground conditions. The leaks typically occurred in the large diameter steel pipeline, Figs. 7a.

Fig. 7 - Damage to water systems in Ciudad Nezahualcóyotl, a) failure due to buckling in a 42 "steel aqueduct, b) location of the area where the greatest damage was concentrated

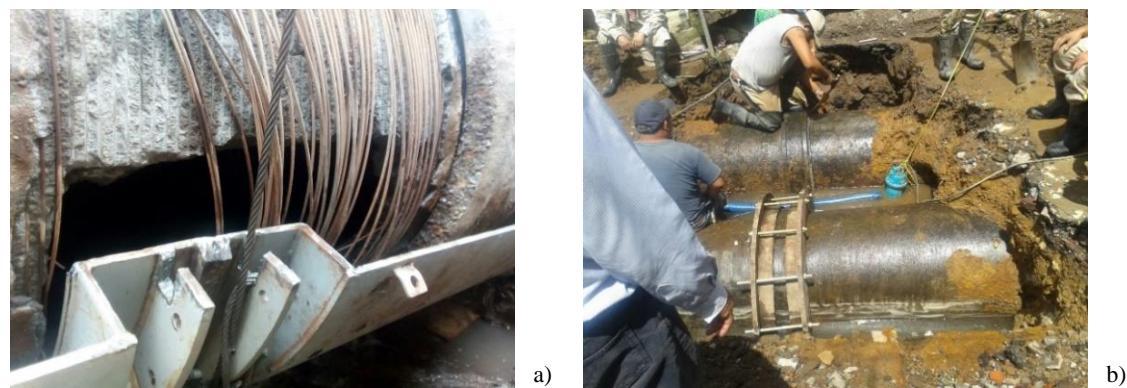
Within the CDMX, most of the damage to primary distribution lines (20" diameters and larger) were in asbestos cement and concrete pipes. The breaks were reported as transverse cracks in pipes, crushing or pull-out at joints, and fracture of special pieces at valve boxes. An example is a fracture of a "T" joint in a 30 in diameter pipeline. This line was constructed at the beginning of the century and is located in an open gallery in the older part of the city. The line had survived previous strong earthquakes without damage and had experienced no significant corrosion or cracking prior to the S19 2017 Puebla-Morelos event. Typical breaks in the primary water network are showed in Figs. 8a-b

Fig. 8 – Damage to the primary and secondary CDMX network, a) typical failure of reinforced concrete aqueducts, b) leaks in steel aqueducts

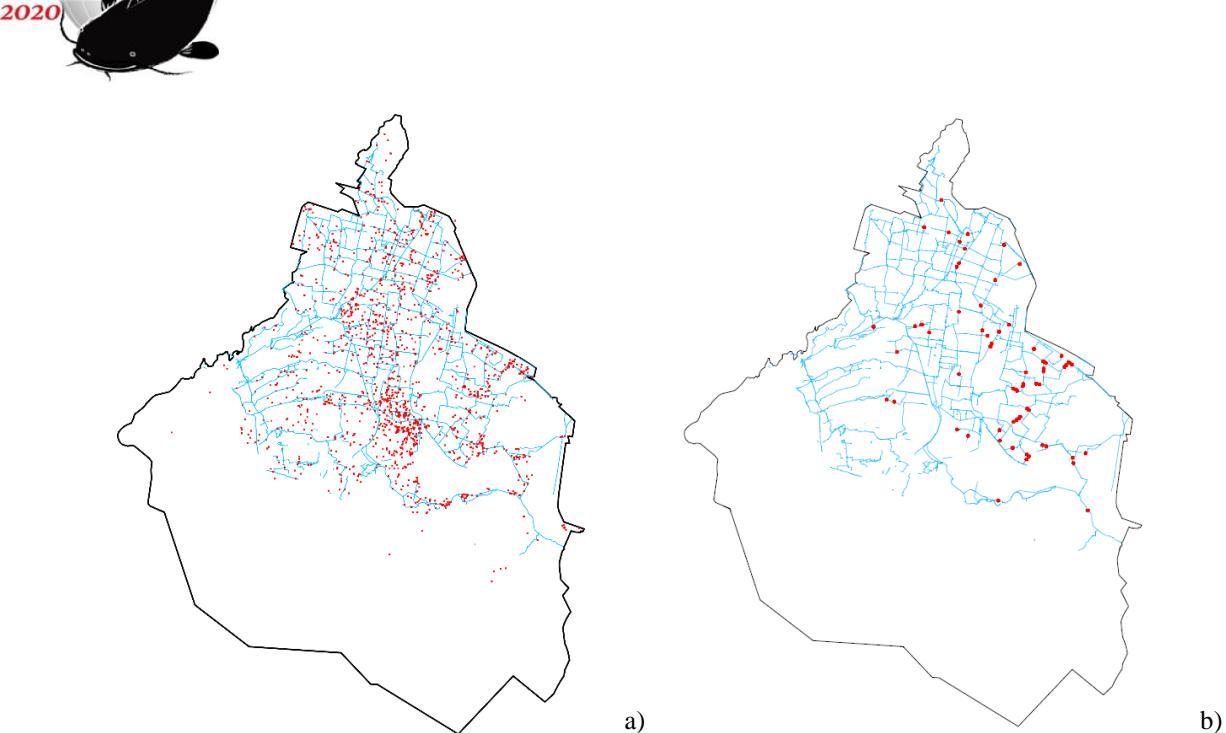
The location of most of the CDMX primary distribution piping breaks were in the lacustrine soil region of the Texcoco lake (Lake Zone). It appears that approximately two thirds (66%) of the leaks/breaks occurred near such junctions while about one quarter (25%) occurred along nominally straight runs of pipe. The precise location of about one tenth (10%) of the leaks/breaks could not be determined. The number of breaks, per Municipality, for various pipe diameters as well as the corresponding damage ratios is showed in the table 4. The location of breaks in primary and secondary CDMX water network are showed in the Figs. 9a-b.

Fig. 9 – CDMX damage distribution due to S19 2017, a) secondary network, b) primary network

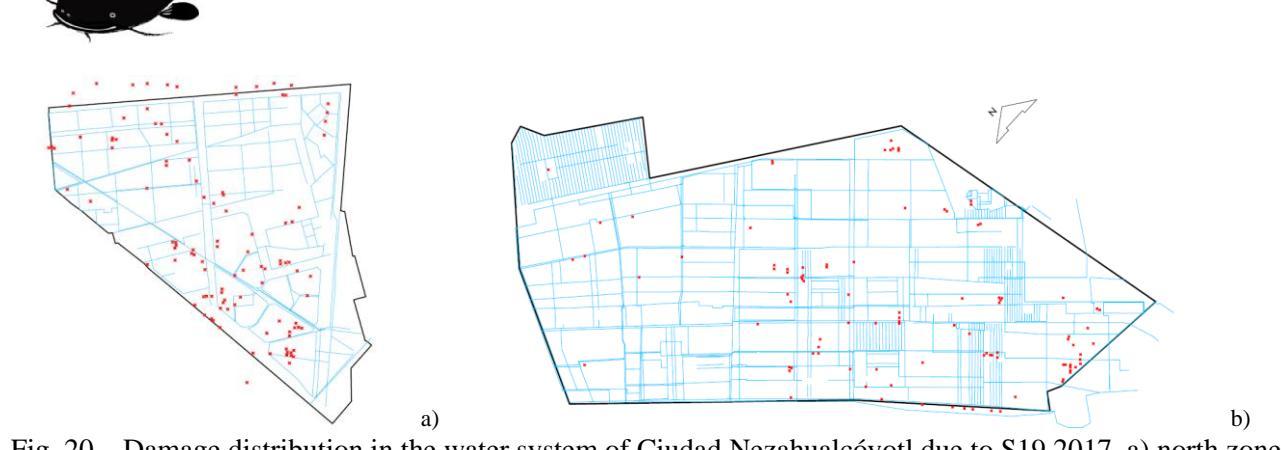
The distribution network in Ciudad Nezahualcóyotl, located in the State of Mexico, suffered about 150 leaks. Most of these occurred at joints close to fixed points such as crossings, bends, valve boxes etc. Failures in the body of the pipes were less frequent and from discussion with engineers in charge of the repairs, these occurred along pipes already weakened by relative settlements which is common in all the urbanized areas of the Lake Zone. As may have occurred in the CDMX, some of the failures may have occurred at the joints weakened by differential settlements. The location of breaks Nezahualcóyotl water network are showed in the Figs. 10a-b The failure rate for Ciudad Nezahualcóyotl was 0.24 breaks per km.

Fig. 20 – Damage distribution in the water system of Ciudad Nezahualcóyotl due to S19 2017, a) north zone, b) central-east zone

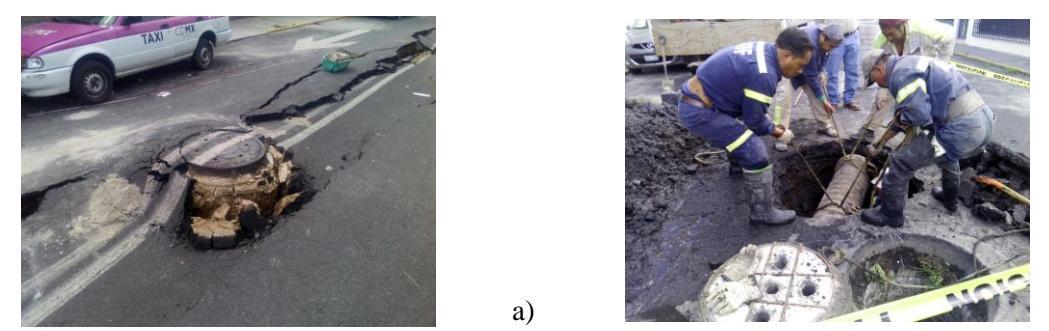
The S19 2017 Puebla-Morelos Earthquake caused minor damage to the sewer system of CDMX. It is concluded that the lack of significant seismic damage to the sewer system may be attributed in part to its burial depth larger than that that of the water systems as well as the difficulty in recognizing damage in an unpressurized system, (see Figs. 11a-b).

Fig. 31 – Damage to the CDMX sewer system, a) subsidence of soil and sewer damage, b) replacement of a sewer pipe from the sewer system
