Preliminary Investigation of the Pile-foundation Buildings Leaned By Damage in the 2011 off the Pacific Coast of Tohoku Earthquake

SUMMARY:

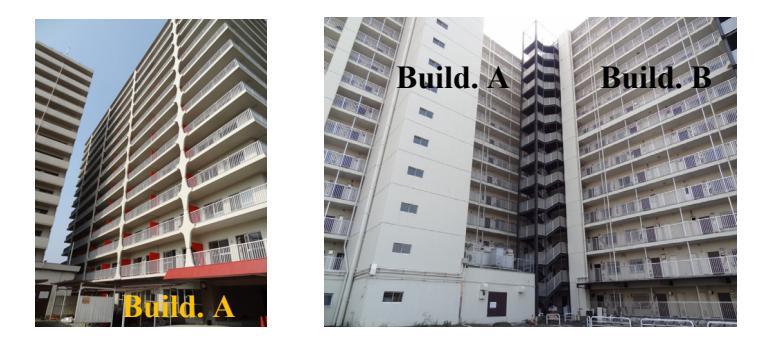
Photo 1. Exterior appearance of the damaged housing complex

Schematic plan and section of the housing complex of STM are illustrated in Figure 6. Photos of the exterior appearance of the buildings are shown in Photo 1. Housing complex STM consists of the two buildings. Both of them are SRC 14-storey buildings supported by pile foundations. Pile foundations are organized by PC piles with autoclave technology of which diameters are 600mm and 500mm. Length of pile is 24m (two 12m-piles are connected by welding). Height of both buildings is about 40m. Construction of the buildings have completed in 1976. After the completion, the buildings suffered severe shaking and were heavily damaged by 1978 Miyagi off shore earthquake.

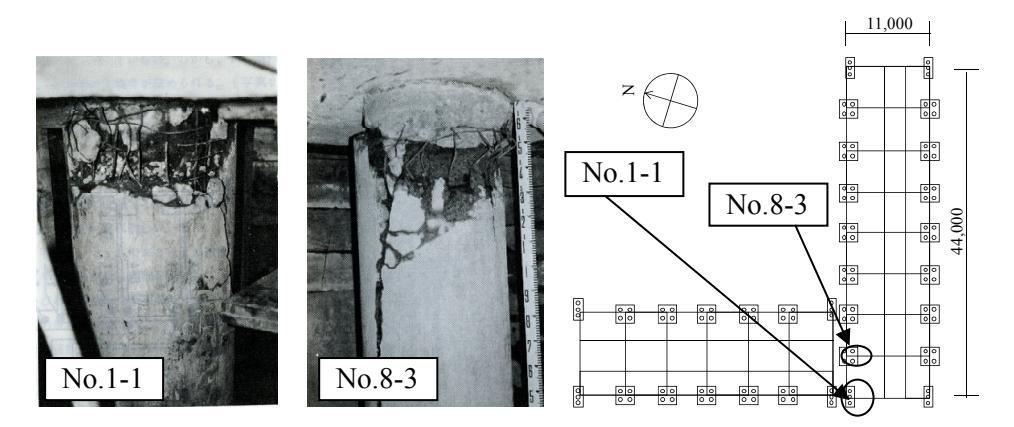
Figure 7. Damage at pile heads in 1978 Miyagi earthquake (After Sugimura and Oh-oka 1981)

The buildings had been also damaged by the 1978 Miyagi off shore earthquake, and then some group piles that are marked by red circles in the left figure of Figure 6 were heavily damaged (Shiga 1980, Sugimura and Oh-oka 1981). According to the damage investigation report of the 1978 Miyagi off shore earthquake, concrete body of pile were crushed, some steel bars indicated buckling and shear cracks were observed at the pile head in some group piles as shown in Figure 7. Those buildings were restored after the 1978 Miyagi earthquake, and residents have kept living in those buildings before the earthquake of March 11 occurred.

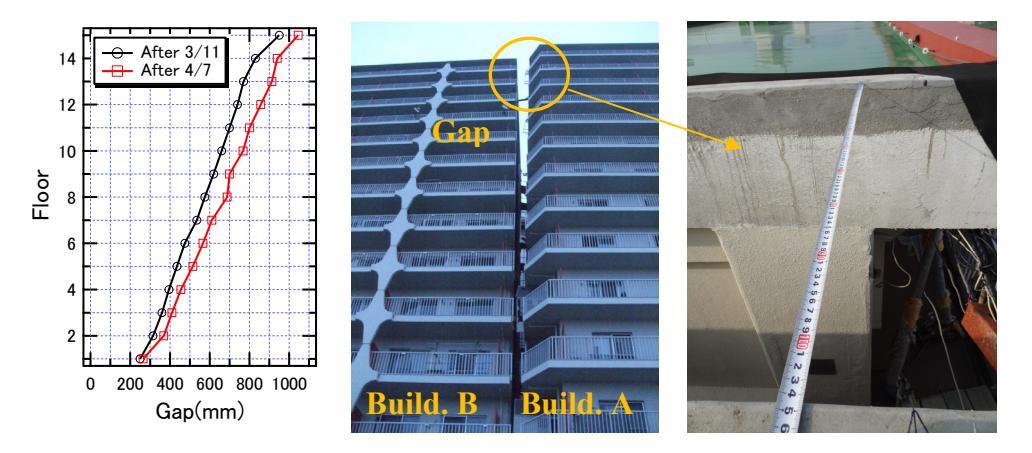
Figure 8. Measured gap between the building A and B

that building A indicates remarkable inclination in NS direction as shown in the photo in Figure 8. Inclination of the building A creates the large gap between the building A and B. Inclination of the building was not observed in the damage by the 1978 earthquake even though severe damage was observed at the pile head in some pile groups. Gap had been measured by the municipal office of Sendai city after the main shock. The authors also measured gap between the buildings at all the floors in October 2011. Measured gaps at each floor between the buildings are shown in the left figure of Figure 8. The figure clearly indicated gap at each floor increased after the aftershock of 04/07. Gap between two buildings was 1,045mm at the roof floor and 265mm at the first floor. Angle of the inclination of the building A was estimated about 1/60 to 1/40. Outstanding inclination as building A was not recognized in the building B.

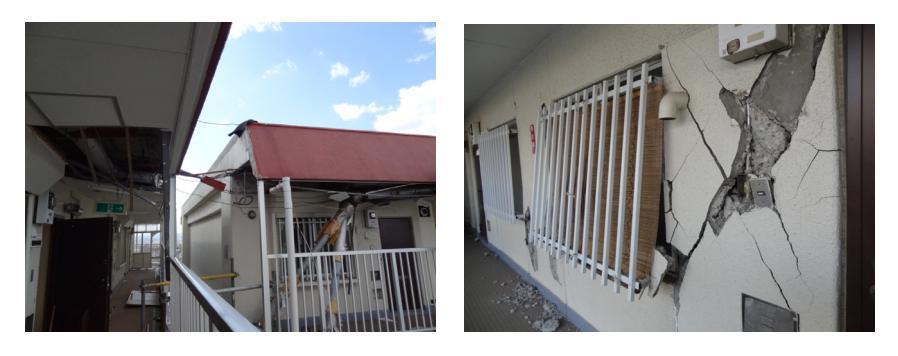
The state of the damaged buildings is shown in Photo 2, 3 and 4. The left photo of Photo 2 is the gap between the building A and B at the 14th floor that is the largest gap of over 1000mm. Large width shear cracks are observed in almost all the non-structural walls facing corridors and balconies as shown in the right photo of Photo 2. This phenomenon was also observed in the damage by the 1978 earthquake.

Photo 2. Gap between the buildings at the 14th floor and damaged non-structural wall

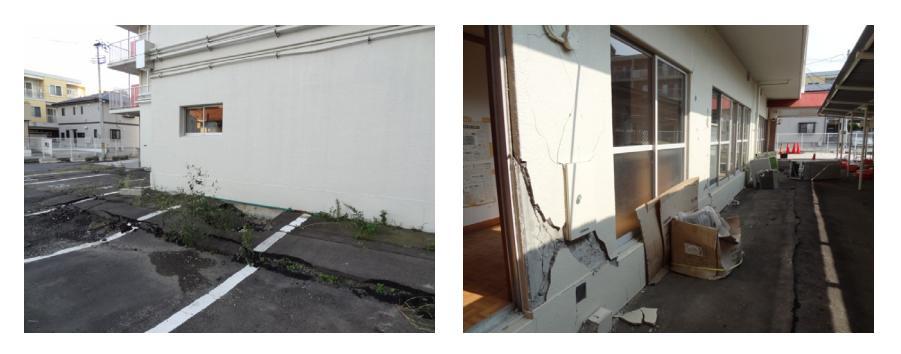
The left photo of Photo 3 shows damage around the foundation of the north side of the building A. After the main shock of 2011/03/11, building A leans to the south. Difference in the level shown in the right photo of Photo 3 is considered to have been generated by the uplifting behaviour induced by the inclination of the building A. This difference in the level is about 14cm, and settlement around the building is about 20 to 25cm. The left photo of Photo 3 shows damage of non-structural wall of the south facade at the first floor of the building A. Severe shear crack is observed as well as the upper floors. Large gap running on the ground is recognized in the right photo of Photo 3. This large gap is also considered to have induced by the uplifting behaviour of the building A to the south.

As mentioned above, the building A leans to the south. The inclination is considered to be the effect of the uplifting behaviour caused by heavy damage at the pile head of some pile groups. Damage around the foundation of the building A indicates the inclination of the building. Moreover, the angle of the inclination of each housing unit at all the floors was measured by the electrical spirit level. Results show that the angle of the inclination of the housing unit floor is about 1/40 to 1/60 corresponding to the estimated angle of the gap between the buildings.

Photo 3. Damage around the foundation and damaged non-structural wall at the first floor

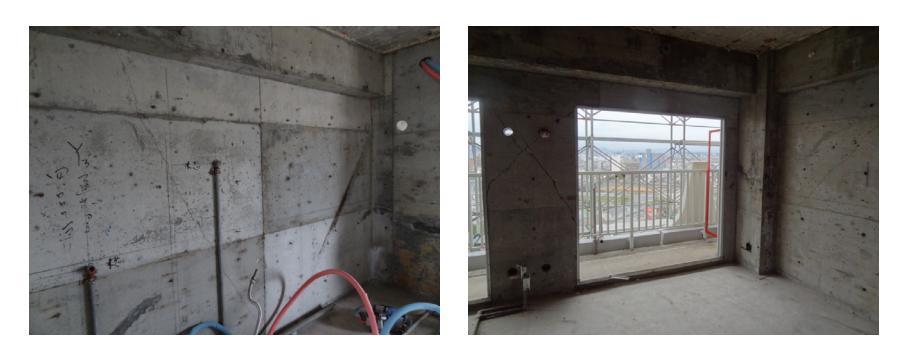
Demolition works of both buildings have started after 2012. At the middle of April 2012, the 14th floor of the building A were completely disappeared. The 13th and 14th floors of the building B remained just the structural elements as SRC columns, girders, beams and earthquake resisting walls without interior elements in each dwelling units. Shear cracks on the earthquake resisting walls have been observed at each dwelling units of the 13th and 14th floors of the building B shown in Photo 4. Shear cracks were measured in each dwelling unit at the two floors and width of the largest one was

about 1mm. On the other hand, narrow shear cracks on the earthquake resisting walls have been observed at one dwelling unit of the 11th floor of the building A. Observed shear cracks on earthquake resisting walls of the building B indicate that input energy by shaking to the building B was greater than the building A. This meets good agreement with the fact that the input energy of the earthquake to the leaned building A is considered to have been absorbed at the severely damaged pile heads.

Photo 4. Shear cracks on the earthquake resisting walls at the 14th floor of the building B
